**DRAFT**  
**GEOTECHNICAL BASIS OF DESIGN**  
**CARLSBAD BEACH ACCESS REPAIRS**  
**CARLSBAD, CALIFORNIA**

*REFERENCE: CIP PROJECT 3896*

Prepared by  
**TERRACOSTA CONSULTING GROUP, INC.**  
San Diego, California

Project No. 3009  
July 3, 2018

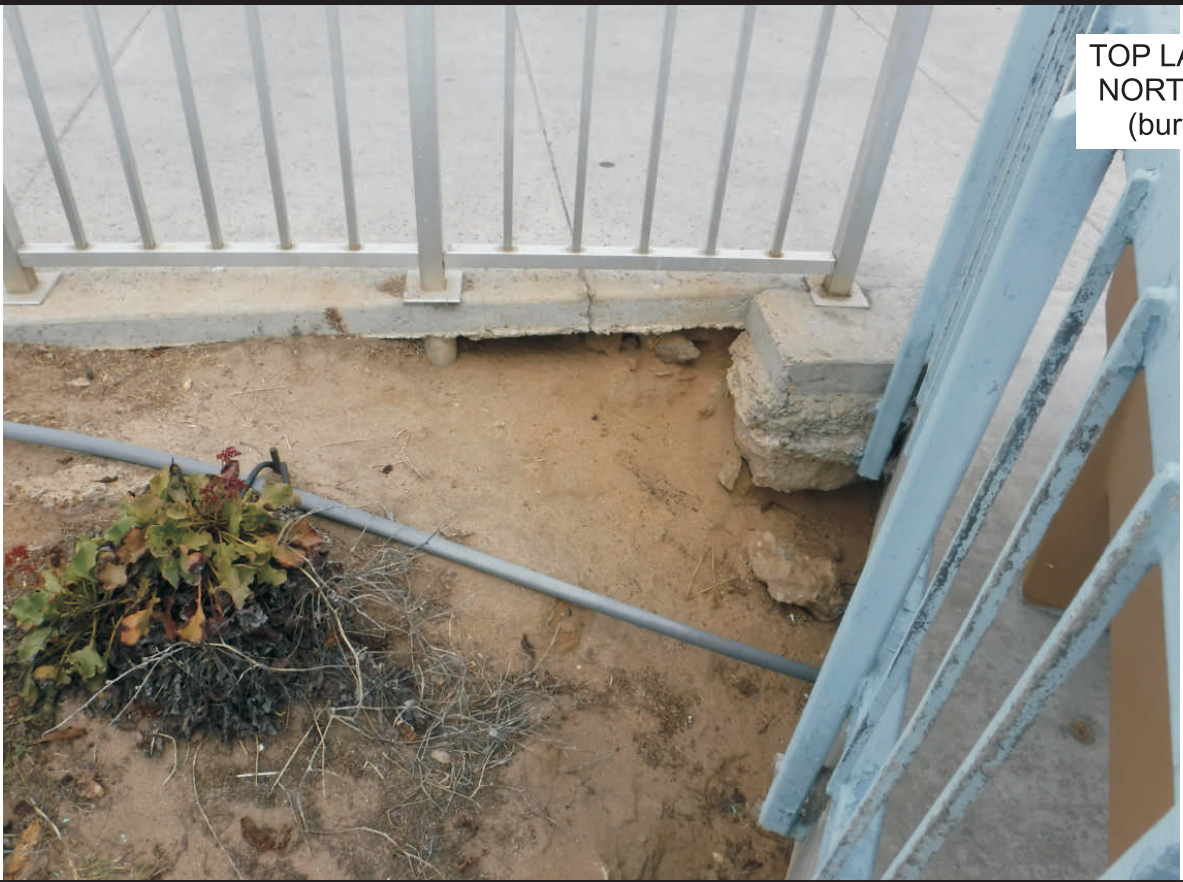
TOP LANDING  
NORTH SIDE  
(burrows)

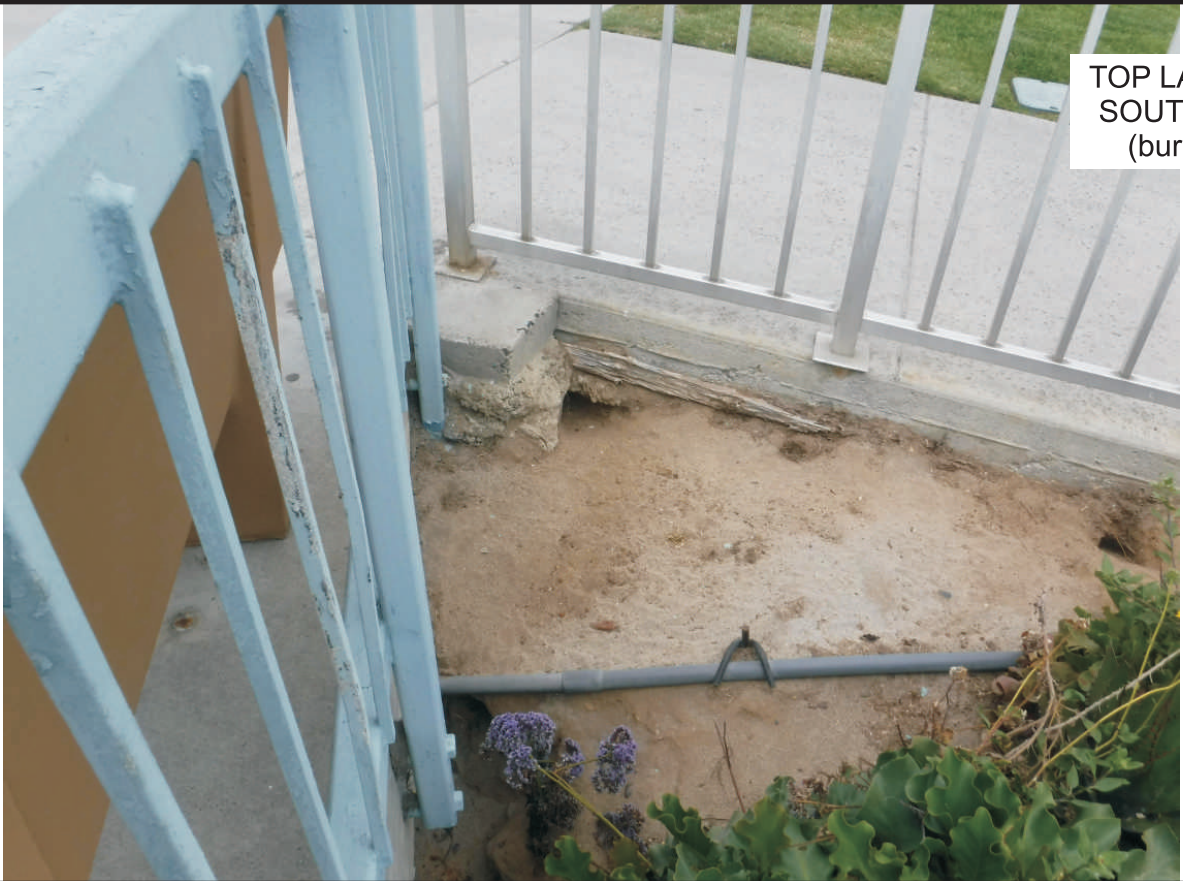
TOP LANDING  
SOUTH SIDE  
(burrows)

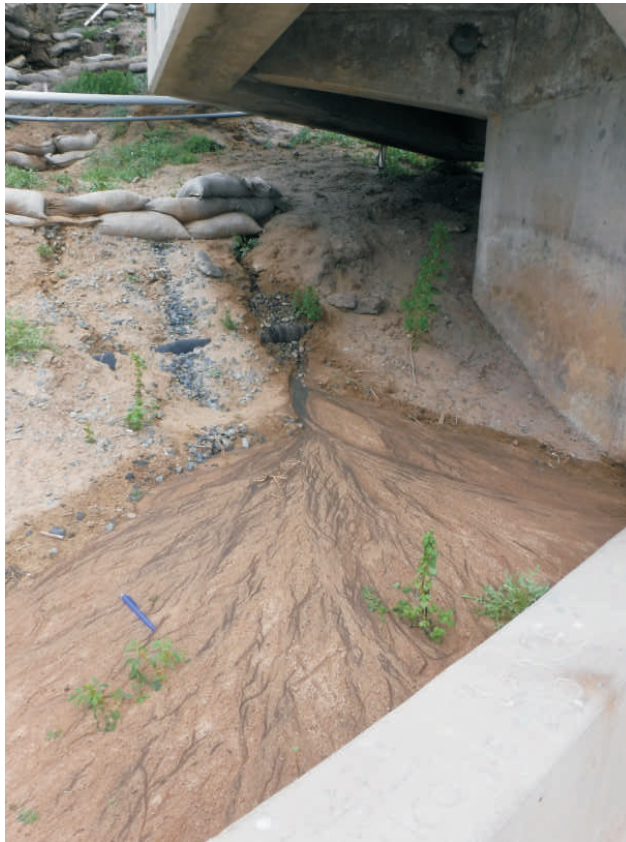
appears to be the result of an irrigation line break/leak. The soils in this rill are moist to wet. The accumulated soils at the base of this rill are moist to wet. Fill soils with asphalt and concrete debris are apparent at and near this stairway.

GULLY AND  
WET SOILS  
(Due to  
irrigation leak?)

**It is our opinion that erosion mitigation measures and/or modifications to this bluff-face area may be warranted.** Such measures and/or modifications include inspection and repair of irrigation pipes and sprinklers. **Other measures and/or modifications for consideration include enhanced interception and control of surface water flow and using alternate soil-retaining devices to replace the existing sand bags and wattles and to better stabilize the bluff-face soils.** In addition, care and minimal disturbance of slope soils should be considered when working on the slope. For example, if removal of the old railroad-tie stairway is proposed, the bluff-face soils should not be disturbed as much as practicable. Also, the vertical rebar should not be pulled out of the bluff face, but can be cut off at the slope face.

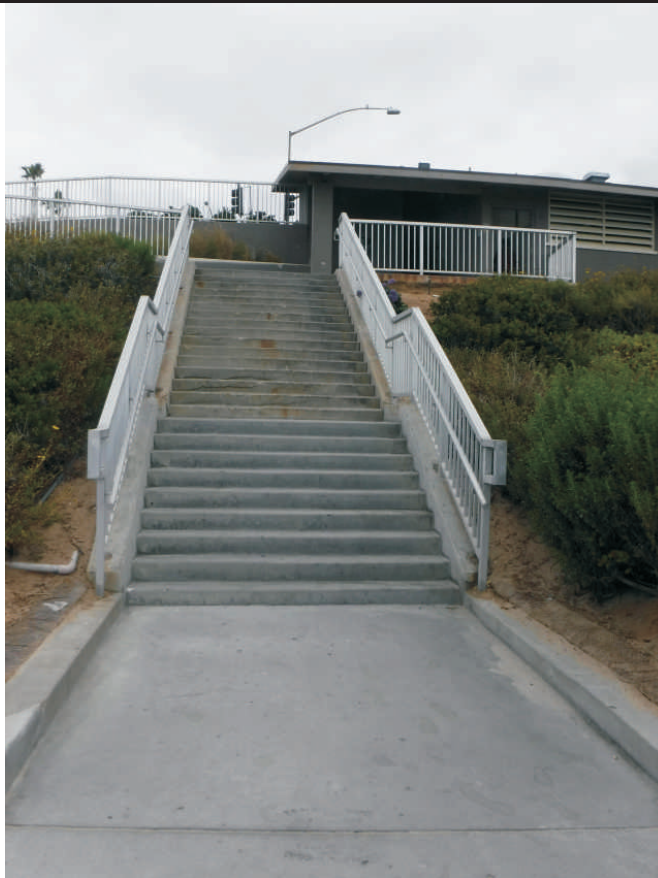
Note that soils have eroded away from foundation

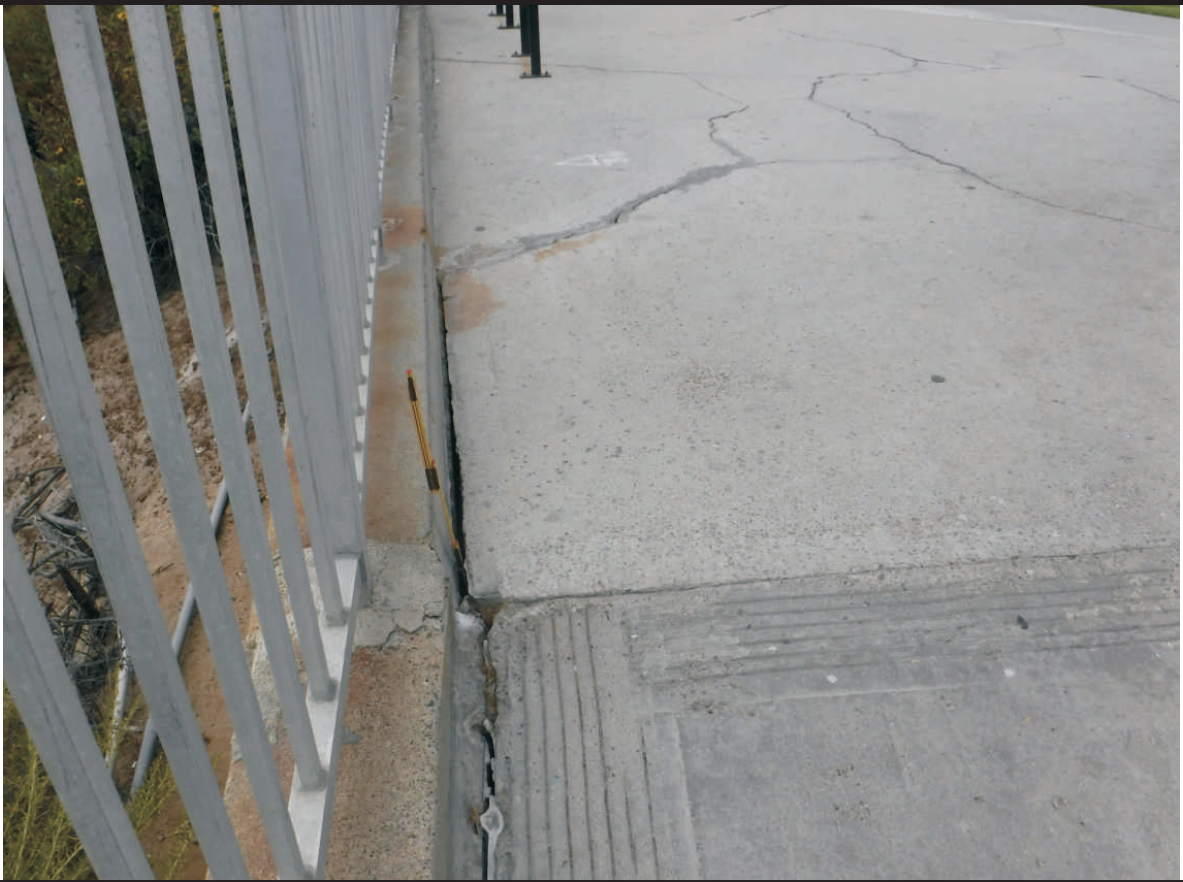
Almost 2-foot deep  
void under sidewalk

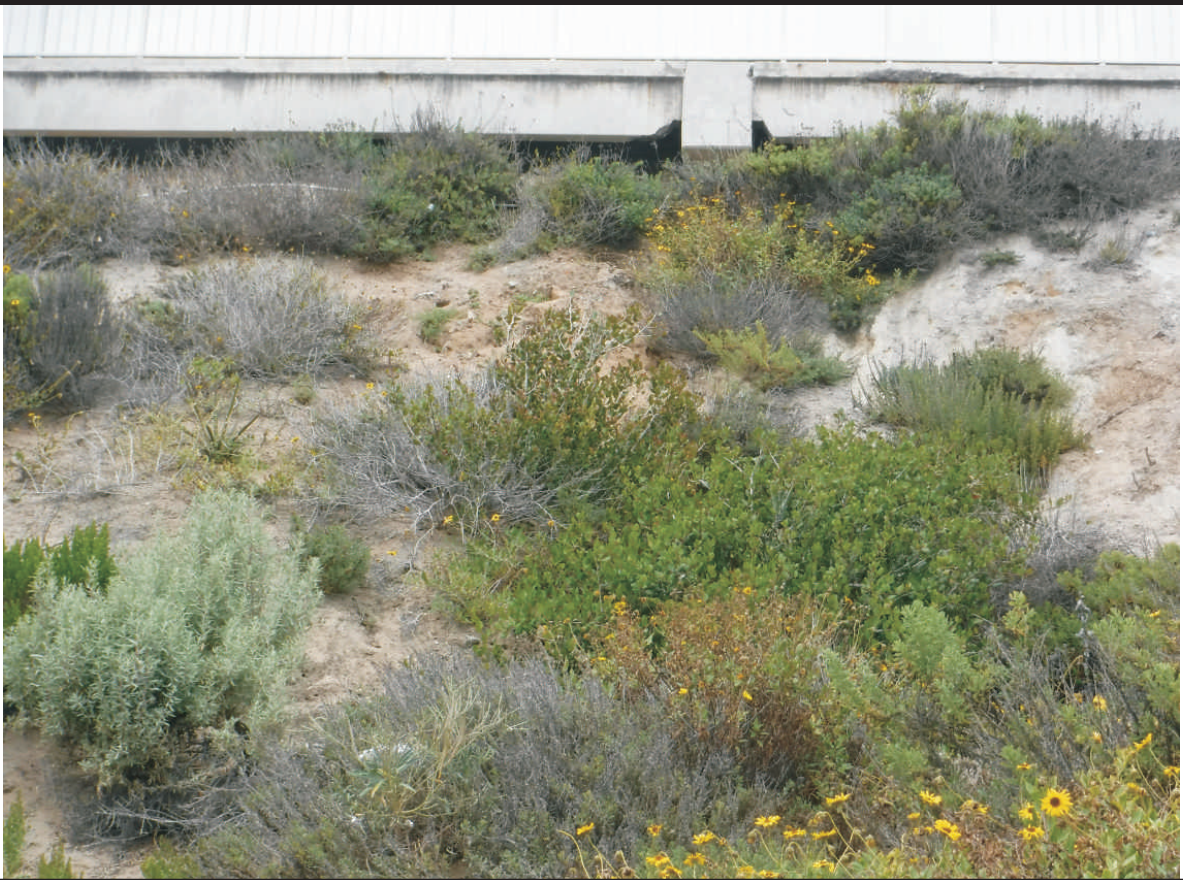
Looking down at sidewalk foundation

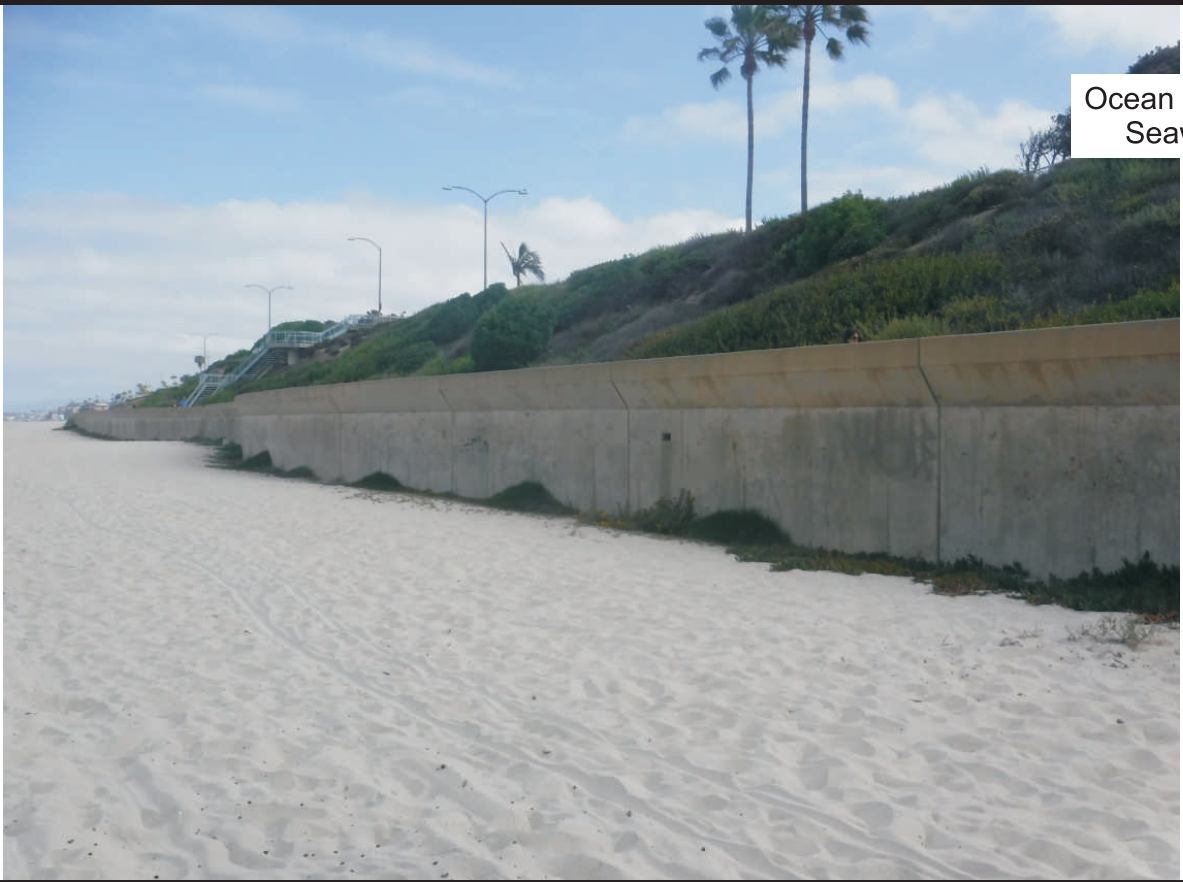
Ocean side of Seawall

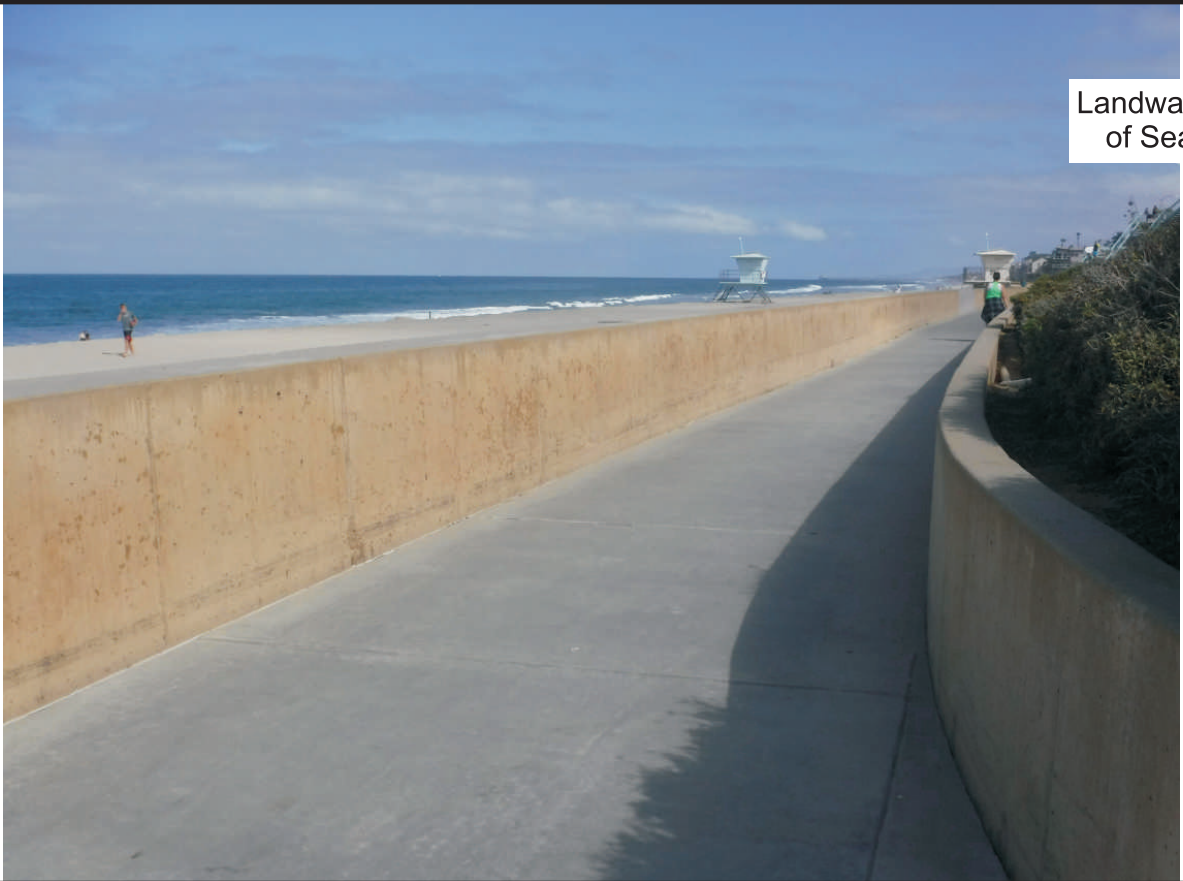
Landward side of Seawall
