APPENDIX D
Feasibility Study

VICTOR CONDO BUILDING

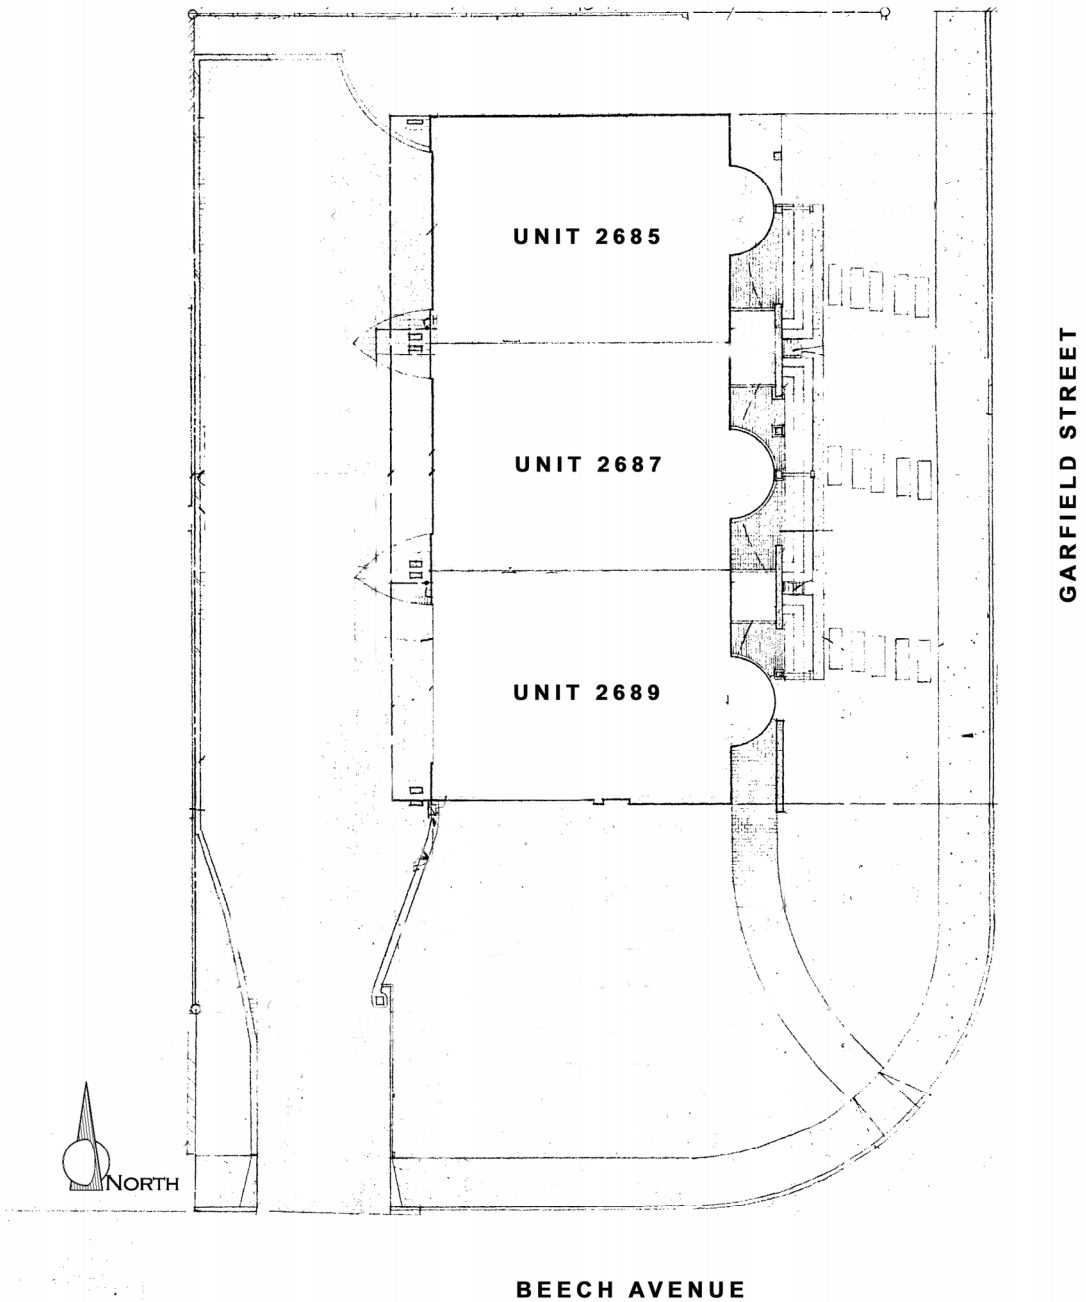
Figure 1: Site Plan.

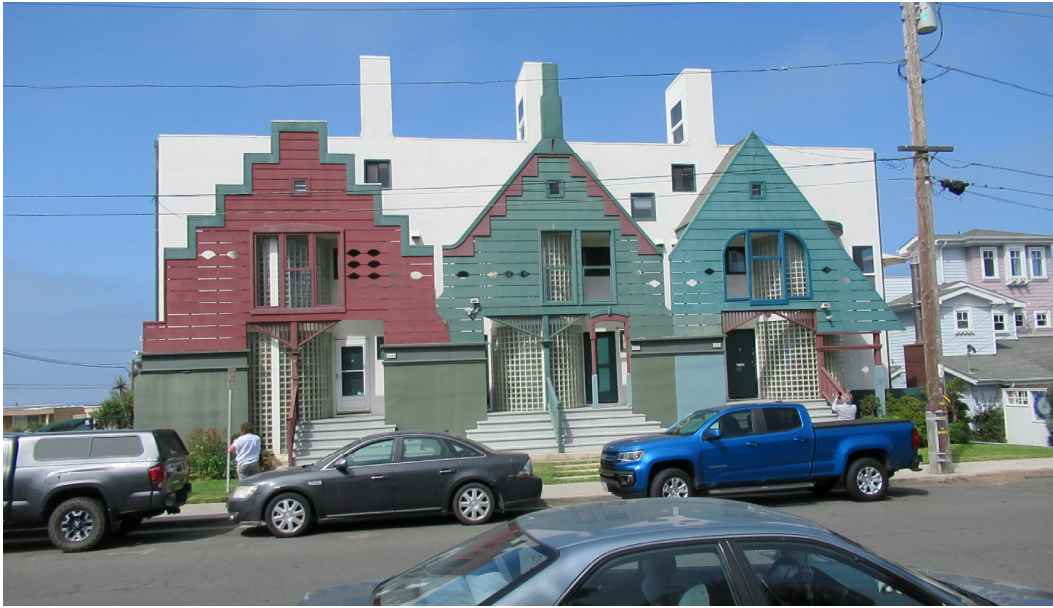
Photo 1: The Victor Condo Building looking west at the primary (east) façade showing the building's distinctive false front façade.

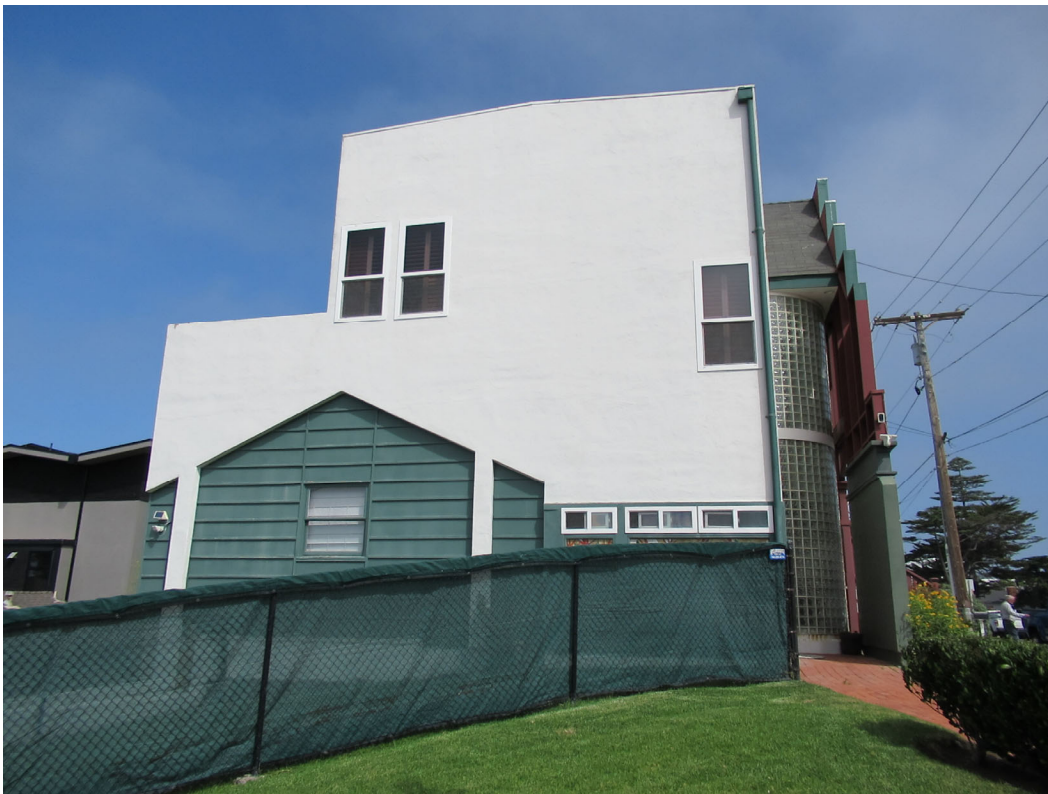
Photo 2: The south façade looking north. There is one original wood double-hung window. The other windows have been replaced.

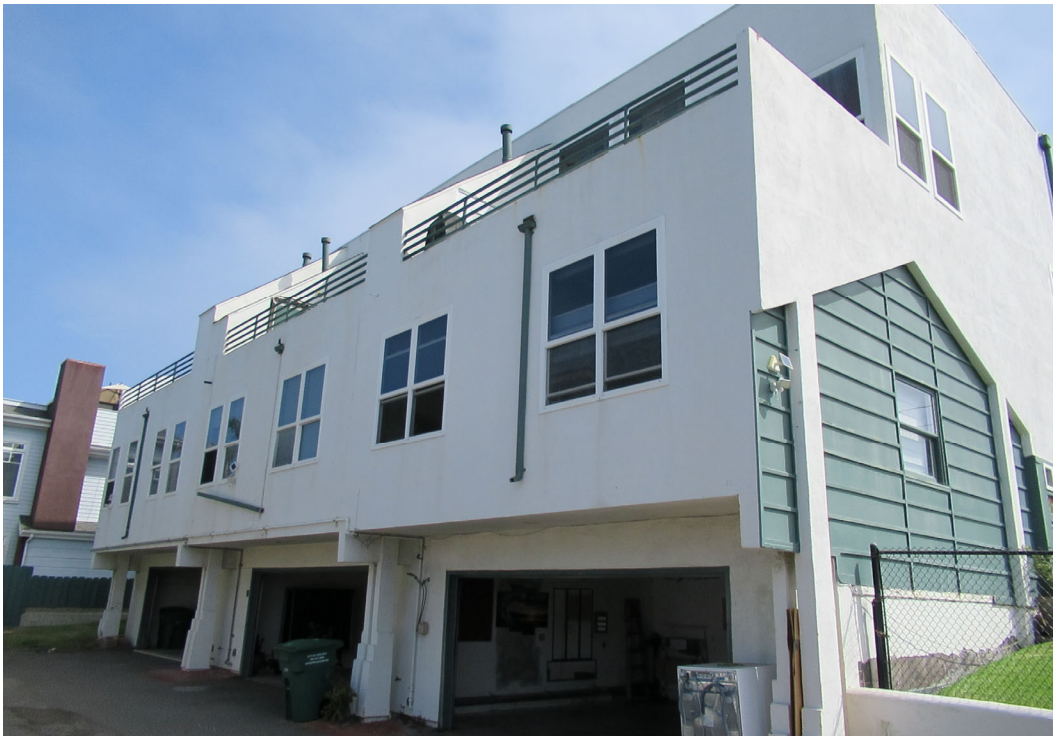
Photo 3: The rear (west) façade looking northeast. All of the windows and exterior doors on the west façade have been replaced.

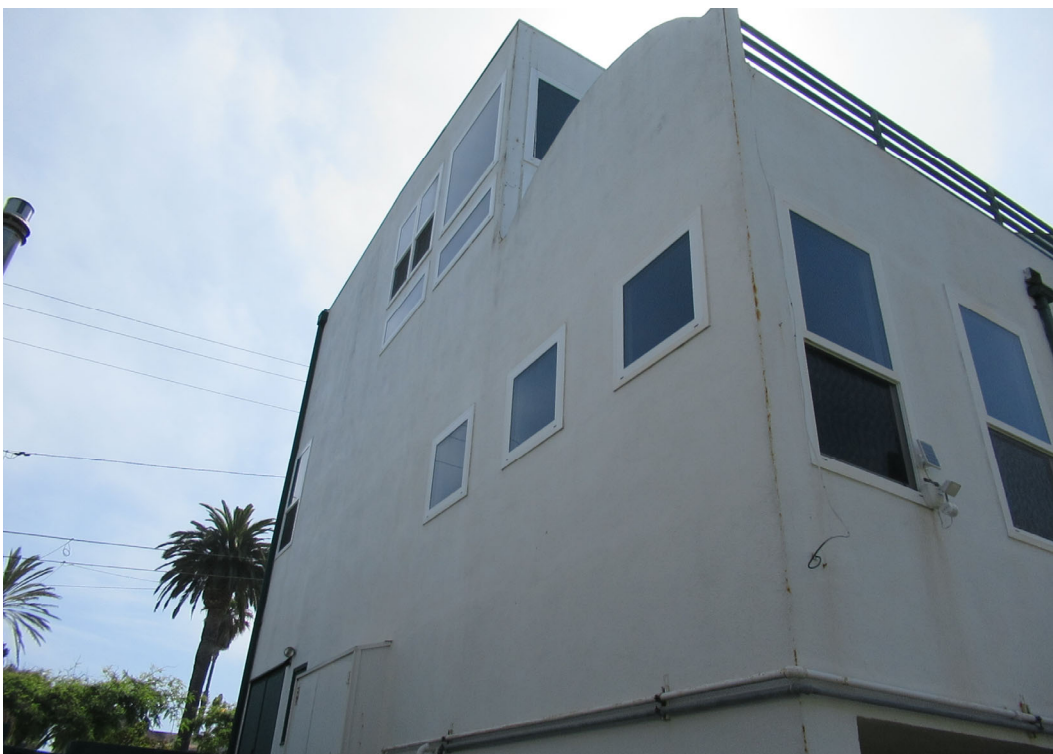
Photo 4: the north façade. All of the windows have been replaced.

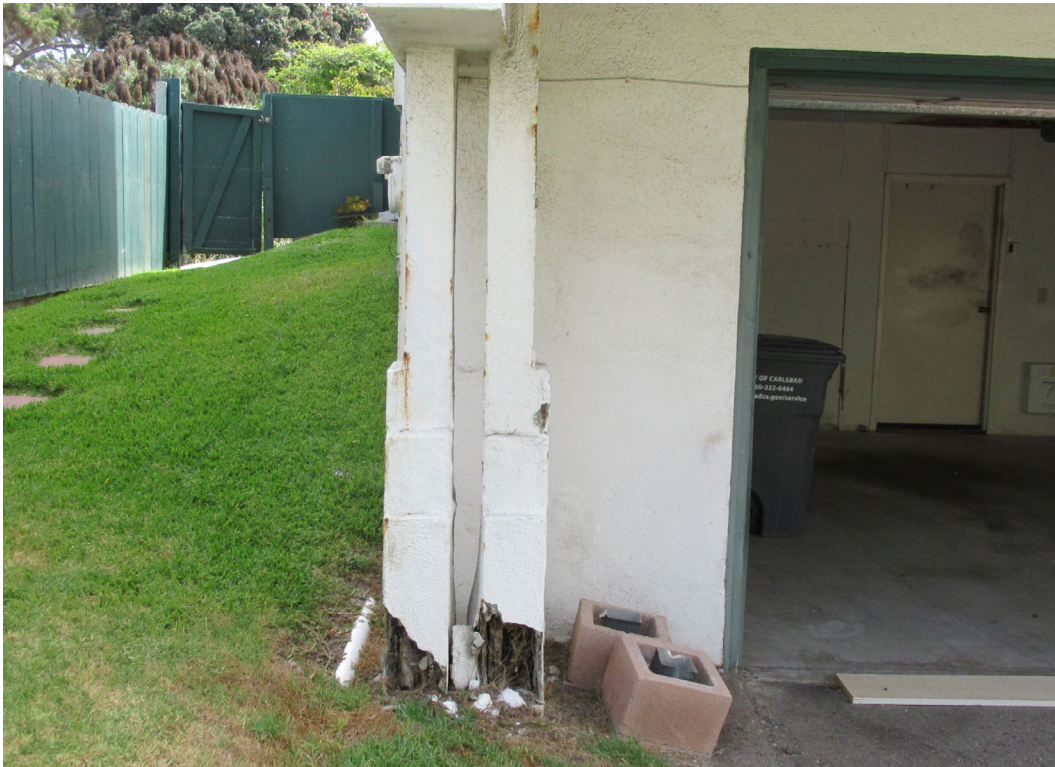
Photo 5: One of four pairs of damaged structural columns on the west façade.

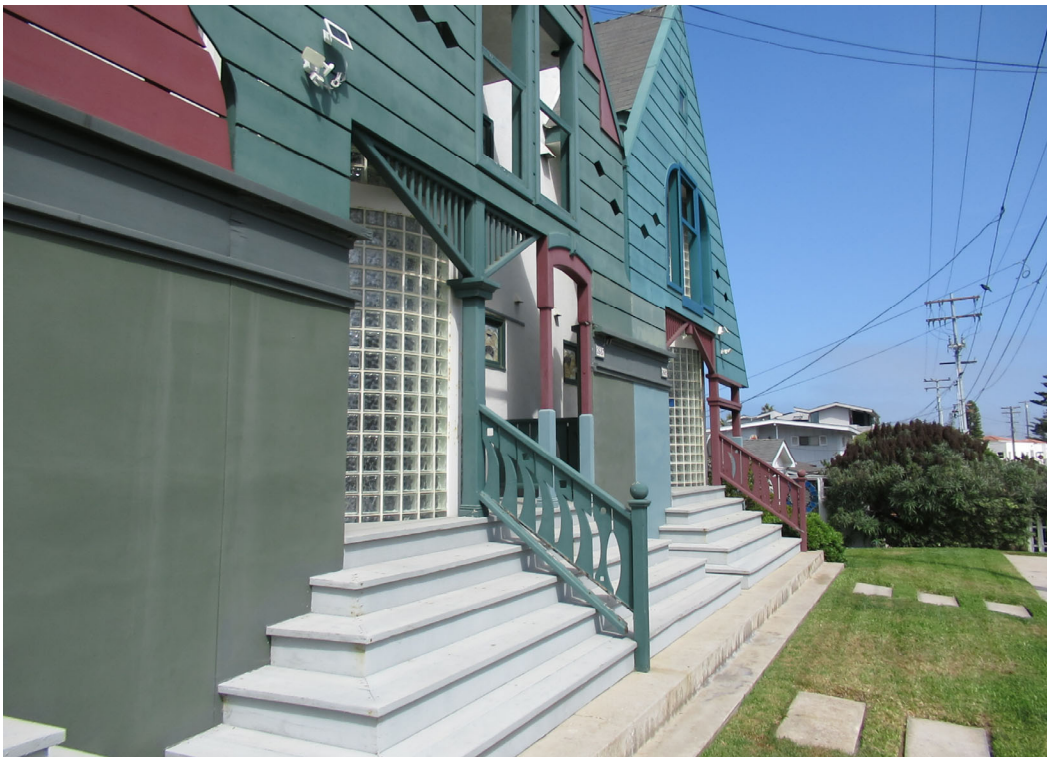
Photo 6: Front façade showing the existing wood steps, wood rails, and other decorative elements.

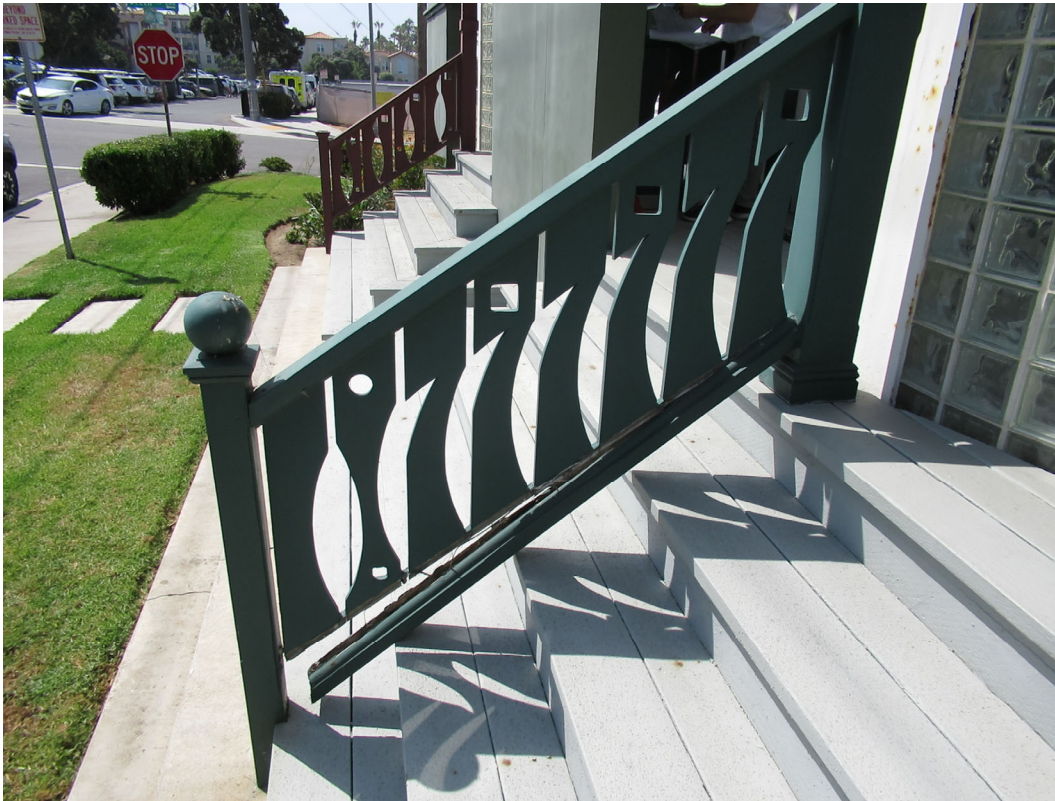
Photo 7: A damaged wood rail on the front (east) steps.

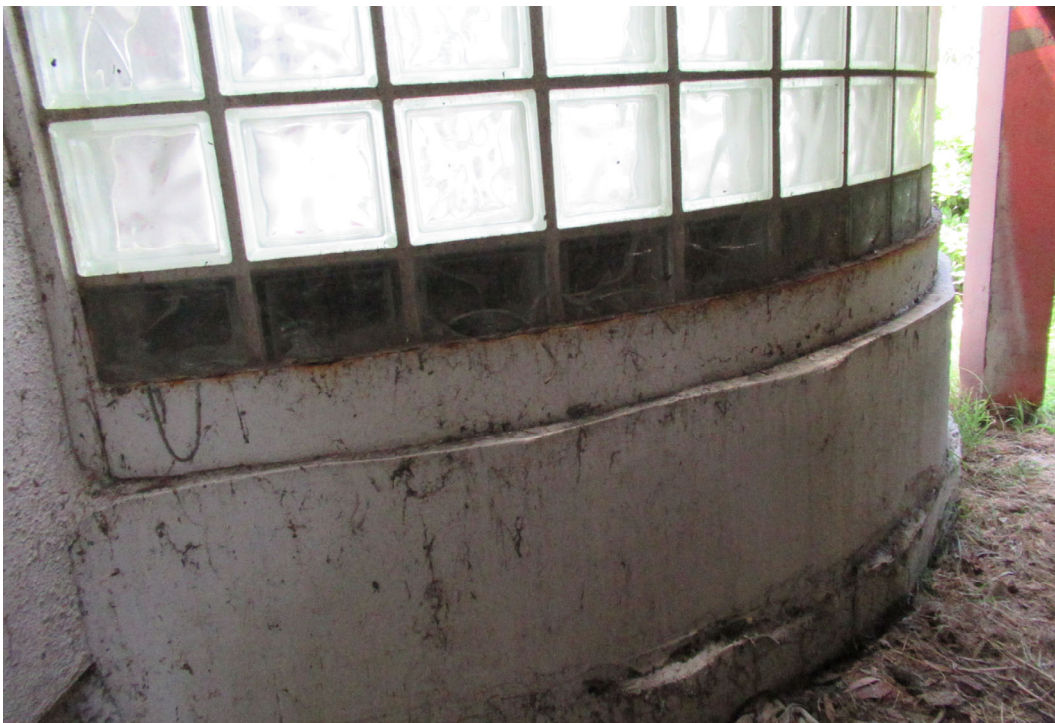
Photo 8: The base of the curved glass block wall at Unit 2689 showing the rusted steel sill and damaged/blocked bottom row of glass blocks.

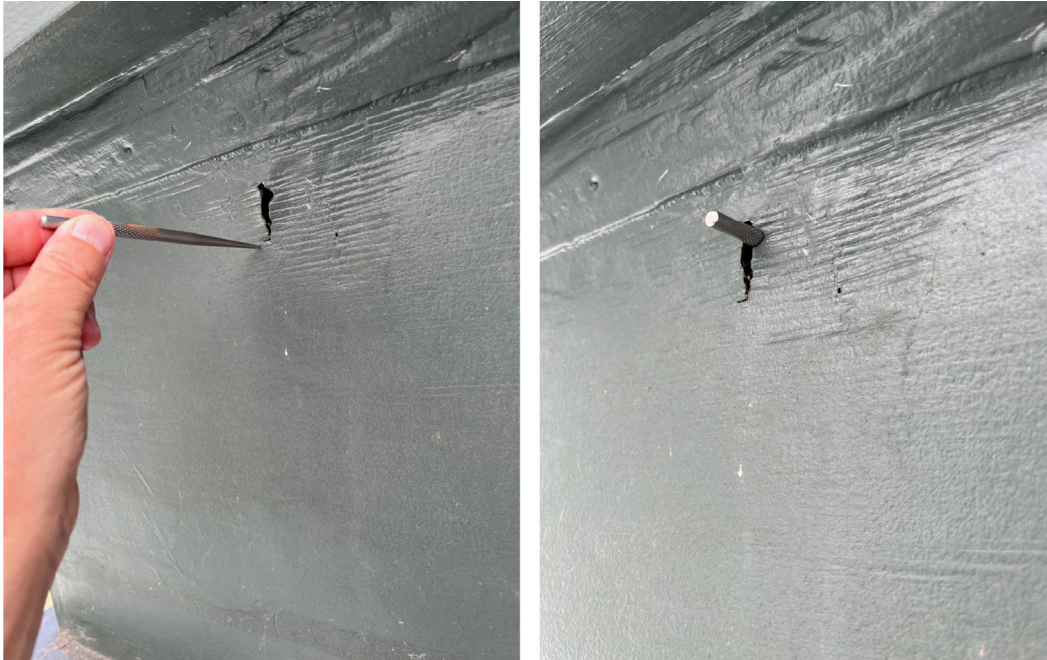
Photo 9: Wood beam damage at the false front. An awl is easily inserted into deteriorated wood framing indicating a large void.

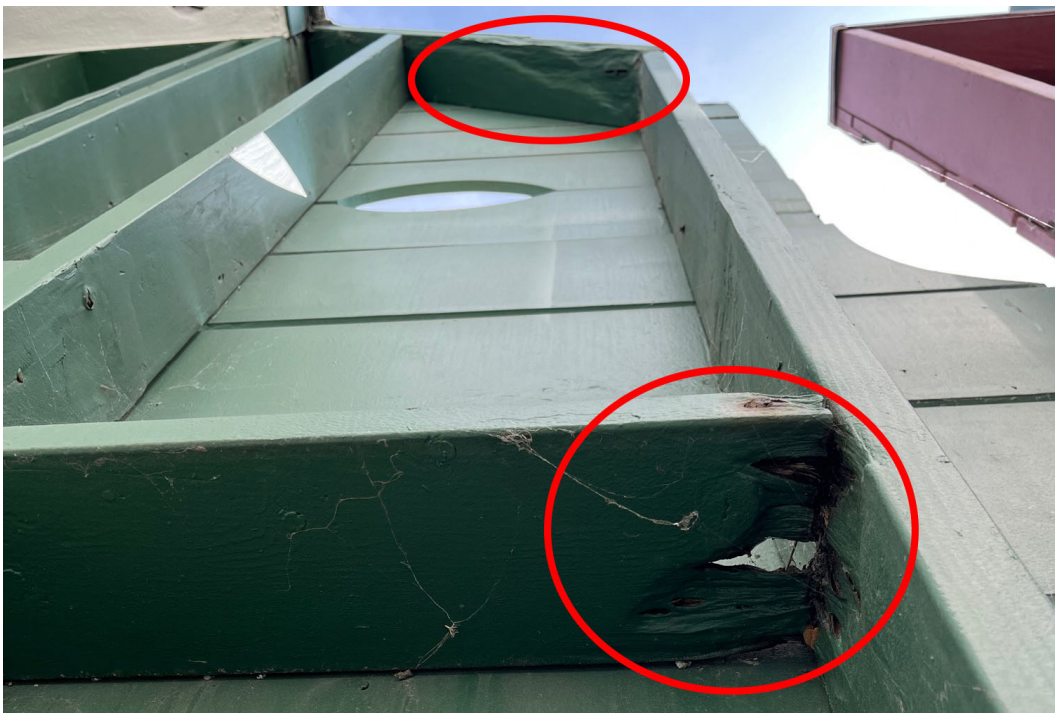
Photo 10: Additional wood damage (circled) in the structural framing of the false front.

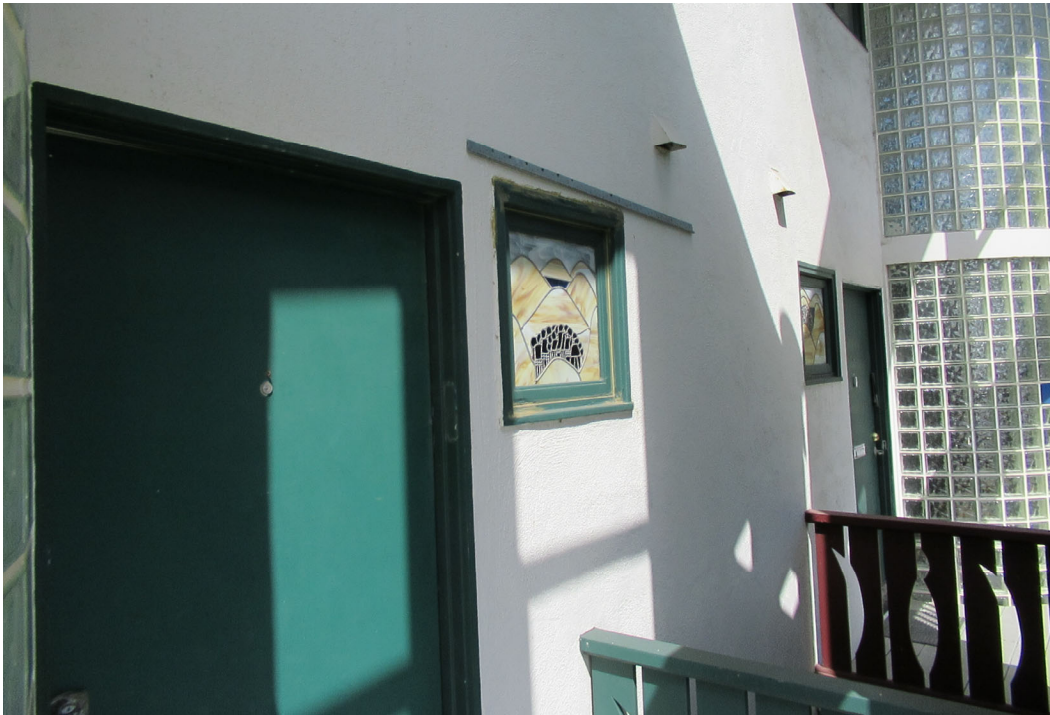
Photo 11: Two original stained-glass windows of the east façade.

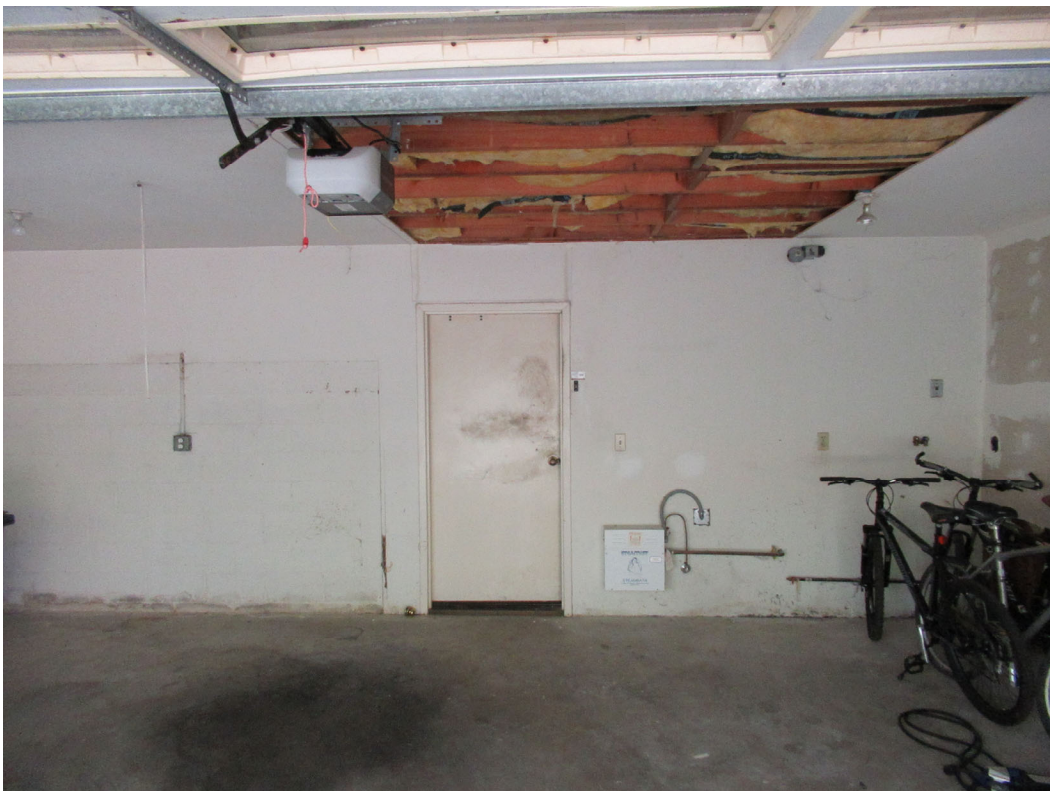
Photo 12: The garage at Unit 2685 showing missing ceiling finishes and efflorescence at the base of the east wall.

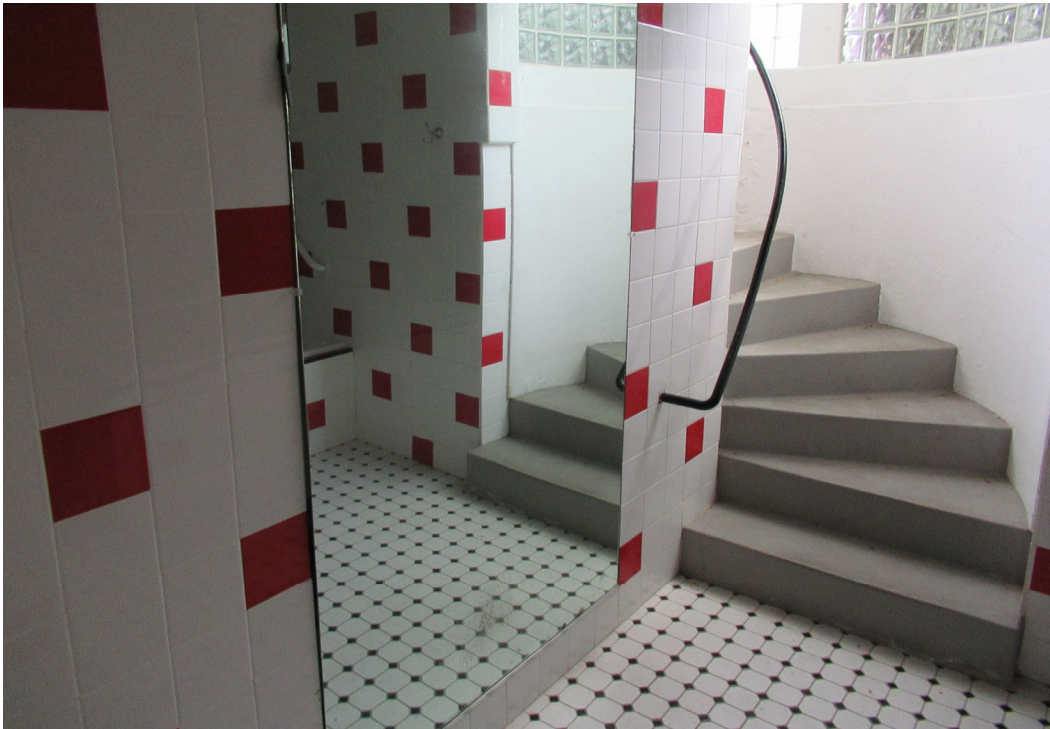
Photo 13: Basement Laundry Room at Unit 2685 which has been converted to a shower room. The existing wall and floor finishes are non-historic.

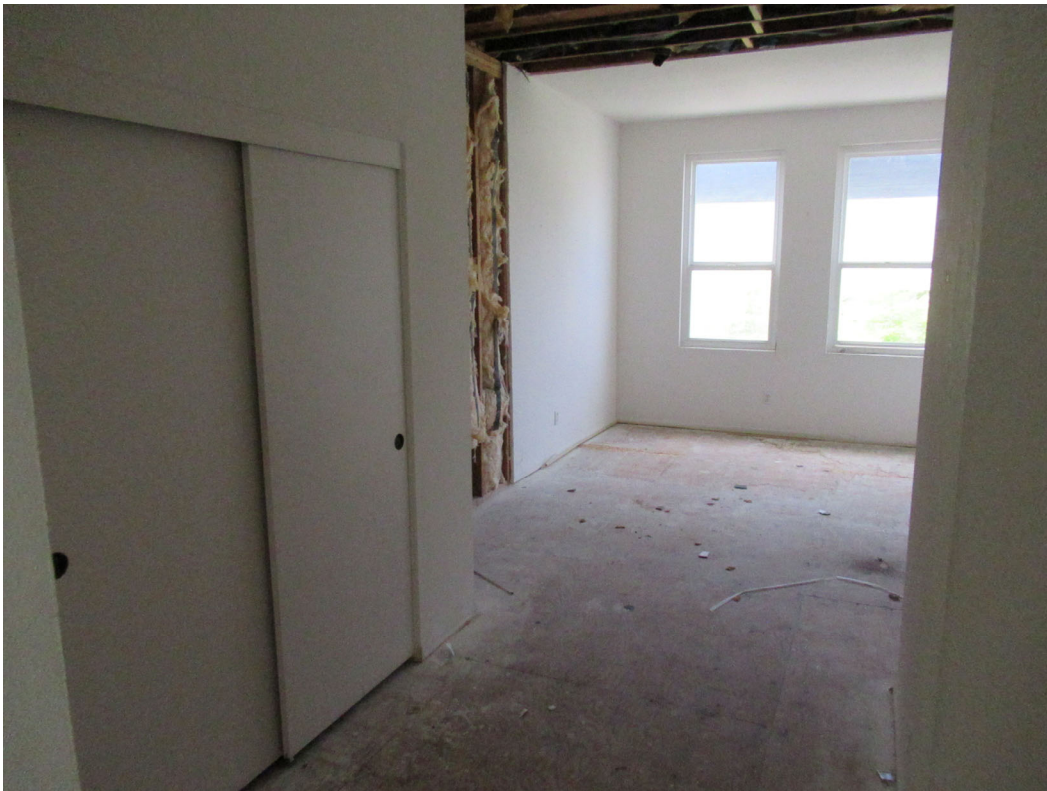
Photo 16: Bedroom 2C showing missing finishes.

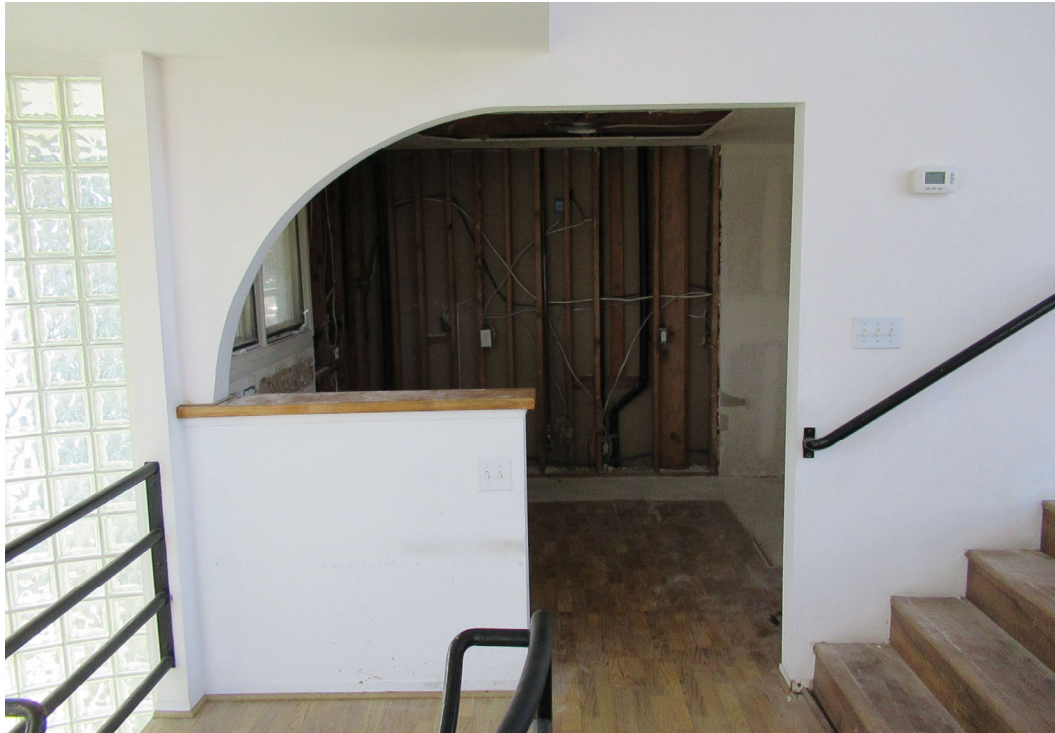
Photo 17: Original kitchen entrance in Unit 2685. Looking south from the Dining Room.

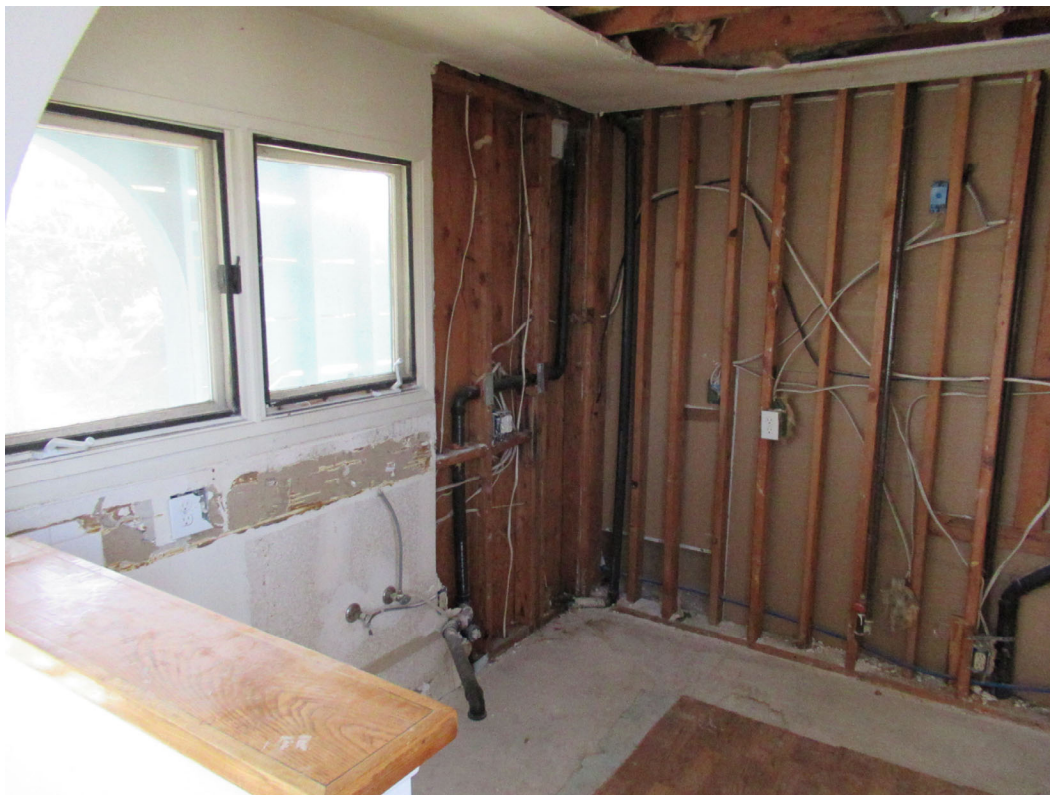
Photo 18: Missing cabinets, finishes, appliances, and fixtures Kitchen C.

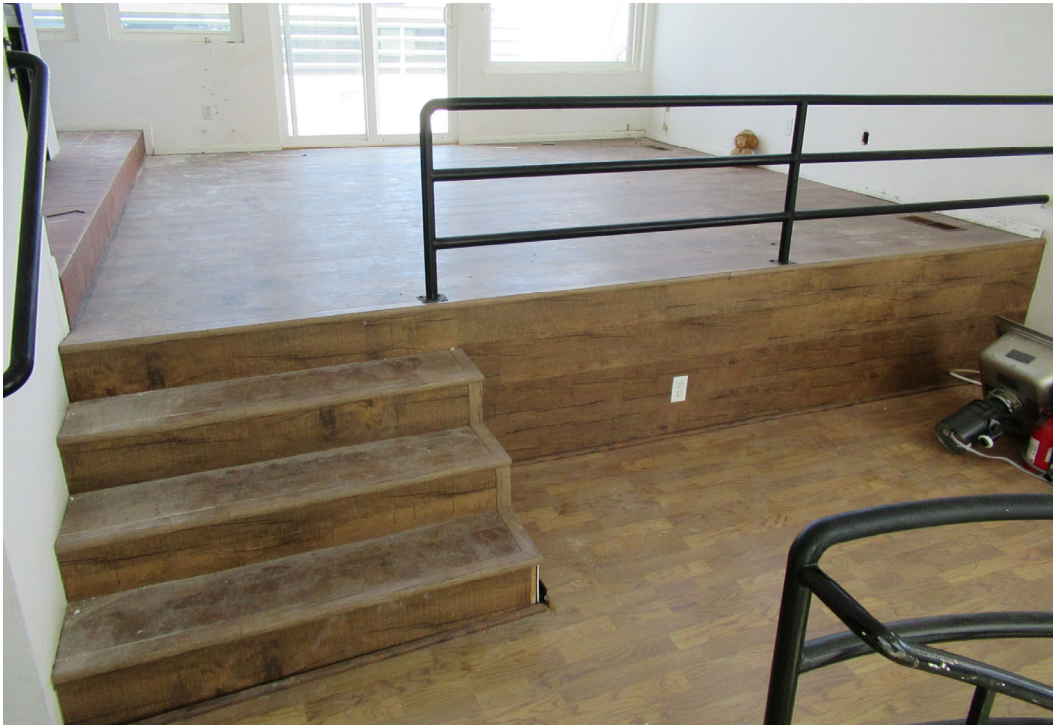
Photo 19: Dining Room C looking west toward the Living Room.

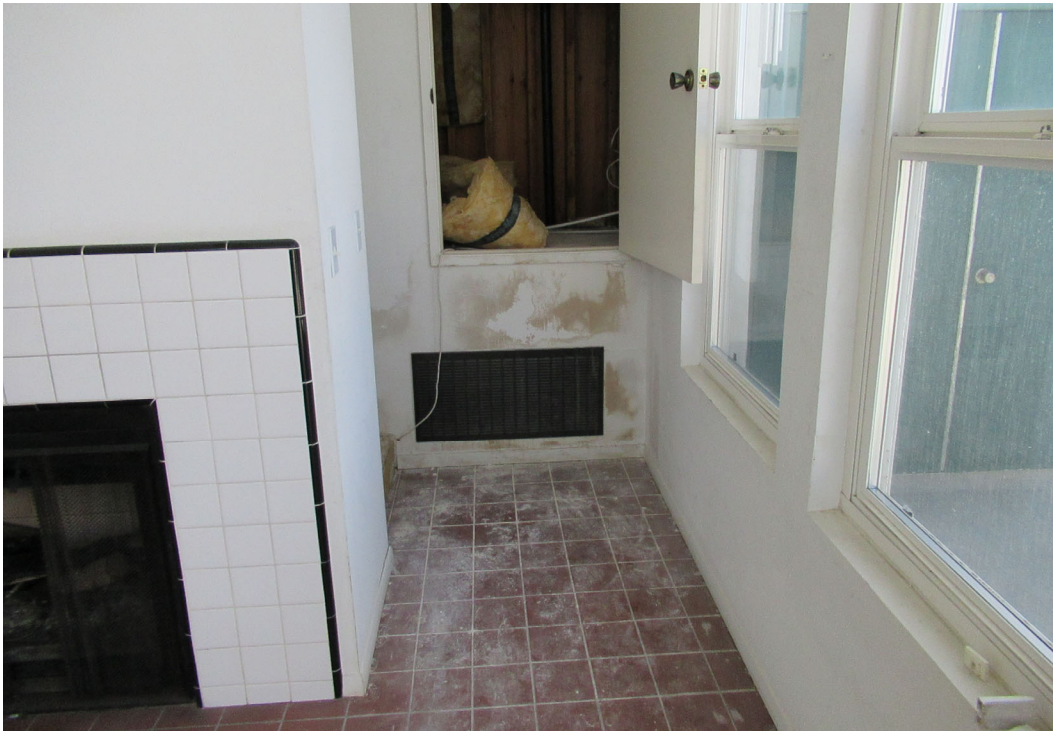
Photo 23: Damaged/stained wall under a mechanical closet on the south wall of Living Room C.

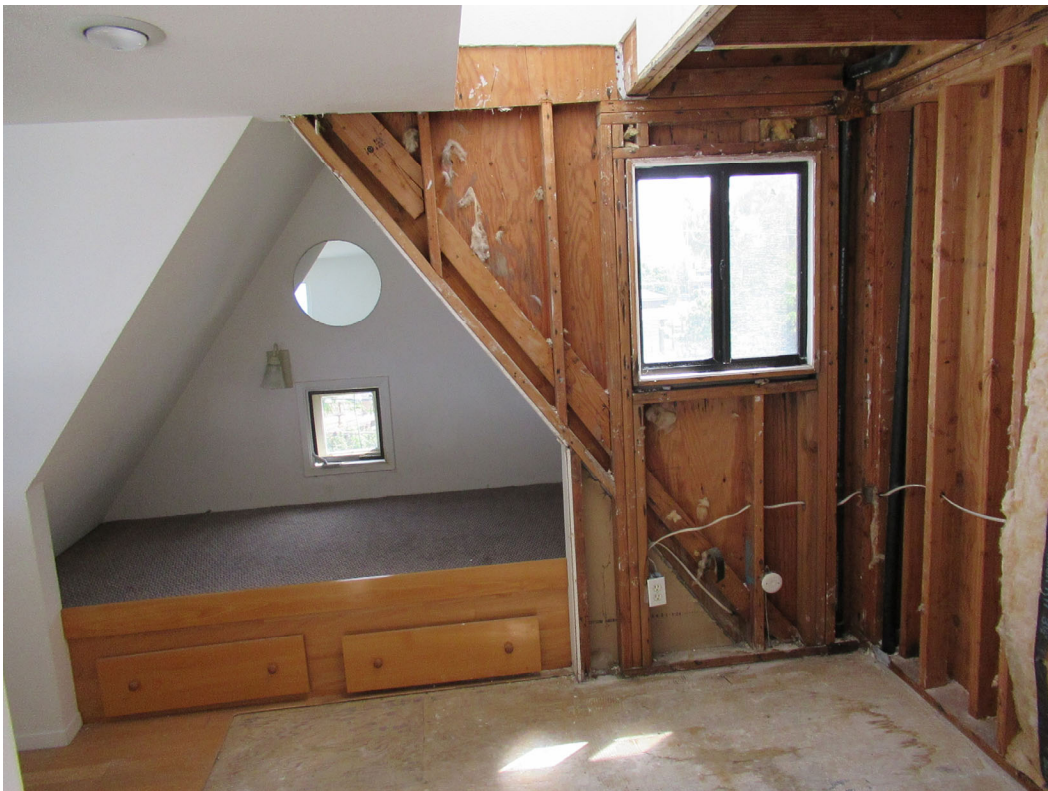
Photo 24: Damaged/missing wall and floor finishes at Mezzanine C.

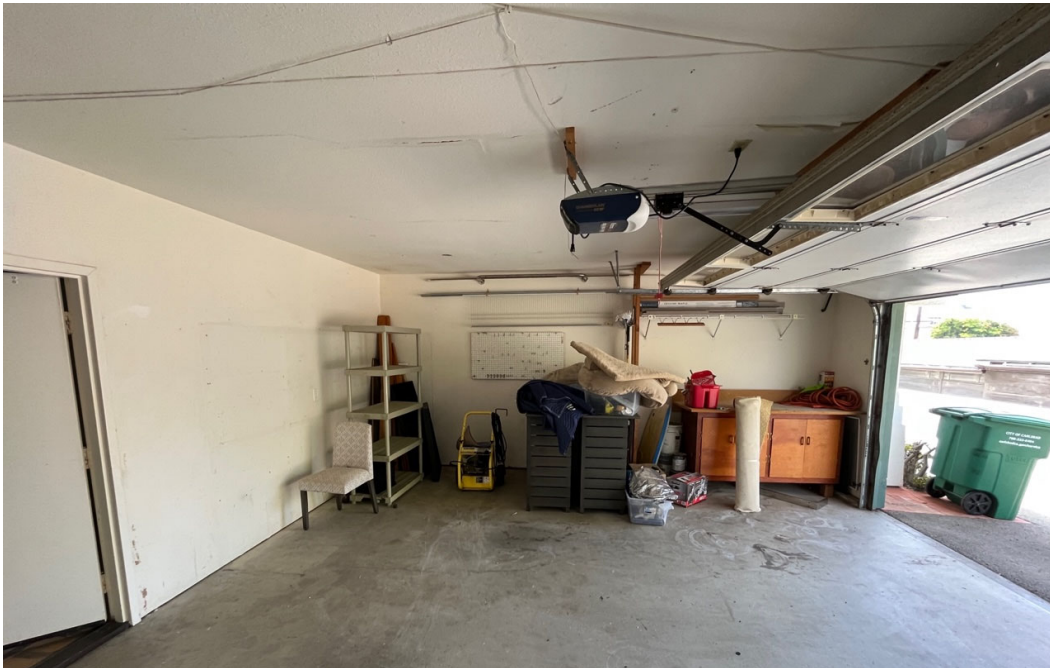
Photo 25: Garage B in Unit 2687 looking south.

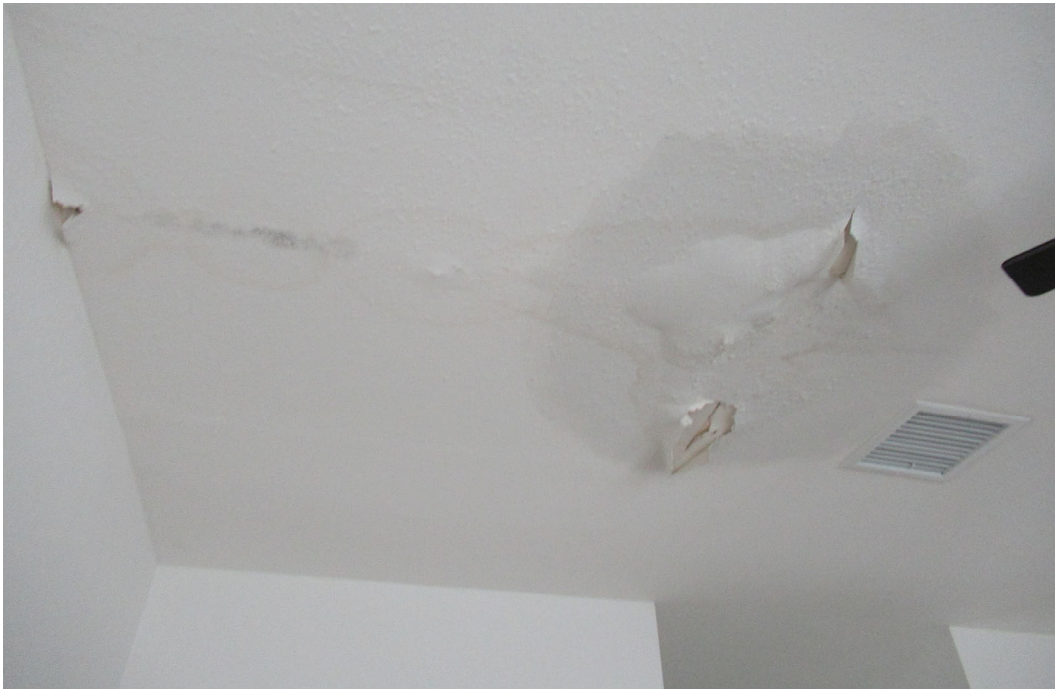
Photo 31: Water damages at the ceiling of Bedroom 2B.

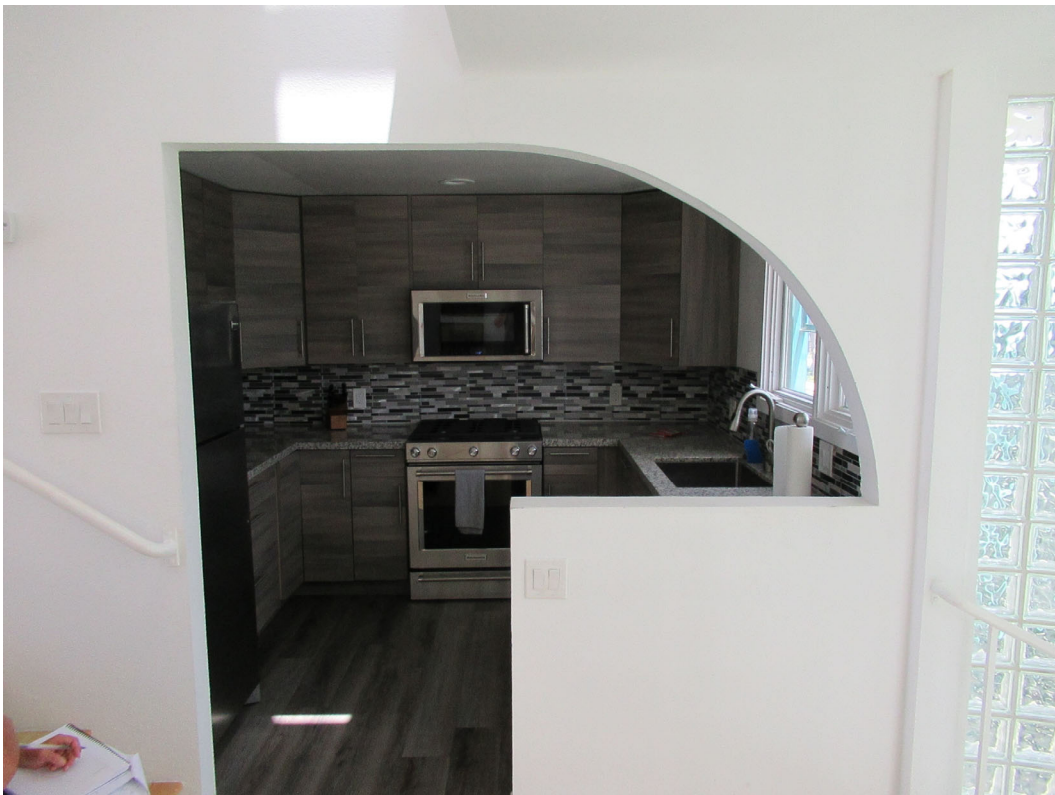
Photo 32: Kitchen B showing non-historic cabinets, tile back splash, appliances, and countertops.

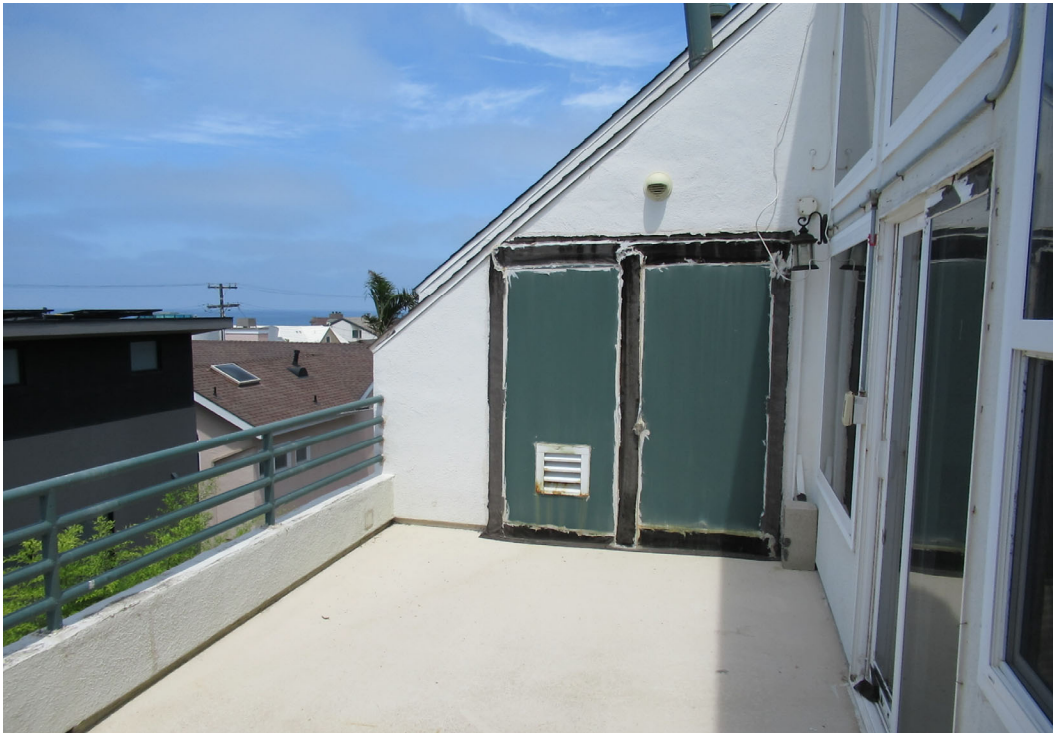
Photo 35: Balcony B showing damages/sealed double doors leading to the mechanical closet.

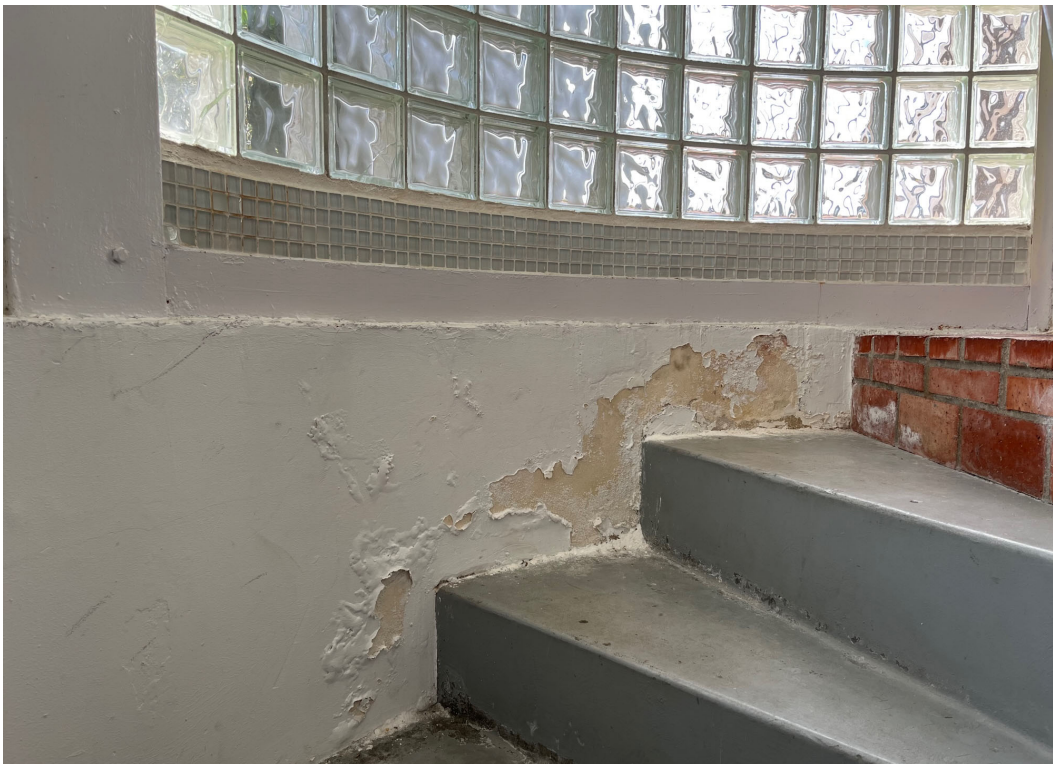
Photo 36: Wall damage at the base of the curved glass block wall in Unit 2689. Moisture is seeping through the CMU foundation wall and the bottom row of glass blocks are covered with non-historic tile on the interior to conceal damage.

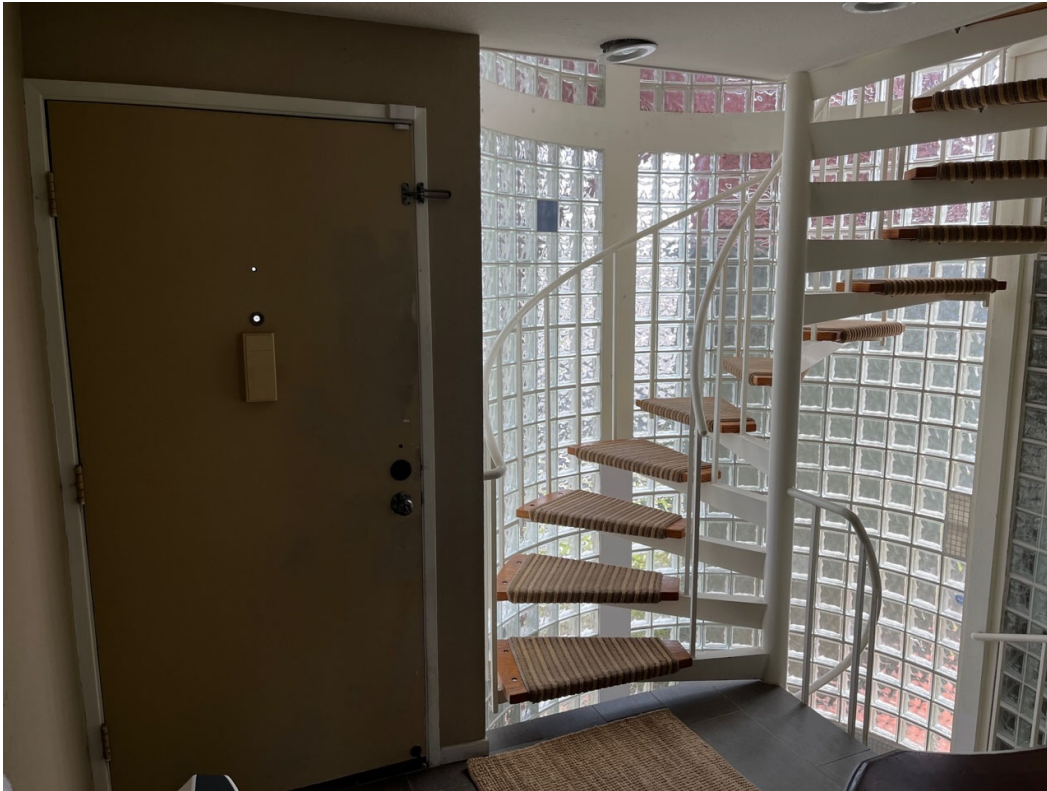
Photo 37: Entry C looking west toward the front entrance and spiral stairs.

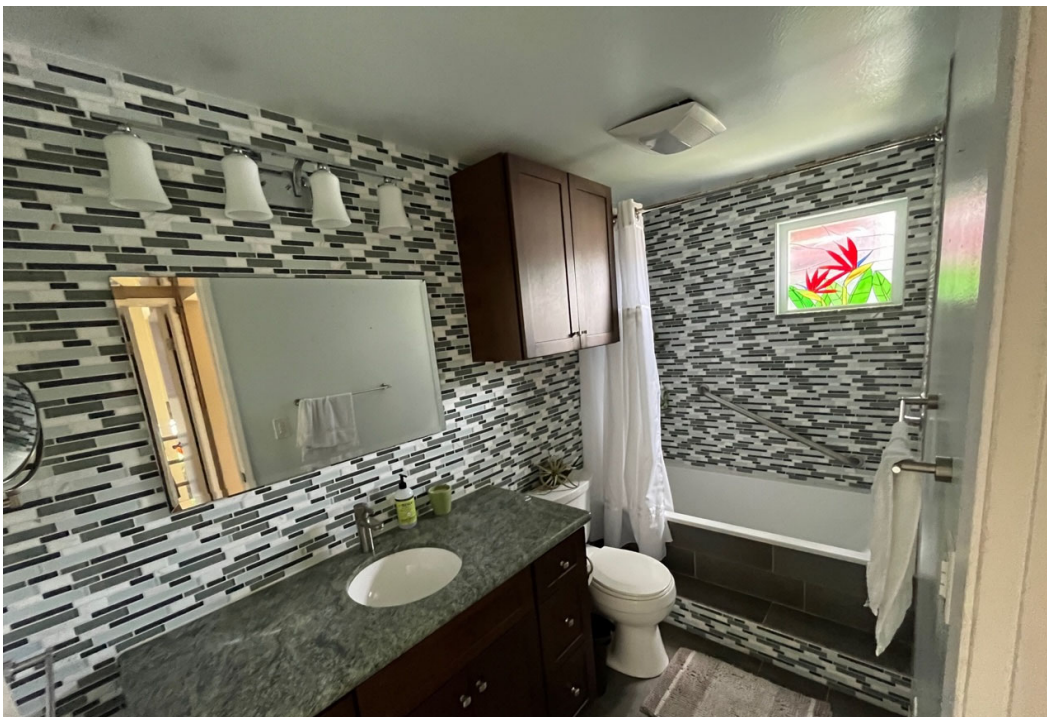
Photo 38: Bathroom 2A showing non-historic fixtures and finishes and the replaced stained-glass window.

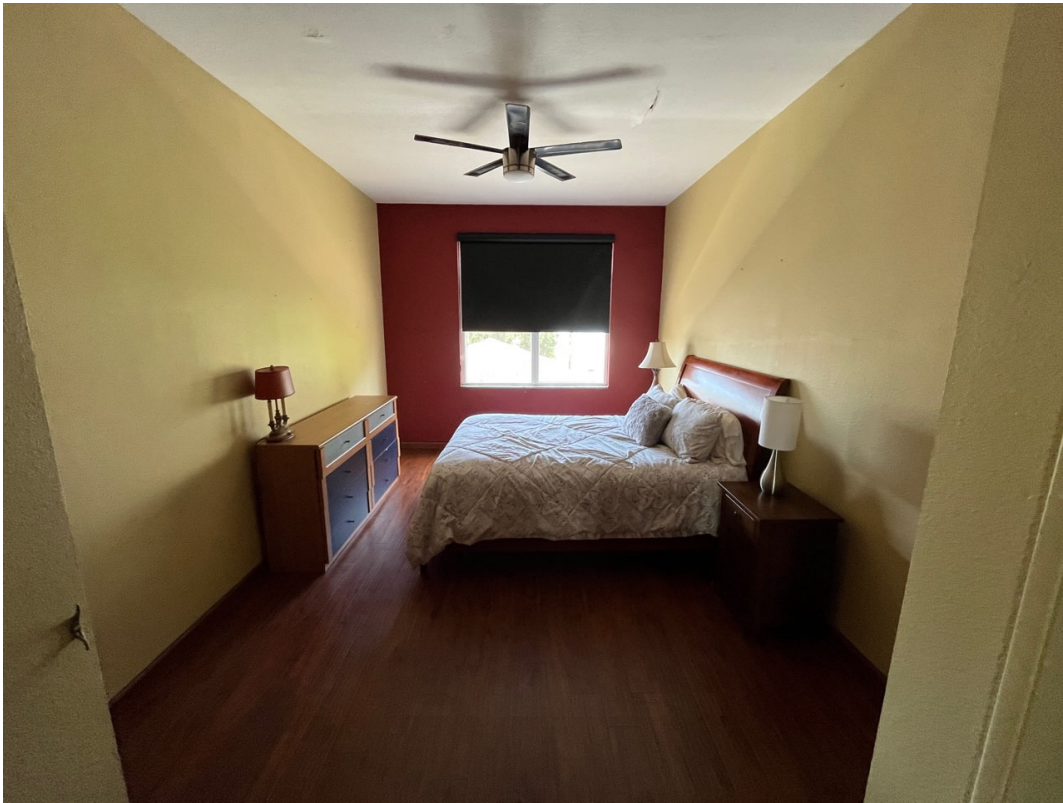
Photo 39: Bedroom 1A looking west.
