**SOUTHERN  
CALIFORNIA  
GEOTECHNICAL**  
*A California Corporation*

Proposal No.: **19G109-1**

Subject: **Surficial Geologic Mapping**  
Proposed Veterans Memorial Park  
Faraday Avenue at Whitman Way  
Carlsbad, California

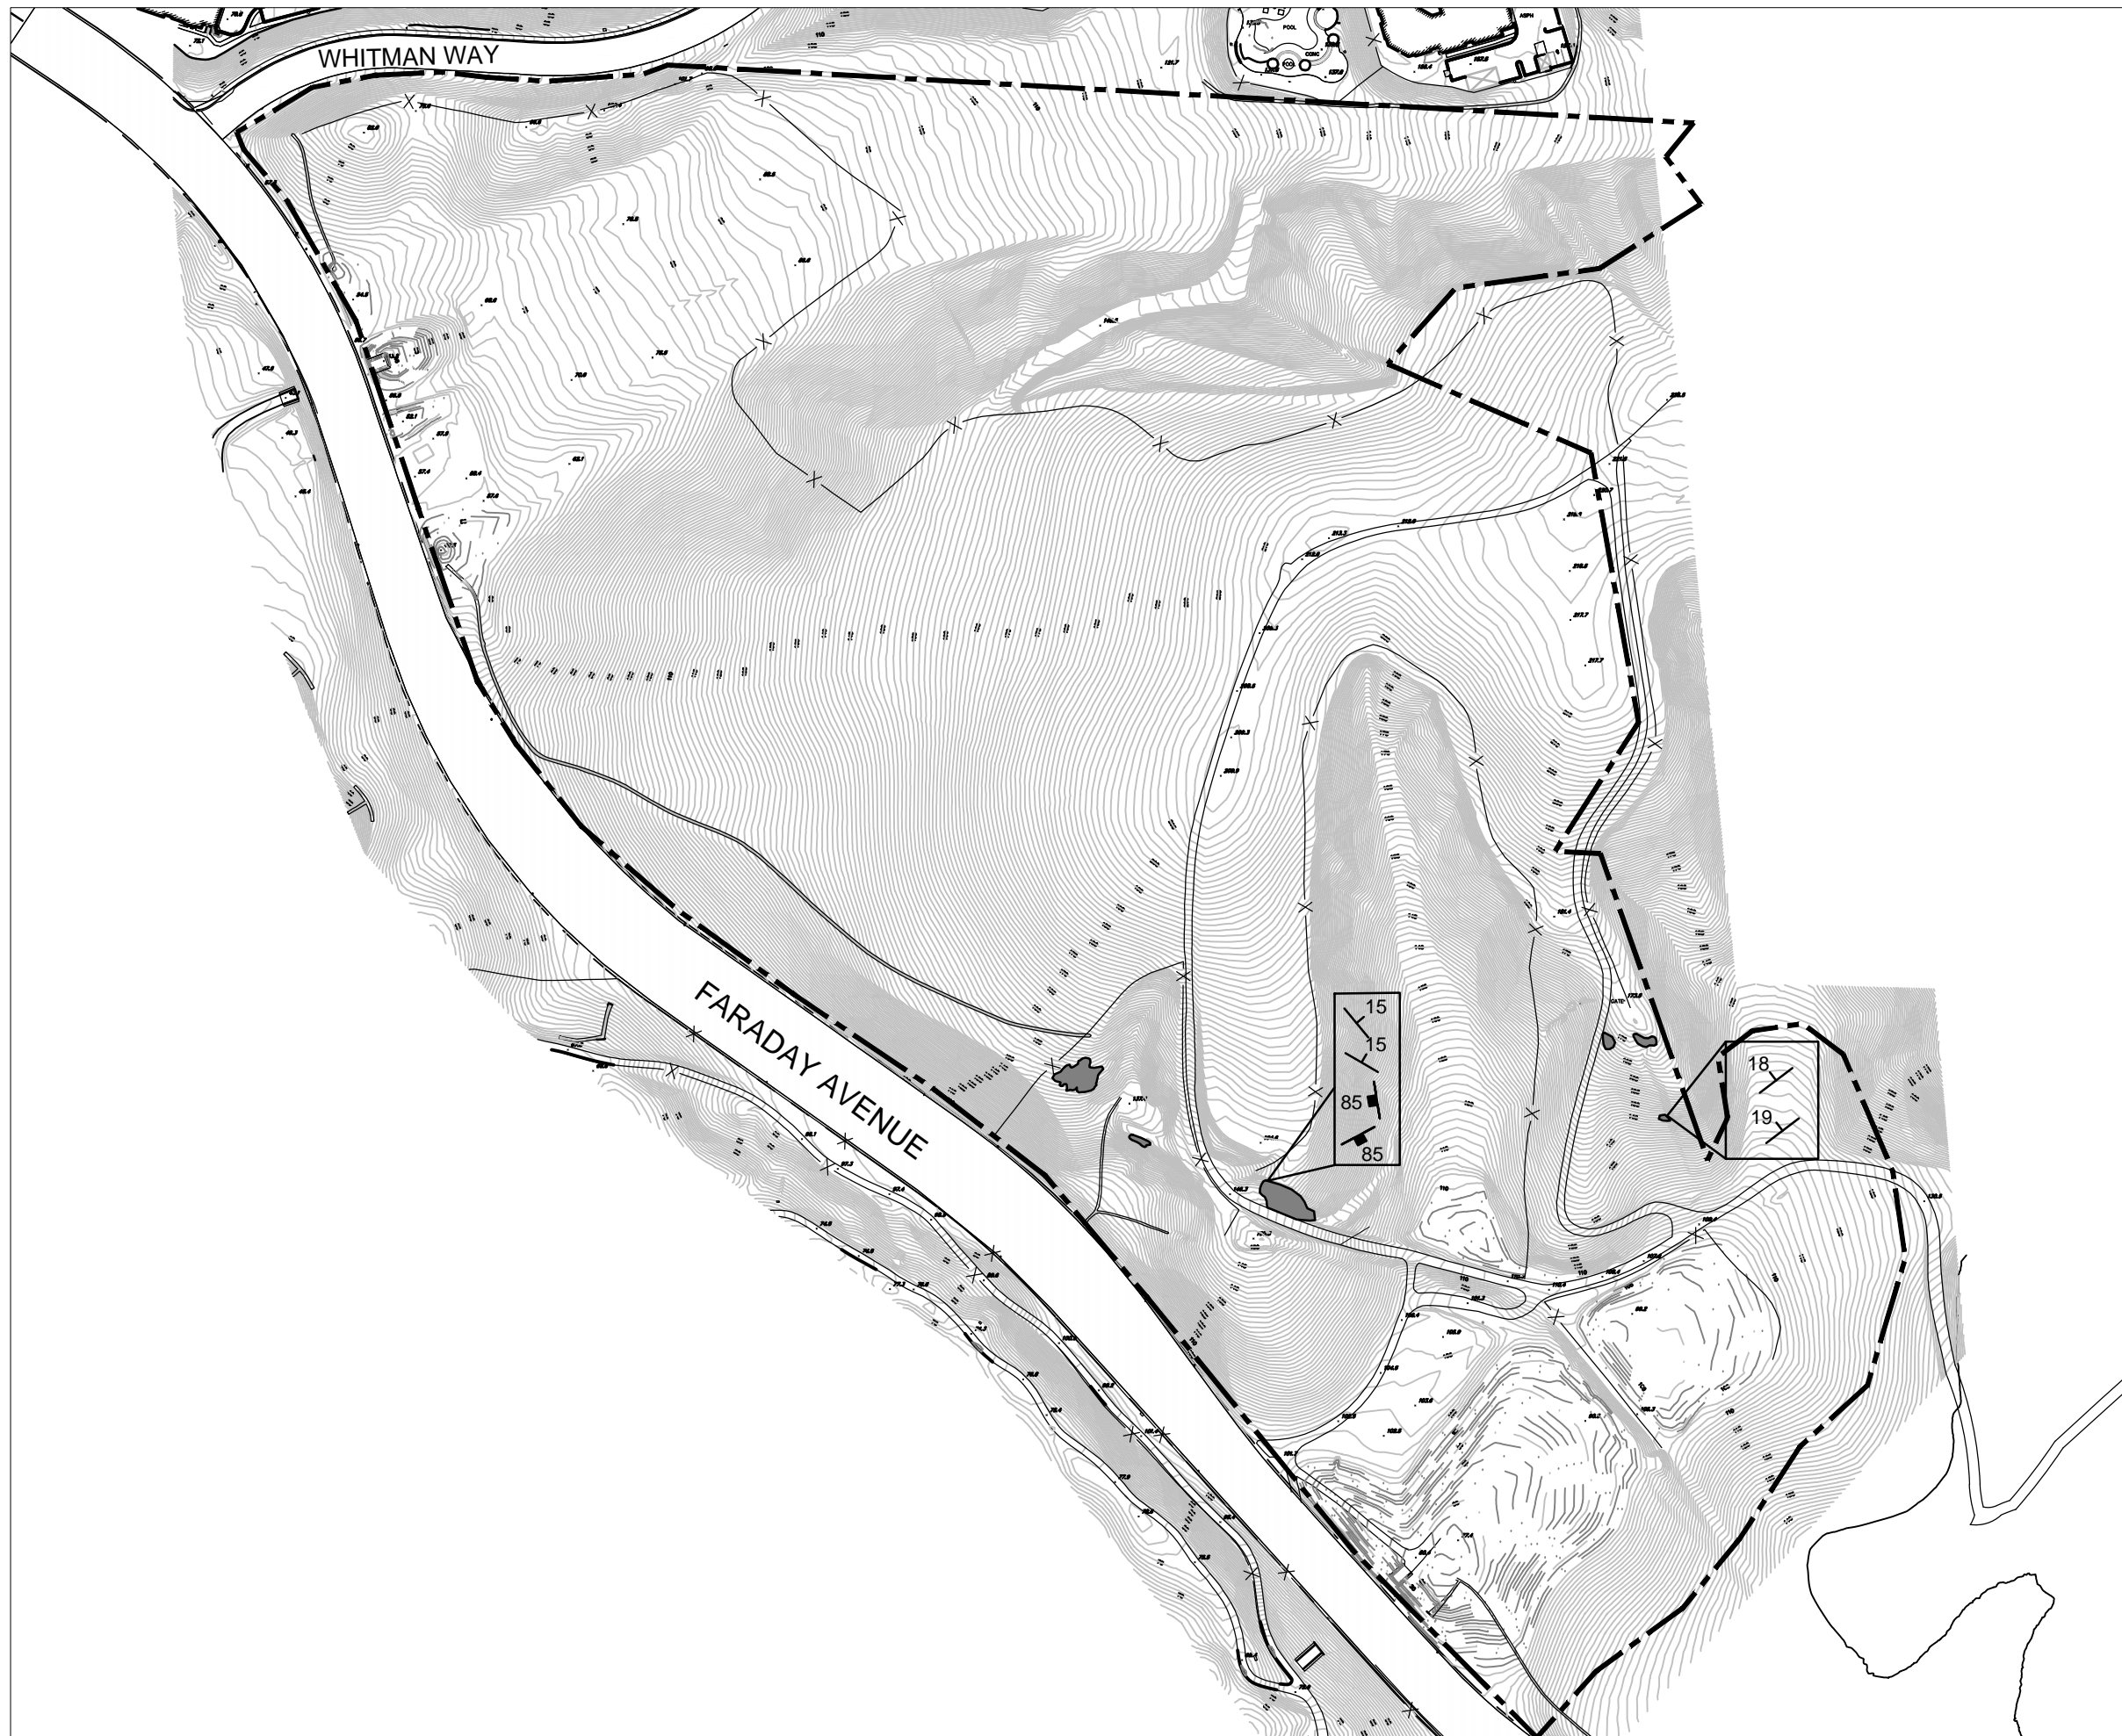
<b>SURFICIAL GEOLOGIC MAP</b>	
VETERANS MEMORIAL PARK	
CARLSBAD, CALIFORNIA	
SCALE: 1" = 200'

As part of this investigation, SCG performed surficial geologic mapping at the subject site. It should be noted that no subsurface investigation was performed as part of this investigation. The geologic mapping was limited to surficial exposure and expression of geologic units and features. Due to the recent rainfall, the site was covered with heavy native grass and weed growth which obscured the near-surface alluvial soils. Bedrock was only exposed in six (6) limited areas throughout the site.

Based on the bedrock exposed at the outcrops at the subject site, it is our opinion that the site is underlain by massive silty fine-grained sandstone with localized interbedded fine-grained sandstone and conglomerate of the Santiago Formation (Map Symbol Tsa). The geologic conditions at the site are generally consistent with the mapped geologic conditions. The bedding attitudes in the Santiago Formation in south-central area of the site generally strike northwest-southeast and dip 15 degrees to the northeast and the bedding attitudes in the Santiago Formation in the eastern area of the site generally strike southeast-southwest and dip 18 to 19 degrees to the northwest. As noted previously, a minor fault (shear joint) plane is mapped near the western boundary of the subject site. However, based on surface observations at the time of the geologic mapping, no evidence of surface expression of faults (i.e. fault scarps, fault line scarps, or displacement in the near surface soils) is present on the subject site. Three questionable landslides are also mapped south-southeast of the subject site. Based on the surface observations at the time of the geologic mapping, no evidence of surface expression of landslides (i.e. head scarps, minor scarps, crown cracks, radial cracks, etc.) is present on the subject site.

Based on the surficial geologic mapping conducted by SCG, there is no evidence of surface expressions for landslides at the subject site. In addition, there were no mapped landslides at the subject site and there were no indicators of landslides during the aerial photograph review.

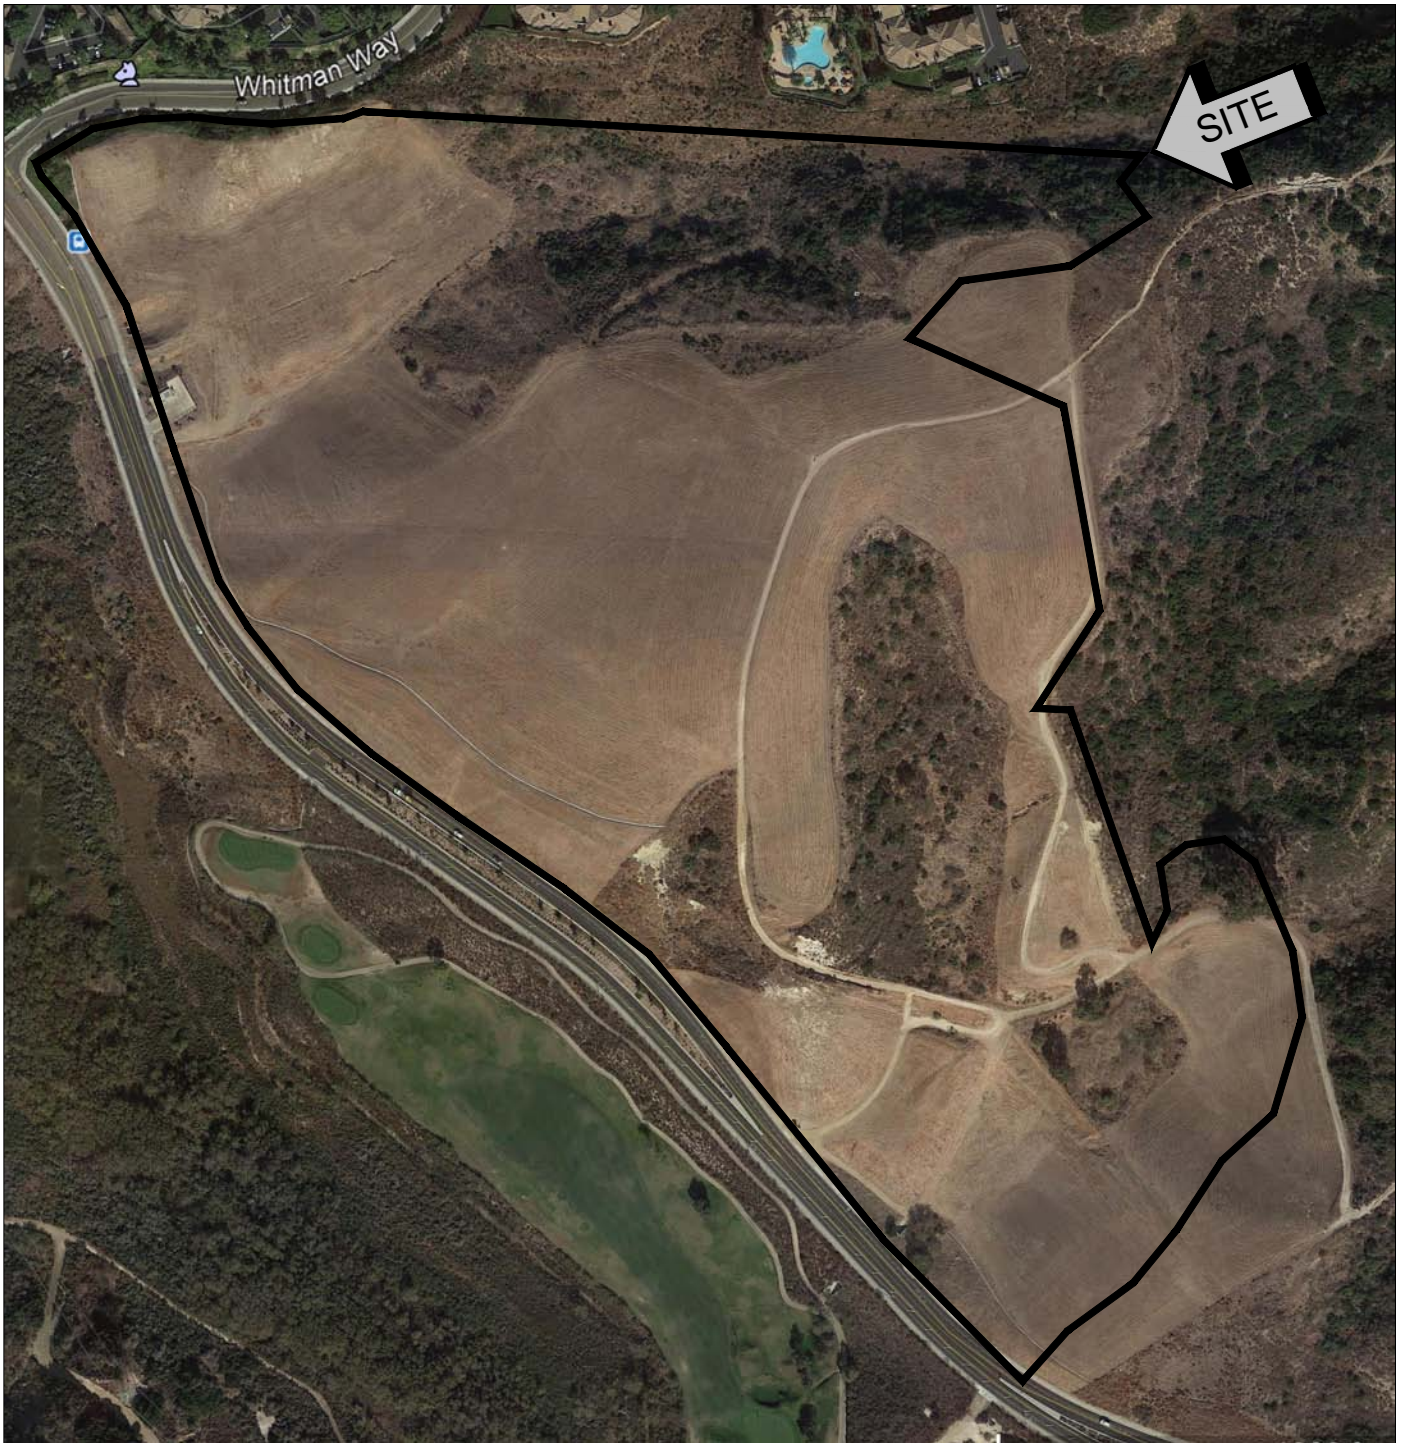
**AERIAL PHOTOGRAPH - 2018**

The subject site appears to be vacant and undeveloped from 1947 to prior to 1980. The subject site appears to have been cleared of vegetation throughout a significant portion of the site after 1980. Faraday Avenue is visible and several dirt hiking trails were also visible for the first time in the 2002 aerial photograph. The site appears to have been in its current configuration since at least 2002.

No geologic hazards such as faulting or landslides were readily visible during the historical aerial photograph review.
