# memorandum

subject Roadkill Study Results – El Camino Real and Cannon Road

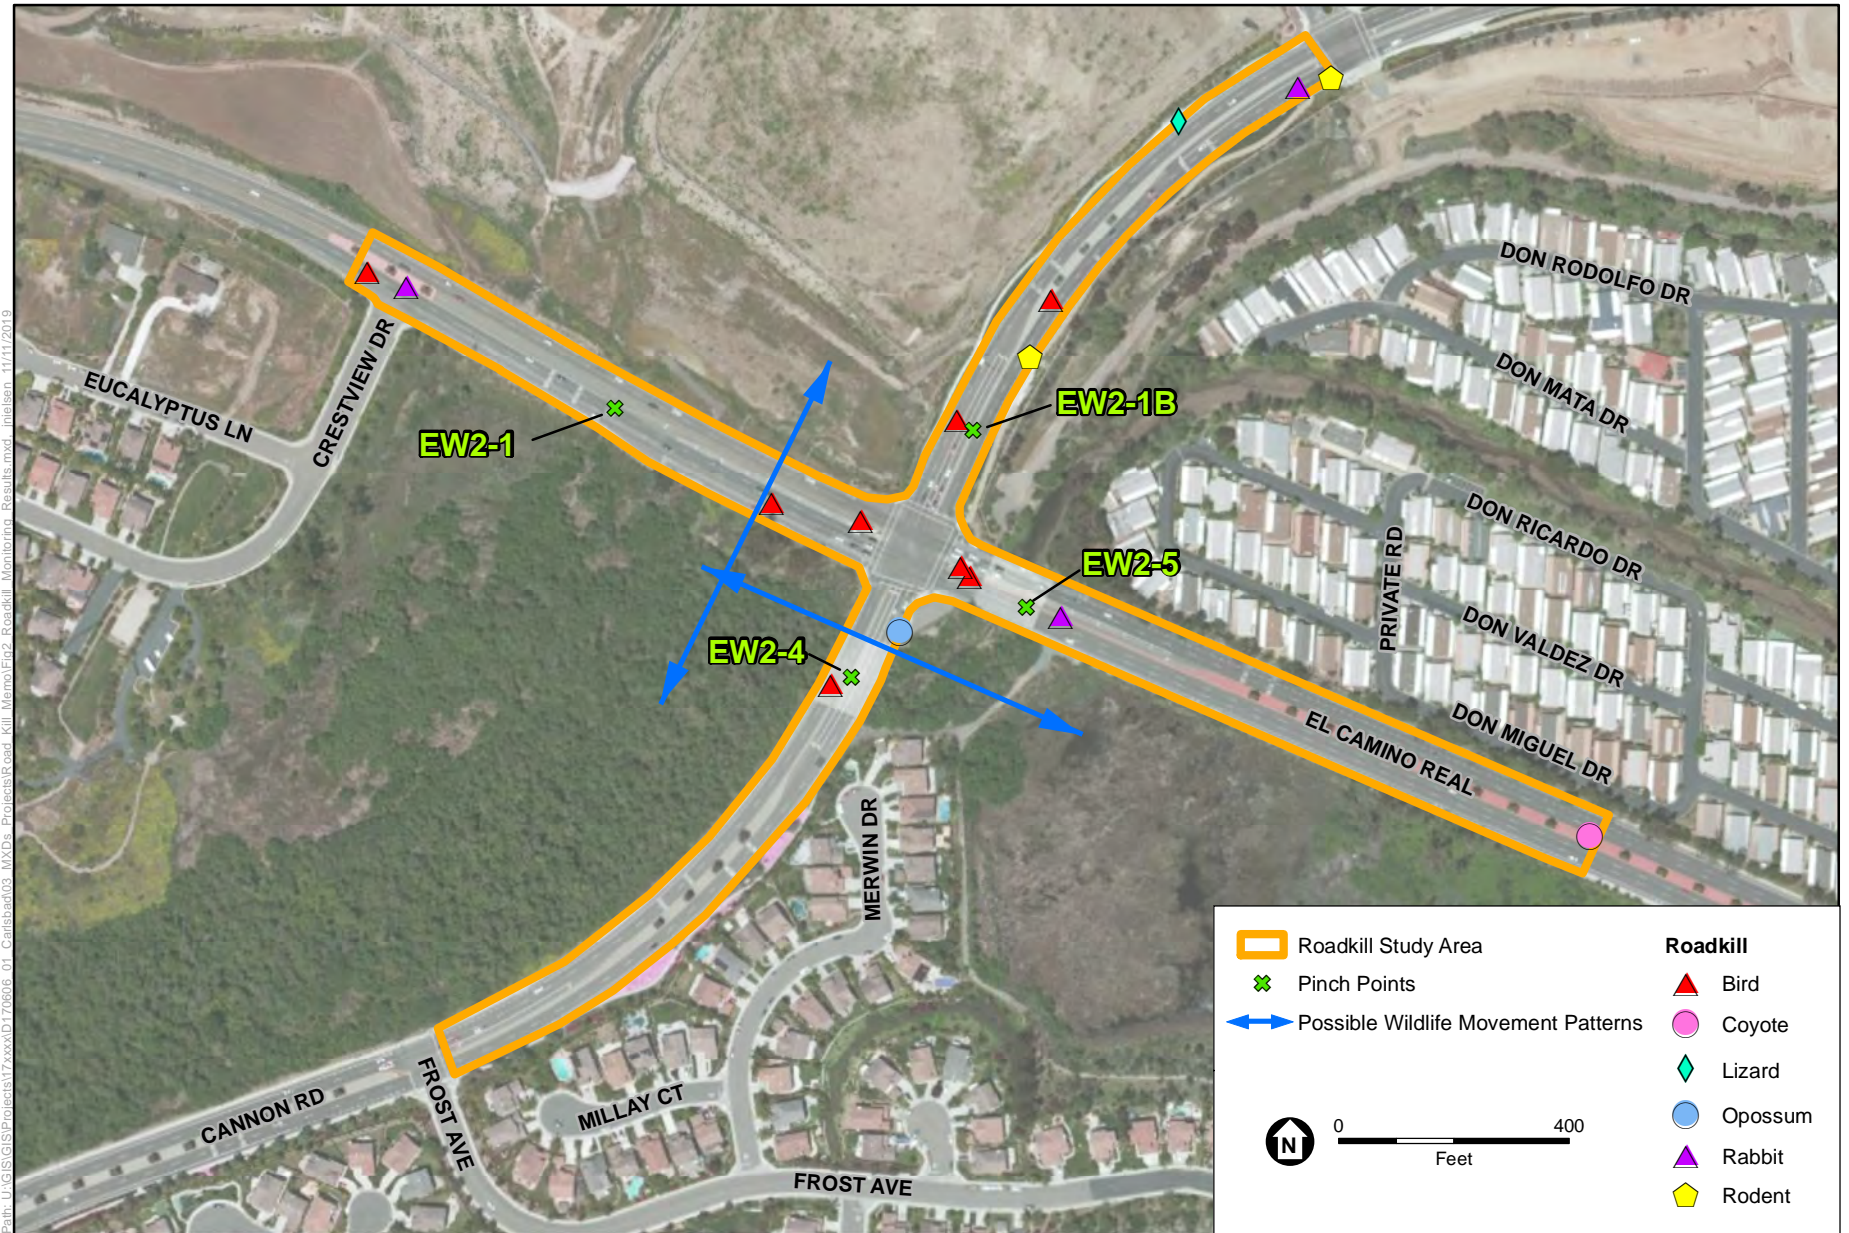
**Figure 2**  
Roadkill Monitoring Results

A total of 16 roadkill occurrences were detected during the 171 survey dates within the 2018–2019 year of monitoring. One (6.25%) roadkill observation was a medium to large mammal: coyote. Six (37.5%) roadkill observations were small mammals: rodents, rabbits, and opossums. Eight (50.0%) roadkill observations were bird species. One (6.25%) roadkill observation was a reptile species (lizard), but it was detected on the sidewalk, presumably hit by a bicyclist. All roadkill observations and their associated survey dates, times, and surveyor information are listed in **Table 1** and locations of all roadkill observations are displayed in **Figure 2**.

As seen in Figure 2, roadkill occurrences of birds are congregated around the intersection of El Camino Real and Cannon Road and less so in the extremities of the survey area. Other studies have found that birds are one of the top taxa to be impacted by vehicle collisions,<sup>8, 9, 10</sup> particularly in areas that support native vegetation and full-time or migratory habitat for birds.<sup>11</sup> This may explain the location and why birds represented the highest number of roadkill occurrences in this study, as native vegetation exists adjacent to the intersection along Agua Hedionda Creek.

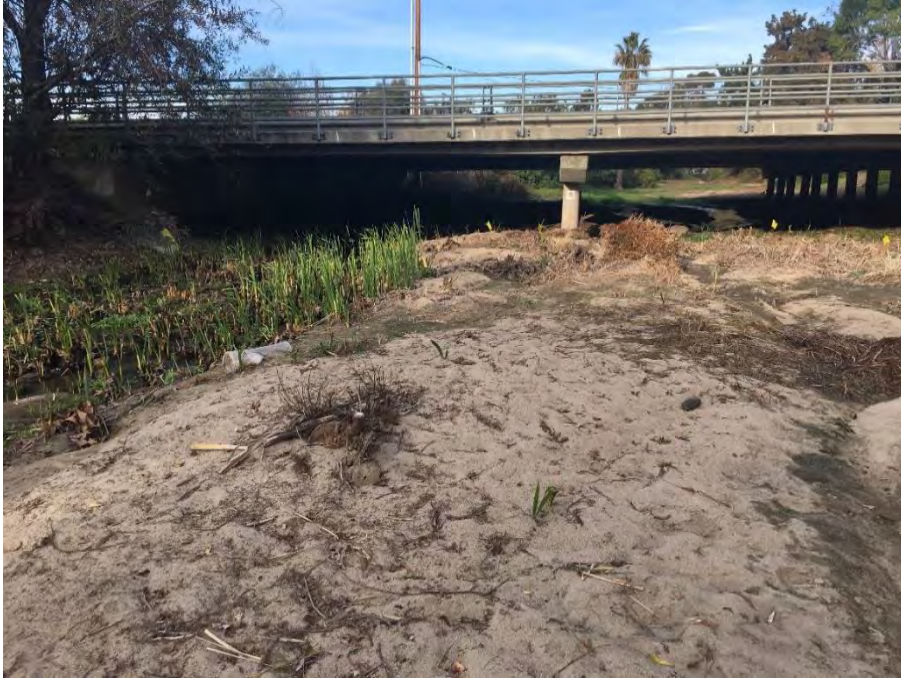
*Looking northeast toward the El Camino Real underpass at EW2-5*

Both EW2-4 and EW2-5 undercrossings are approximately 50 feet wide and 7 to 10 feet high, with scattered, open vegetation (**Attachment A**). These corridors have been documented by wildlife cameras to support a variety of wildlife, including coyote, bobcat, opossum, raccoon, skunk, and cottontail rabbit, among others. However, the busy intersection of El Camino Real and Cannon Road is a wildlife movement pinch point, funneling wildlife to these areas, which can increase the potential for wildlife to cross “at-grade,” above at the street level. El Camino Real and Cannon Road are highly traveled as El Camino Real is a six-lane road with a speed limit of 55 miles per hour and Cannon Road is a four-lane road with a speed limit of 50 miles per hour; therefore, these roads are expected to be a barrier for wildlife movement through direct mortality from vehicle collisions. The primary focus of this study was to determine if medium to large mammal species are moving across the roads at the El Camino Real and Cannon Road intersection and getting hit by cars rather than traveling underneath. Medium to large mammal species were targeted because these species demonstrate longer-range movement patterns and are likely more threatened by habitat fragmentation from roads.<sup>3</sup> In order to assess how frequent wildlife deaths from vehicle strikes occur in the intersection, ESA biologists and volunteers from Preserve Calavera monitored the El Camino Real and Cannon Road intersection for a year to document roadkill occurrences.

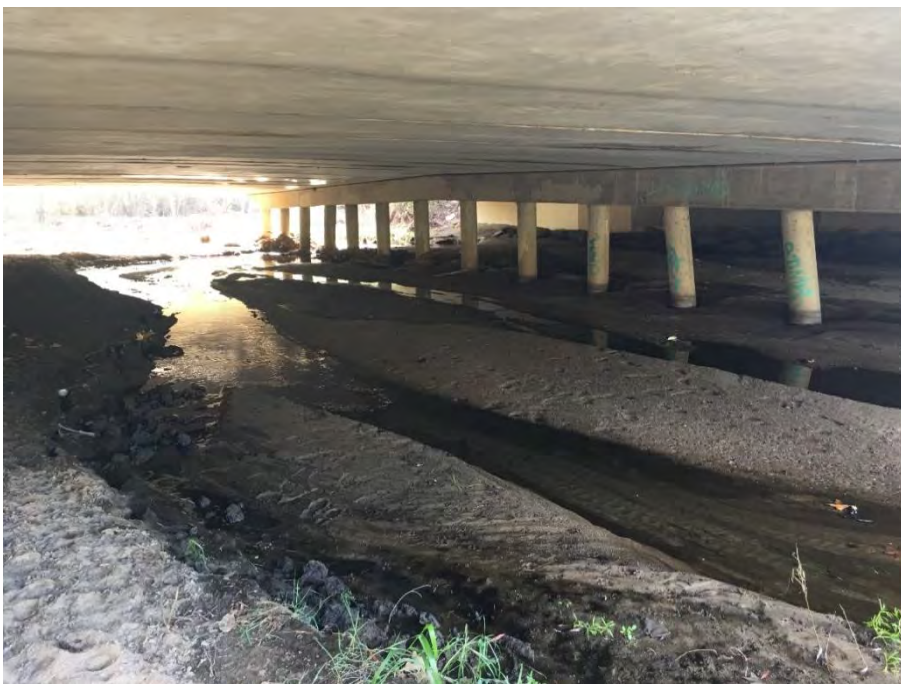
*Looking south underneath the underpass at EW2-5*

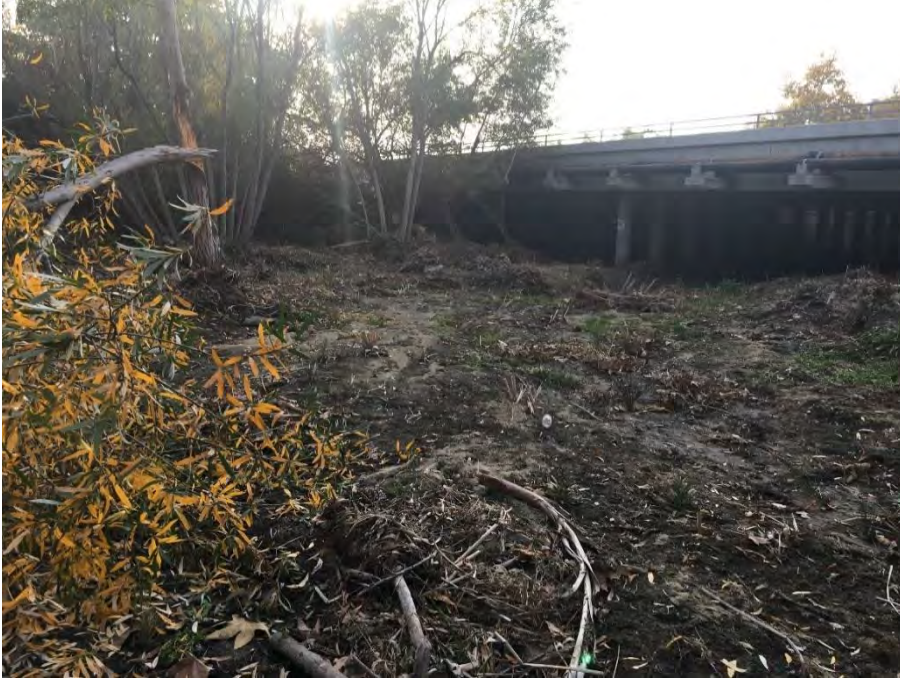
*Looking southwest toward the Cannon Road underpass at EW2-4*

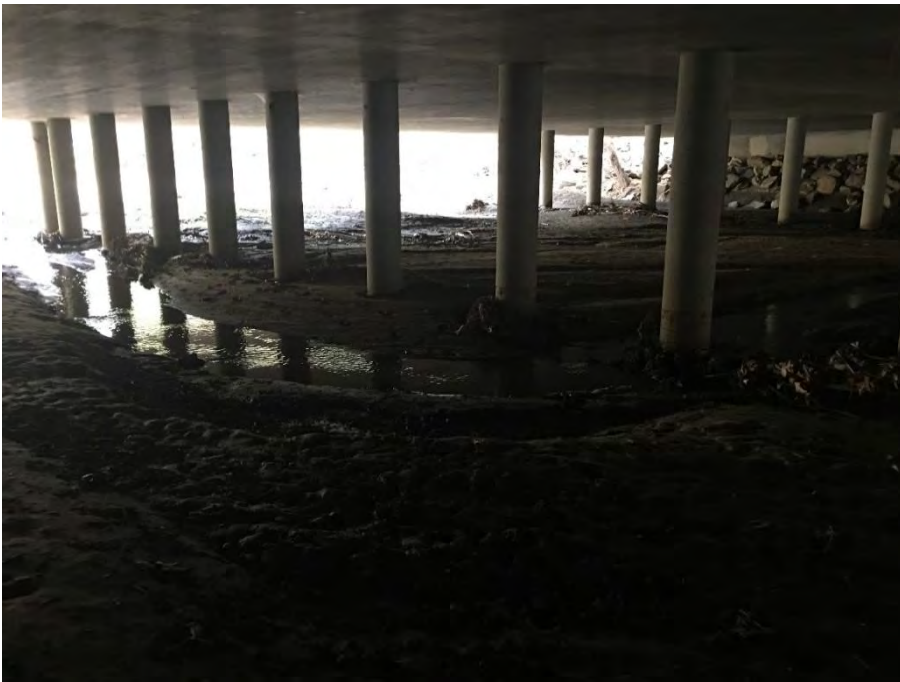
*Looking east underneath the underpass at EW2-4*
