# Memorandum

**Date:** February 12, 2018  
**From:** Rosanne Humphrey, HMP Coordinator  
**Re:** Summary of Wildlife Movement Activities in Carlsbad

This memorandum summarizes the results of wildlife movement monitoring that occurred between 2006 and 2017 within the Carlsbad Habitat Management Plan (HMP) preserve system (Figure 1).

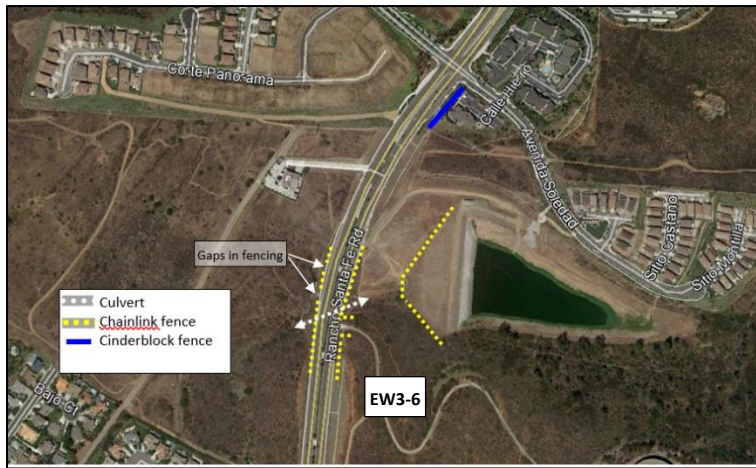
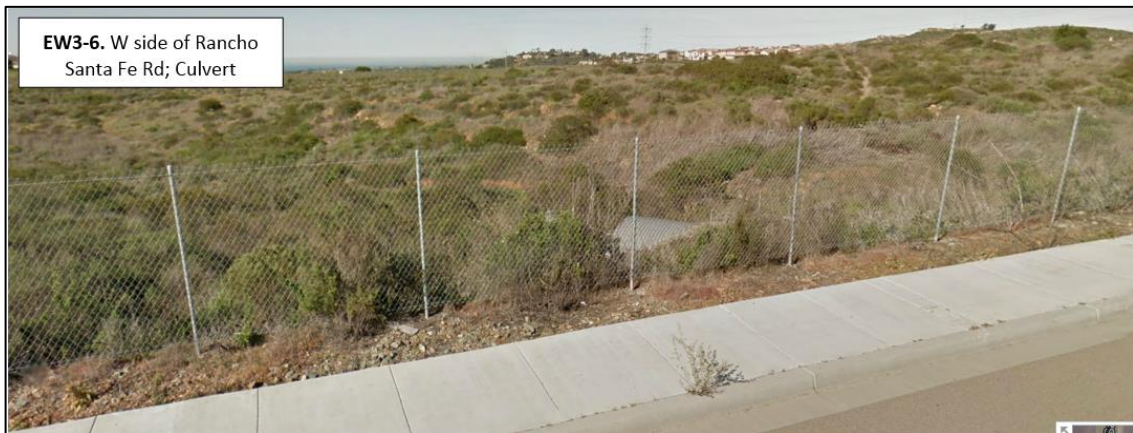
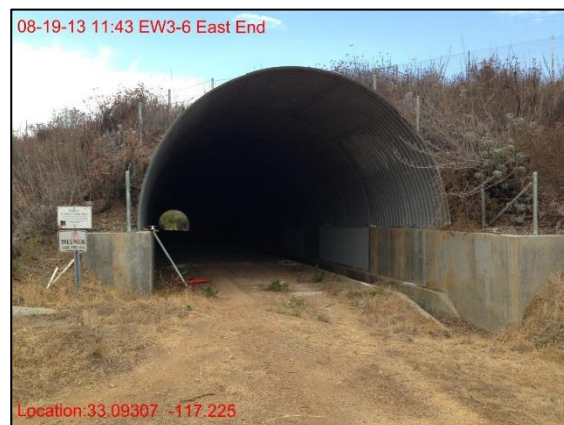
**Example of pinchpoint inventory information included in 2015 final report (EW3-6 shown)**

The next step was to visit each of the 104 potential pinchpoints, take photographs of each entrance and surrounding area, collect data describing the condition and characteristics of that location, and input the data into a database. The datasheet was developed in consultation with U.S. Geological Society (USGS) biologists. Examples of data collected include nearest creek, nearest road, road conditions, structure type, bottom type, structure measurements (length, height, width), nearby fencing description, vegetation (type, thickness, cover) at each undercrossing entrance, and specific threats to movement. The entire pinchpoint inventory, including aerial imagery, street view imagery, field visit photos, and field data is included in the final report (City of Carlsbad et al. 2015). An example of the information collected for each pinchpoint is provided below (pinchpoint EW3-6).

<b>Corridor</b>	EW3	<b>Point Code:</b>	EW3-6a	<b>Assessment Date</b>	8/19/2013	<b>Surveyors:</b>	M. Spiegelberg		
<b>Latitude:</b>	33.09309000000	<b>Longitude:</b>	-117.22457900000	<b>GPS Datum:</b>	WGS 84				
<b>Nearest River:</b>	San Marcos Creek								
<b>Nearest Road</b>	Rancho Santa Fe Road, S of Avenida Soledad		<b>Road Conditions:</b>	Divided roadway with two or more lanes each					
<b>Structure Type:</b>	arch culvert	<b>Multi Chambers?</b>	no	<b>Structure Material</b>	Metal				
<b>Bottom Type:</b>	dirt, hard armored								
<b>Height(m):</b>	3.93	<b>Width (m)</b>	5.25	<b>Length (m):</b>	91.40	<b>Openness Ratio:</b>	0.2	<b>Constraints</b>	No
<b>Description of Constraints</b>	Arch wildlife tunnel								
<b>Access Logistics</b>	Not good for tracking.								
<b>Fencing:</b>	Chain link on each side of RSF Rd. Extends over 100 feet in each direction								
<b>Camera Options:</b>	CNLM mounted cameras in tunnel and outside of tunnel

<b>Tracking Potential</b>	Not good, hard surface								
<b>Species/Sign Observed:</b>	None

<b>N or E Entrance</b>	<b>Veg. Thickness</b>	none	<b>Dominant Vegetation Type</b>	short grasses/forbs					
<b>Cover Classes at 20</b>	<b>Shrubs</b>	1 (1-5%)	<b>Grass/Herbs</b>	1 (1-5%)	<b>Trees:</b>	1 (1-5%)			
	<b>Bare/Rock:</b>	5 (76-100%)	<b>Native Species:</b>	1 (1-5%)	<b>Exotic Species</b>	1 (1-5%)			
<b>S or W Entranc</b>	<b>Veg. Thickness</b>	open	<b>Dominant Vegetation Typ</b>	shrubs					
<b>Cover Classes at 20</b>	<b>Shrubs</b>	2 (6-25%)	<b>Grass/Herb</b>	1 (1-5%)	<b>Trees:</b>	2 (6-25%)			
	<b>Bare/Rock:</b>	3 (26-50%)	<b>Native Species:</b>	2 (6-25%)	<b>Exotic Species</b>	1 (1-5%)			
<b>Veg. Comments:</b>	Open on east side, mostly open on south side, some willows block a portion of opening on west side

<b>Primary Threat:</b>	busy roadway	<b>Severity</b>	3 (moderate/not imminen
<b>Secondary Threat:</b>	Long tunnel	<b>Severity</b>	3 (moderate/not imminen
<b>Mgmt Recommendations</b>	Patrol and keep people out		
<b>Comments:</b>	Unclear why deer are not using tunnel; radio collar deer for study in this area		
	MHCP Monitoring Priority
