LEO CARRILLO RANCH PARK MASTER PLAN

Phase 3 Priorities and Cost Estimate Update
February 2015

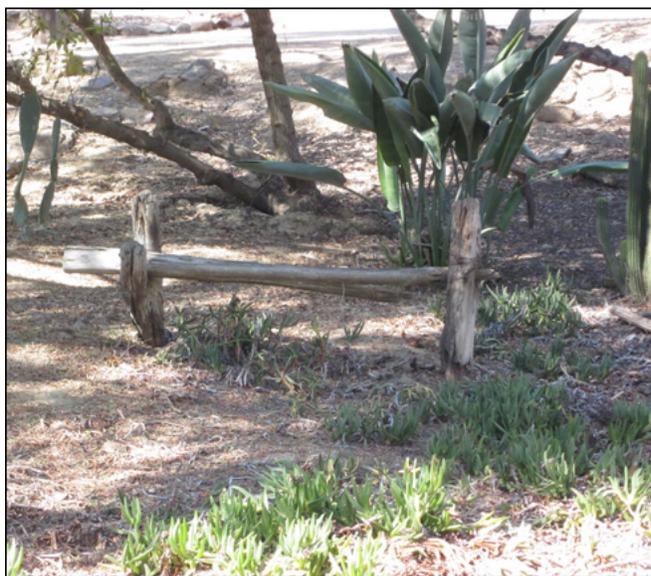
Existing Hitching Post

There are currently a variety of hitching posts located throughout the ranch. An additional three (3) hitching posts will be incorporated into the main Hacienda and courtyard areas. These hitching posts should mimic the historic hitching posts (see drawing below) and should be incorporated into the Ranch scene in an authentic and sensitive manner.

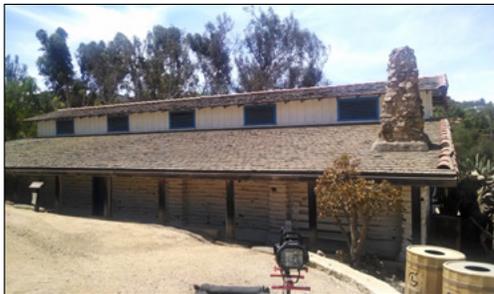
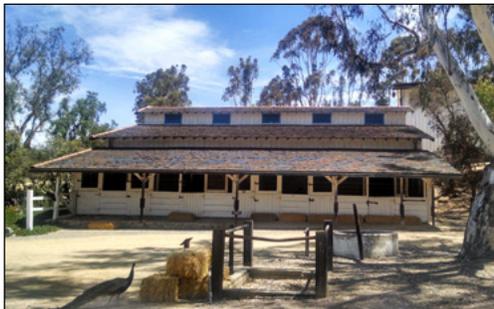
Existing Conditions

The stable is approximately 62' wide x 70' long x 17' high (average). The walls of the stable were seismically stabilized in 1992. In order to accommodate the activities outlined above, the stable will need to provide stabilized decomposed granite flooring, repair the existing clay tile flooring, repair worn wood features, provide interior lighting and security system, improve drainage, and replace the 20-year-old wood shingle roof.

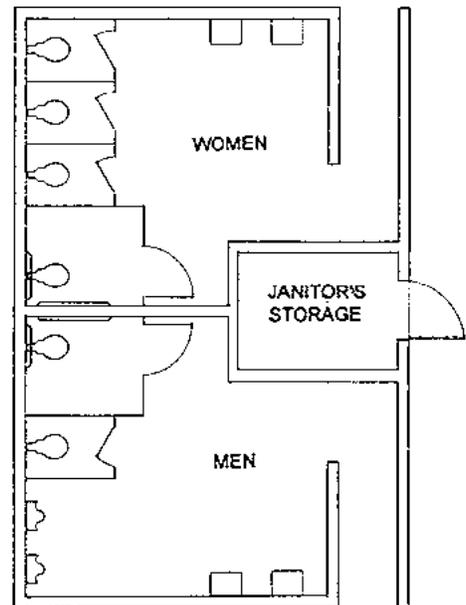
Floor Plan

The structure will be approximately 22' wide x 34' long x 12' high and include lighting, mechanical and plumbing fixtures. The structure will incorporate wood cladding to replicate the historic chicken coop. In addition, the surrounding area will include landscaping and irrigation. See the images below for the preliminary design of the new facility.

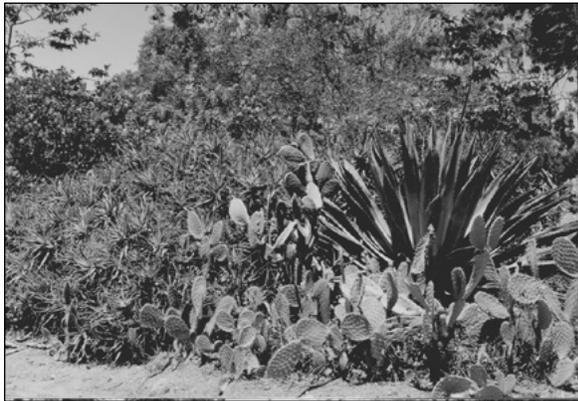
Historic Botanical Garden

The botanical collection of Leo Carrillo Ranch was special and exceptional, and plays just as important of a role in the historic importance to the ranch as the adobe structures. There have been many documented references to the native vegetation for which Leo expressed such a strong appreciation, including their forgotten Native American names and their medicinal qualities.

The variety of plant material types and habitats of the Ranch are diverse. The unique rural site includes riparian habitat, freshwater marsh, baccharis scrub, non-native grassland, eucalyptus woodland, cactus/succulent theme, and subtropical plantings.

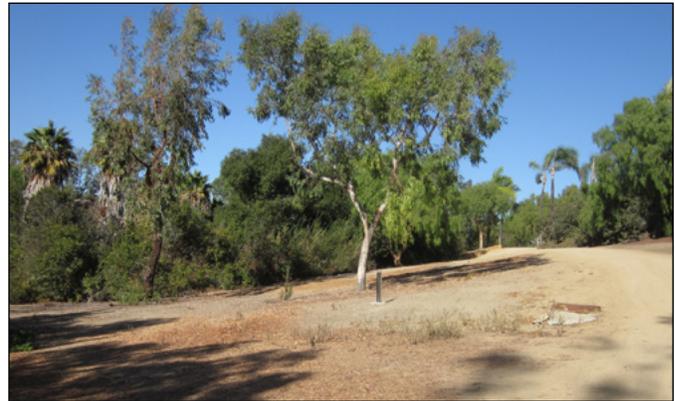
Existing Conditions

The area identified for the Botanical Garden is approximately 21,500 square feet in size - 6,850 square feet for the botanical garden and 14,650 square feet for the orange grove. Prior to installation, this area will require weed/plant removal and grading. The botanical garden will include installation of approximately 250 plants and 26 orange trees (or other suitable alternative) along with irrigation. Garden amenities will include identification and educational signage. The Botanical Garden will also incorporate stabilized decomposed granite pathways (included in Botanical Trail cost estimate) built on the natural contours of the land that meander through various botanical collections and gardens:

In order to accommodate new uses and events on the ranch, a service road has been built through the Botanical Garden area and into the service area located behind the Cabana. Future design for the Botanical Garden must incorporate this road into the project design.

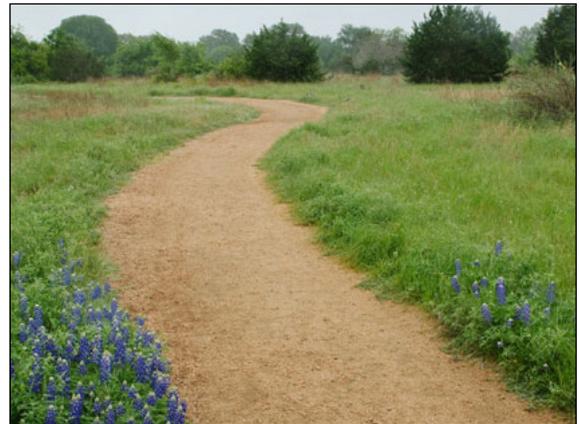
Proposed Trail Conditions

6. Pedestrian Trail Surface: Excavate to six inches depth, apply City surface approved soil sterilant and install paving with thickened edge and compact afterwards. A 6" square concrete curb or 2' x 6' redwood header may be utilized for containment.

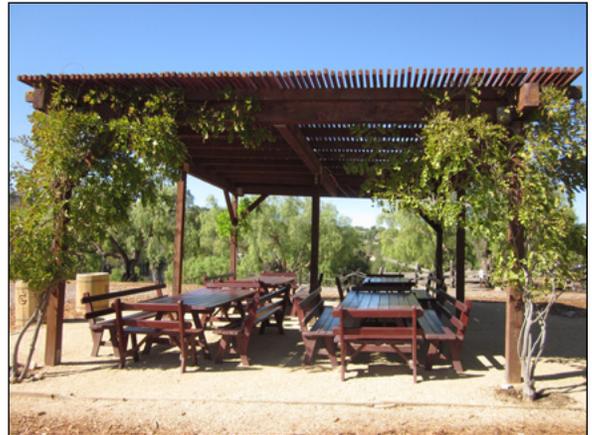
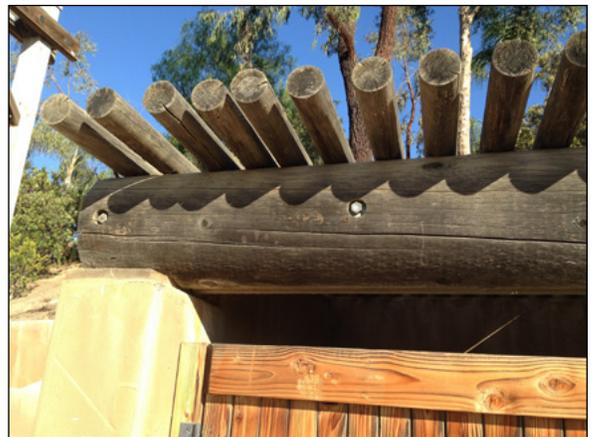
Existing structures at Leo Carrillo Ranch with similar characteristics - arbor in picnic area (left) and trash enclosure (right).

The arbor will be 9' high x 60' long and include 8" diameter posts, 6" diameter beams, and 4" diameter joists. Building materials will include clean peeled redwood lodge poles, clear all heart that has been weathered by either sandblasting or other acceptable means. The redwood should be allowed to weather to a "silver-gray" color.

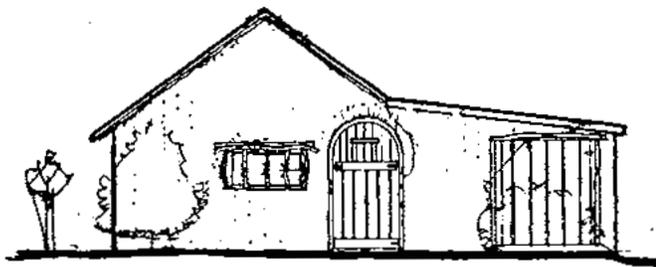
North Elevation

The Cantina is approximately 14' wide x 26' long x 12' high. The walls of the Cantina were seismically stabilized in 1992, however, additional roof, landscape, and wood repairs will be needed. Miscellaneous items stored in the Cantina will need to be removed and placed in a permanent storage area. See cost estimate for a full list of repairs.

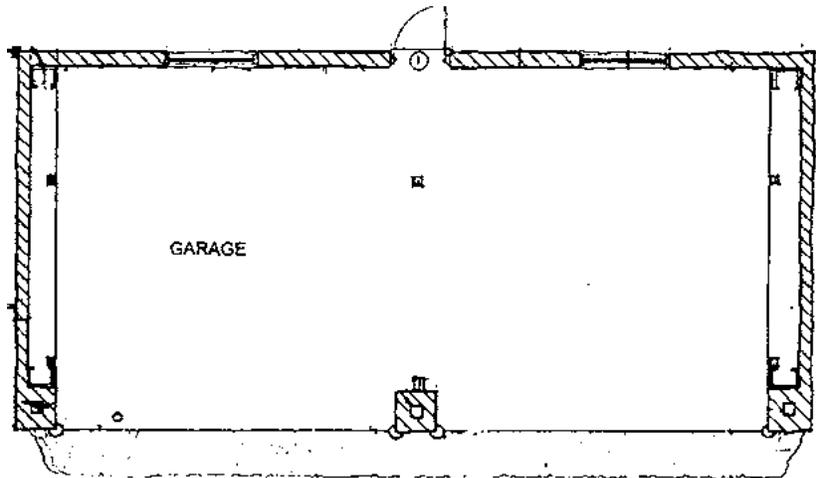
Floor Plan

The Carriage House is approximately 21' wide x 43' long x 12' high. The existing clay tile roof is in need of minor repair to reattach loose tiles. Most of the rawhide strap connections a the wood trusses need replacing. A number of other repairs are needed to repair termite and dry rot damage. See cost estimate for a full list of repairs.

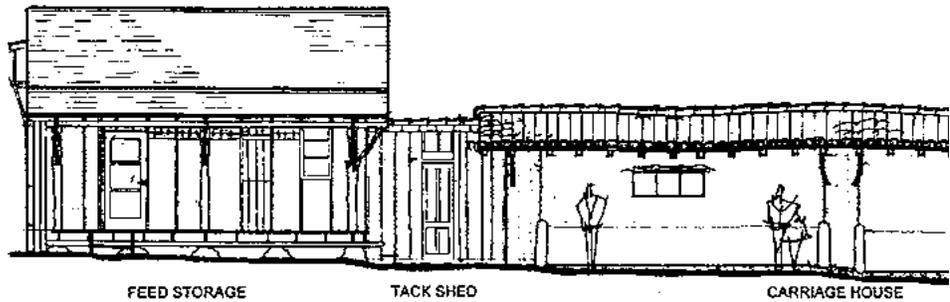
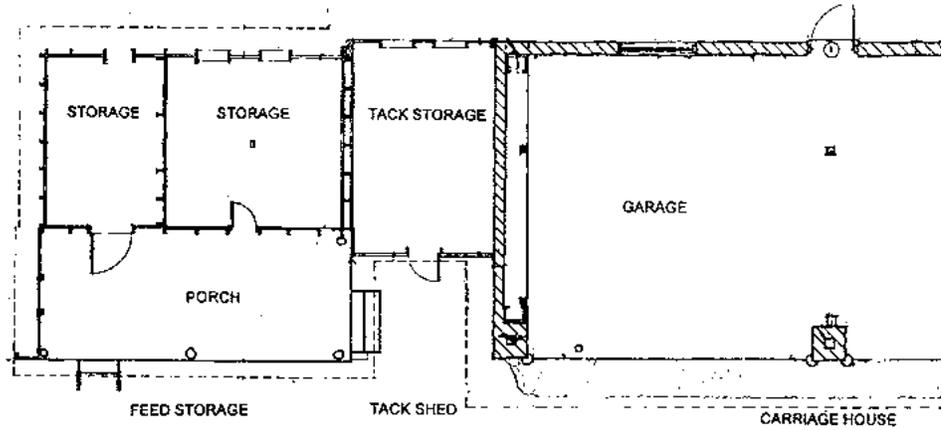
Floor Plans & Elevations for Tack Shed & Feed Storage Building

The Feed Storage Building is approximately 20' wide x 20' long x 16' high. The Tack Shed is approximately 9' wide x 14' long x 16' high. The roof for these structures will need to be replaced and the foundation will need to undergo a structural evaluation to determine stabilization requirements. In addition, wood members will be replaced to repair termite and dry rot damage. See cost estimate for a full list of repairs.

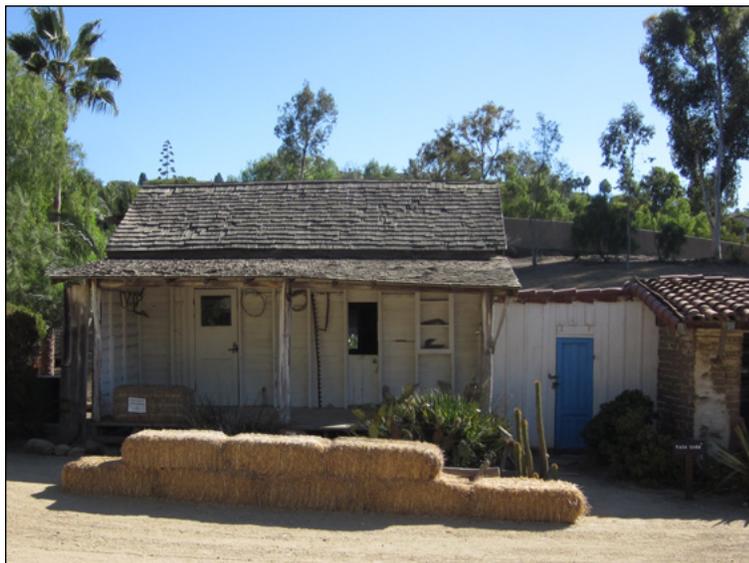
Feed Storage Building (left) and Tack Shed (right)

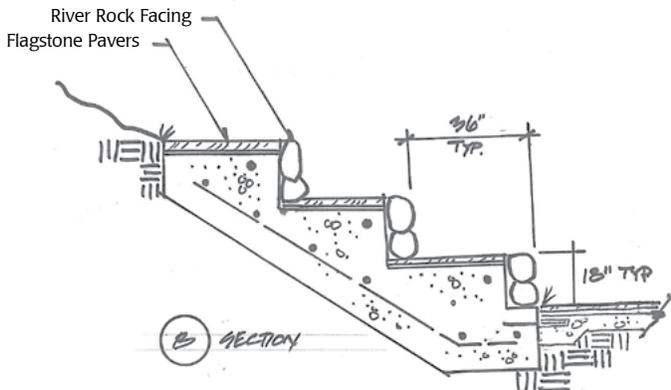
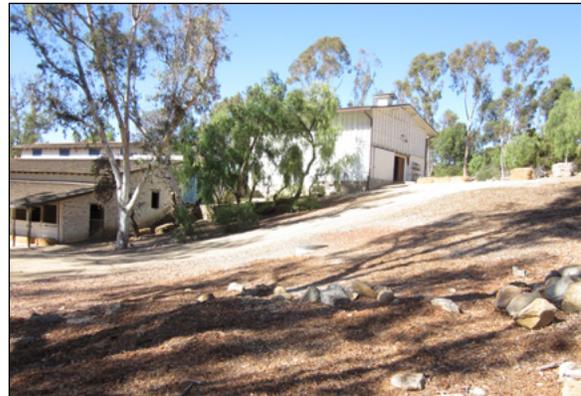
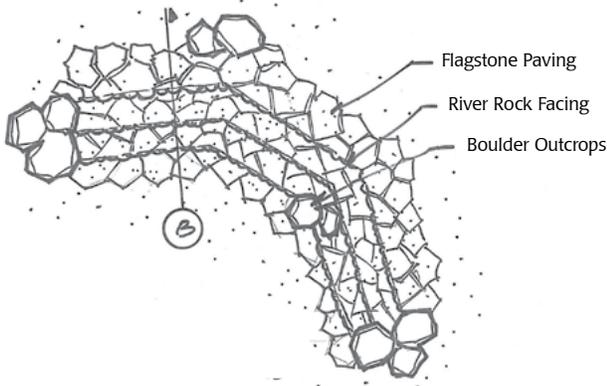
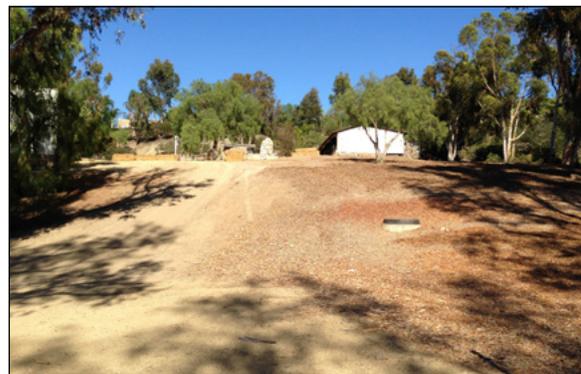
Section & Plan View of Amphitheater Steps

The gathering area could take advantage of and conform to the shaded sloping topography south of the stable and wood barn. The design for the amphitheater could incorporate 3 levels of seating (each seat/stair approximately 36" wide by 18" high), rebar reinforced concrete base with river rock facing and flagstone paver top, and boulder outcrops located throughout.

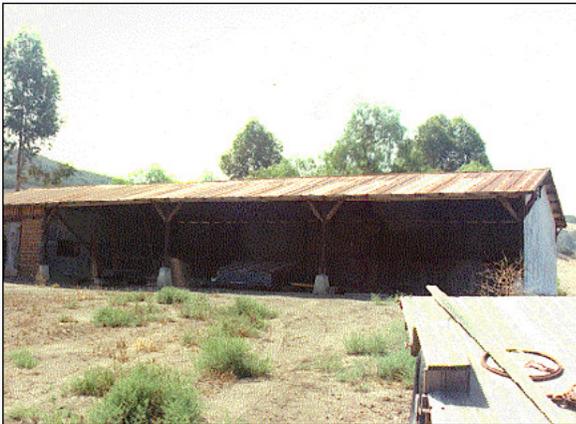
Historic Equipment Shed

The equipment shed will continue to serve as a storage areas for ranch equipment. The structure is approximately 27' wide x 62' long x 12' high.

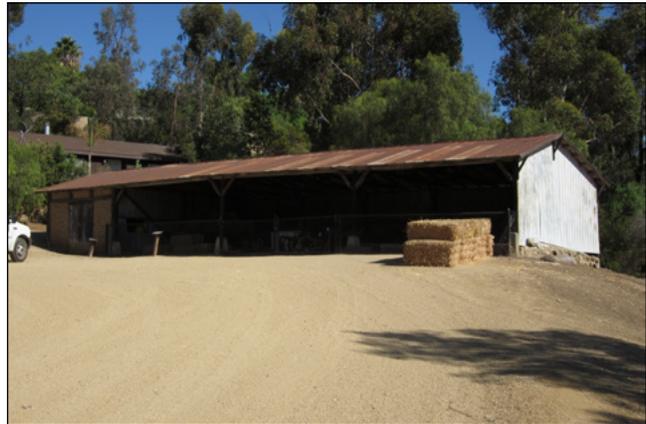
Existing Conditions

The adobe wall at the blacksmith's shop will need to be seismically stabilized. The stone foundation wall needs repairs and the wood structure needs reinforcement to the foundation. The metal seam roof and siding will need repair and wood with termite and dryrot damage will need to be replaced throughout the structure. See cost estimate for a full list of repairs.

EQUIPMENT SHED						
DESCRIPTION	QUANTITY	UNIT	UNIT COST	ITEM COST	MARK UP*	TOTAL COST
General adobe maintenance needed	1	LS	\$3,700	\$3,700	\$1,733	\$5,433
Stabilize adobe wall at the black-smith's shop	12	LF	\$500	\$6,000	\$2,810	\$8,810
General maintenance & repair for wood structures	1	LS	\$10,000	\$10,000	\$4,684	\$14,684
Repair roof eaves, termite & dry rot damage	1	LS	\$3,500	\$3,500	\$1,639	\$5,139
Repair wood headers & branch framing, termite & dry rot damage	1	LS	\$5,000	\$5,000	\$2,342	\$7,342
Repair / reconstruct stone foundation wall	1	LS	\$12,000	\$12,000	\$5,620	\$17,620
Reinforce, brace & anchor wood structure to the foundation	1	LS	\$5,000	\$5,000	\$2,342	\$7,342
Repair metal seam roof & siding	1	LS	\$7,500	\$7,500	\$3,513	\$11,013
Landscaping	100	SF	\$12	\$1,200	\$562	\$1,762
Irrigation	100	SF	\$6	\$600	\$281	\$881
Total						\$80,026

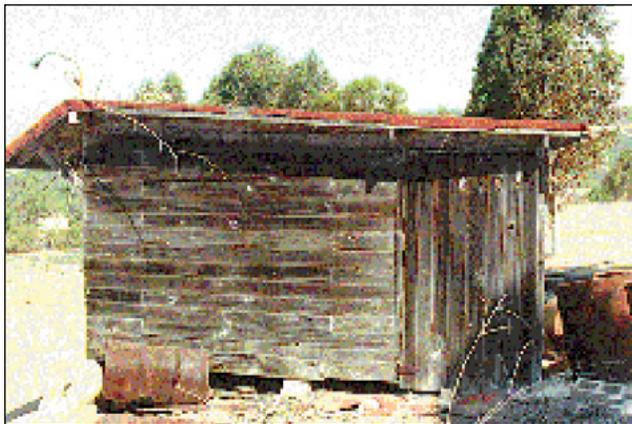
Storage Shed (1998)

The storage shed is approximately 12 feet wide x 14 feet long x 9 feet high. The roof is currently missing and should be replaced with wood shingles or other material that is consistent with historic materials used on the ranch. The wood doors will need to be restored/replaced and the retaining wall and foundation will need repairs. Some of the wood has been damaged by termites/dryrot and needs replacement as well.

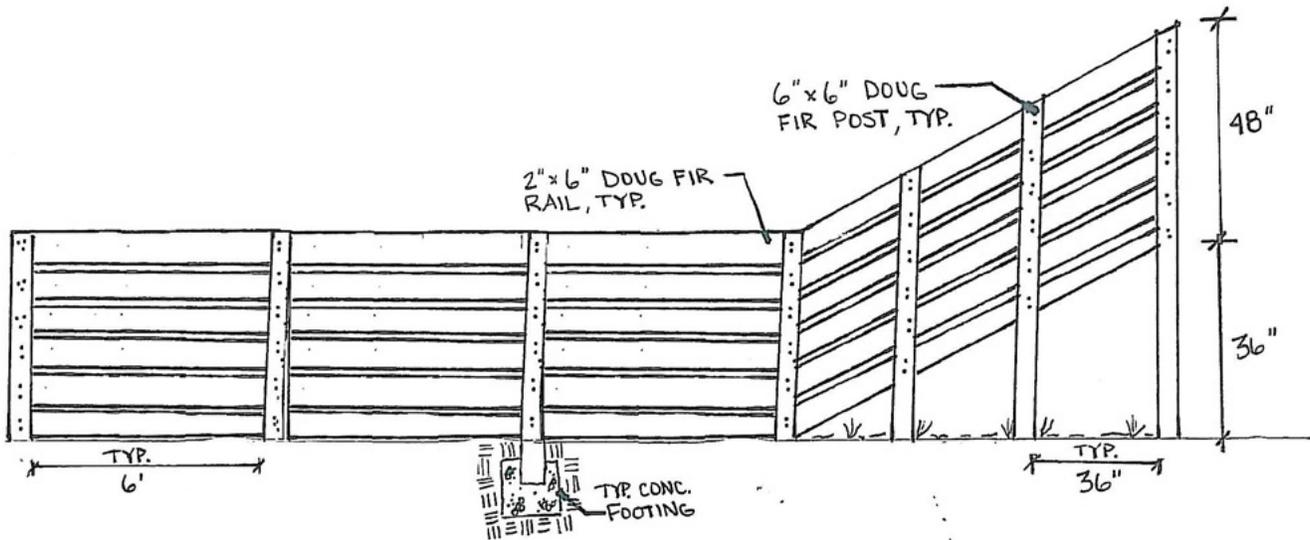
Proposed Cattle Chute

The new cattle chute will be constructed with douglas fir with wood preservative. It will be approximately 4' wide x 30' long with concrete footings (see sketch below).

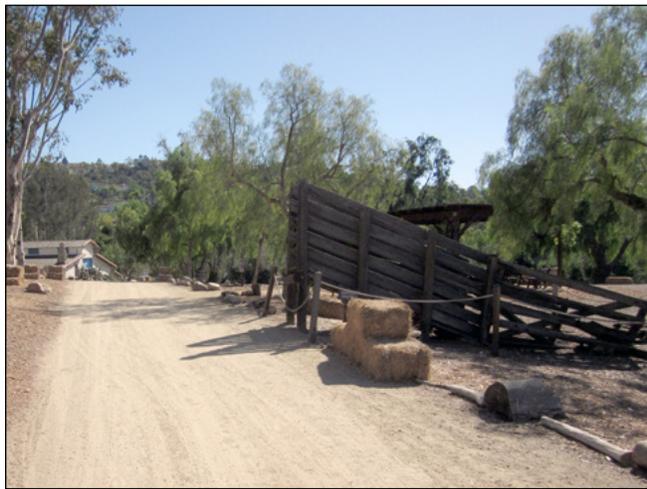
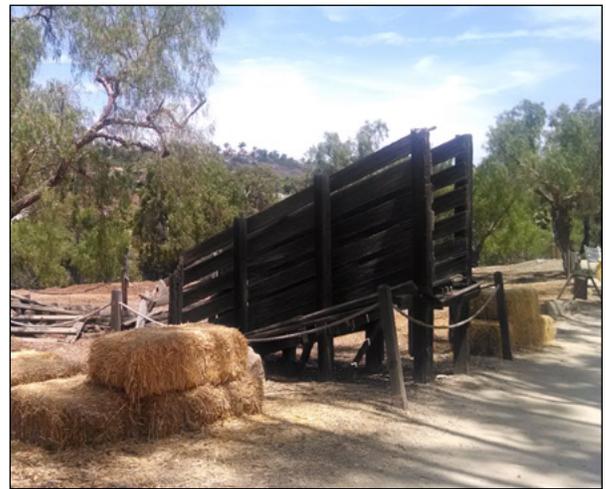
Existing Conditions - Cattle Chute location along main road (left) and deteriorating condition of existing cattle chute (right).

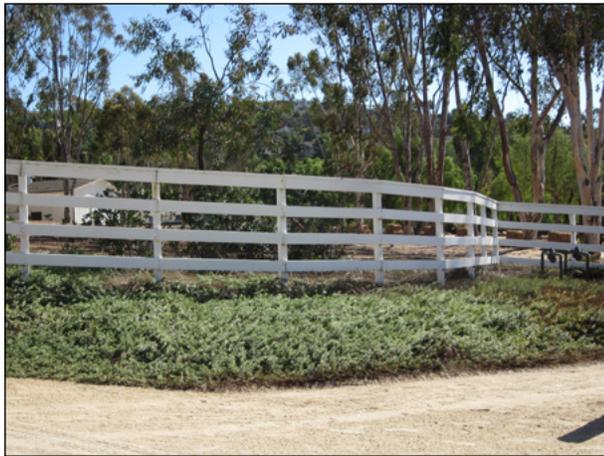
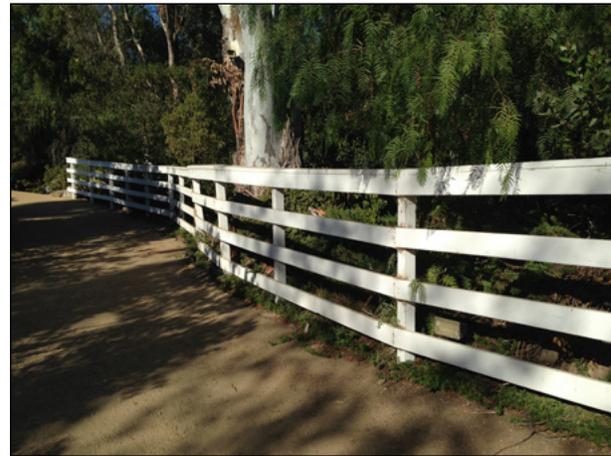
Existing Conditions

The original five (5) foot high white corral fencing will be restored per the fence plan. Various areas of fencing around the ranch have already been restored to match the style and character of the original fence. An additional 1,750 linear feet of fencing will be installed in the south eastern portion of the ranch.

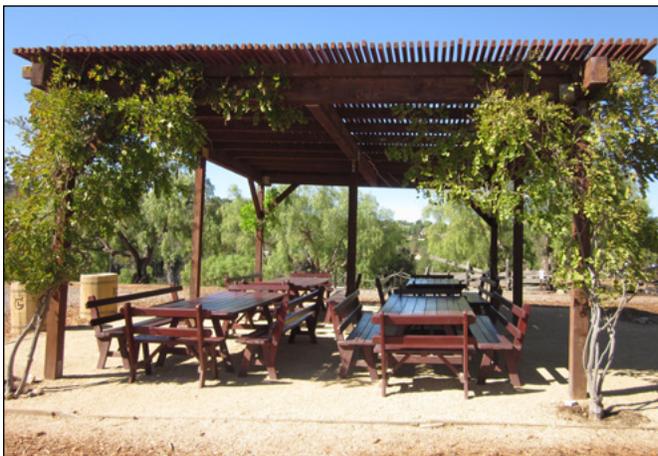
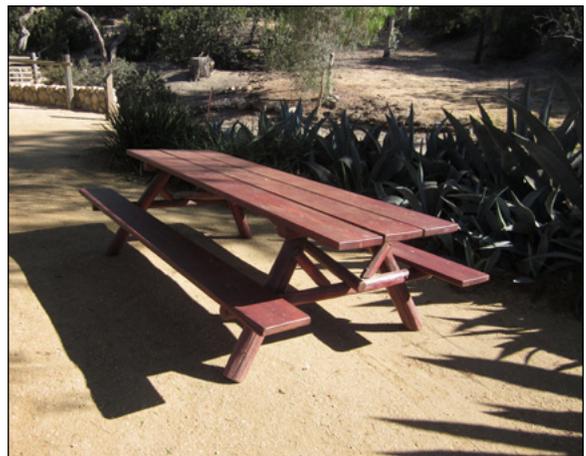
Proposed Picnic Table Area will Mimic Existing Seating Areas

There are currently a number of picnic tables located throughout the ranch. An additional two (2) picnic will be placed in the area south of the parking lot. These tables will be prefabricated and will look similar to existing picnic tables within the ranch.

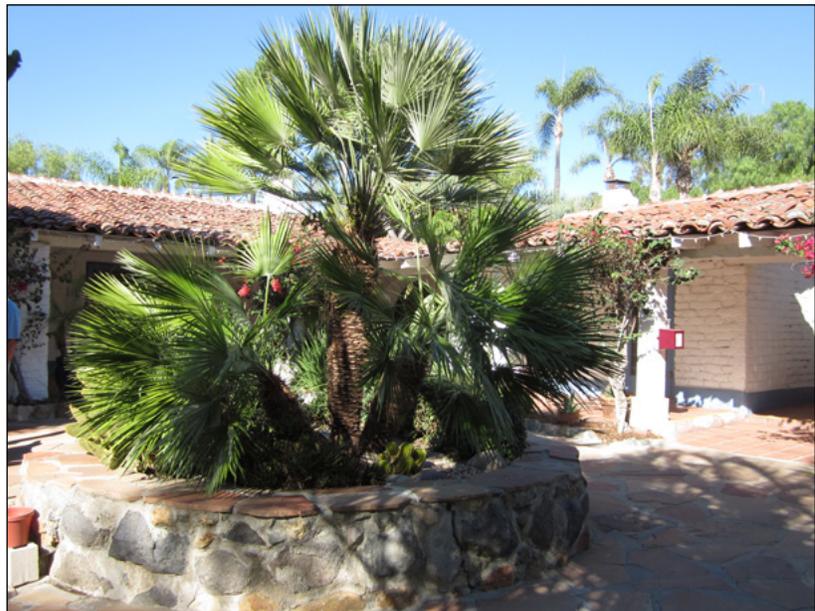
Small Fish Pond

There are two fish ponds located on the ranch. The smaller pond (located in the hacienda courtyard) is currently used as a planting area with a small water area. The total pond area is approximately 60 square feet. The water area will be expanded to include 1/3 of the total pond area while retaining some of the existing plants.

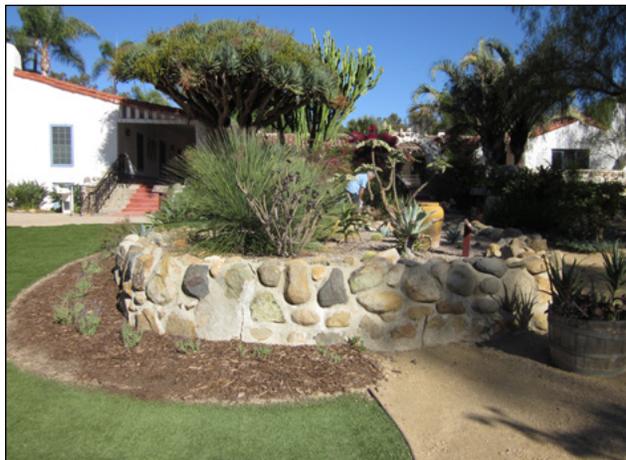
Large Fish Pond Perimeter Wall

The larger pond (located to the south of the pool) is approximately 450 square feet. This pond is a unique feature that creates interest for the backyard area. The pond is currently used as a planting area so the existing vegetation will need to be removed. In addition, the bottom and perimeter walls have many cracks that need to be repaired, the plumbing lines need repair, and the bottom will need to be sealed. The new pond will include 18" of water, and island area (1/3 of total pond area), circulating pump and overflow box, aquatic vegetation, natural rock, boulders and aquatic wildlife.

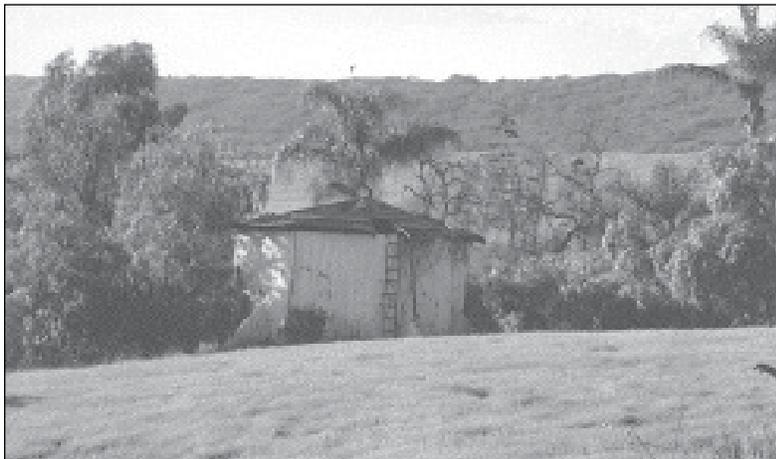
Water Tank (1998)

The water tank is approximately 20' wide x 10'-12' high. There are two large vertical cracks that need repair by epoxy anchoring and grout crack injection. The existing concrete buttresses are separating from the walls and will be anchored to the walls using epoxy. In addition, the temporary roof structure will be replaced with a historically accurate conical roof structure. Finally, all vegetation adjacent to the concrete walls will be removed.

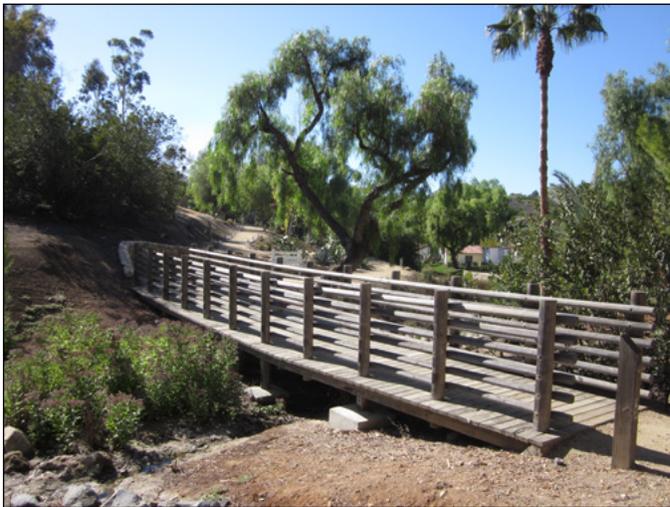
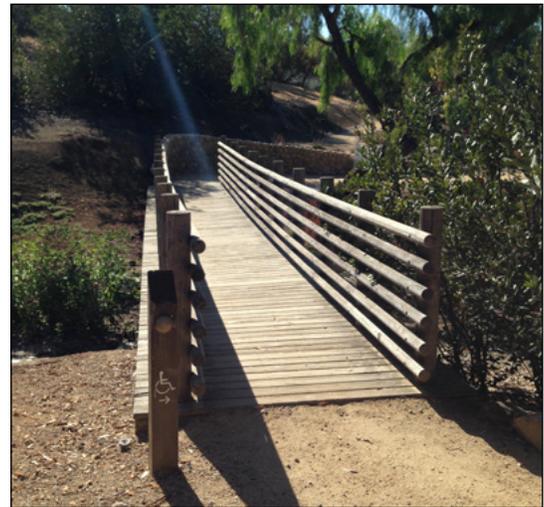
The new pedestrian bridge will be approximately 17' long x 5' wide and made of douglas fir lodge poles with a redwood decking. Simple steel bolts will be used as fasteners, and should be hidden where possible. See construction documents from Phase 2 for more information on construction details.

Existing Bridges - New bridge will be constructed to match existing bridges
