**REPORT OF PRELIMINARY GEOTECHNICAL  
INVESTIGATION**

Proposed 2-Story Valley View Office Building  
Palmer Way North of Impala Drive  
Carlsbad, California  
Assessor's Parcel No. 209-040-43-00

**JOB NO. 18-11749**  
23 February 2018

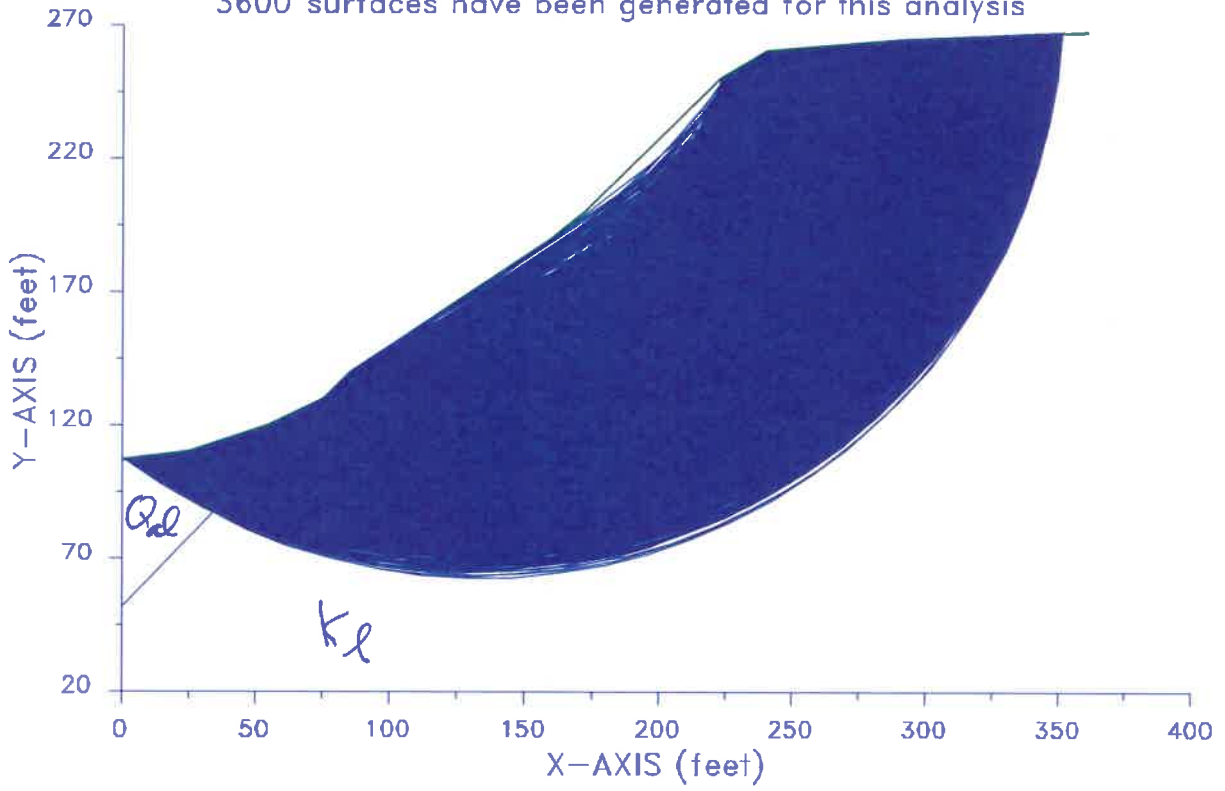
Valley View Section A peak  
3600 surfaces have been generated for this analysis

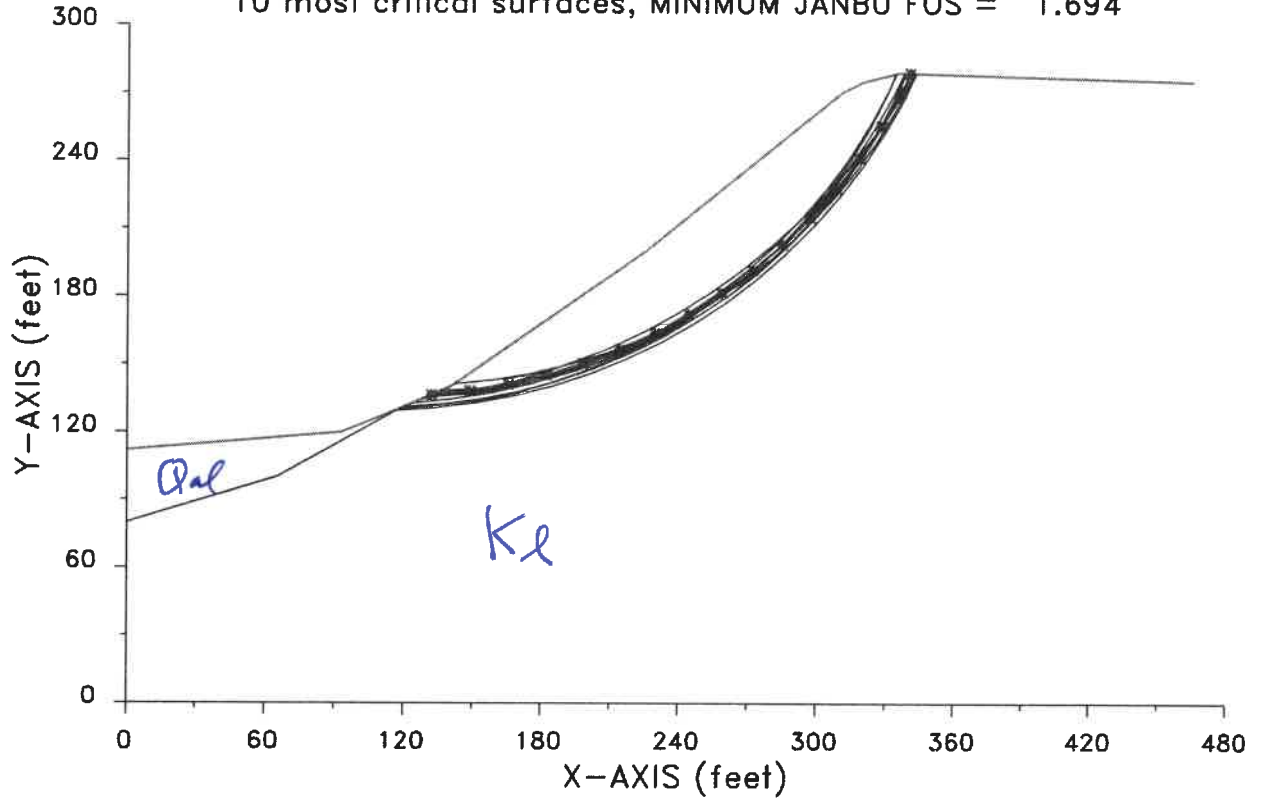
Valley View Section B

10 most critical surfaces, MINIMUM JANBU FOS = 1.694

Modified JANBU FOS	Correction Factor	Initial x-coord (ft)	Terminal x-coord (ft)	Available Strength (lb)
1.	1.694	1.055	131.69	340.10	7.117E+05
2.	1.697	1.055	123.56	339.86	7.345E+05
3.	1.698	1.056	141.86	341.86	7.115E+05
4.	1.698	1.050	127.63	341.70	6.752E+05
5.	1.699	1.059	135.76	337.92	7.384E+05
6.	1.700	1.057	119.49	339.72	7.803E+05
7.	1.701	1.057	129.66	333.71	6.780E+05
8.	1.702	1.059	129.66	333.44	7.084E+05
9.	1.702	1.058	117.46	342.41	8.324E+05
10.	1.703	1.057	115.42	337.25	7.539E+05

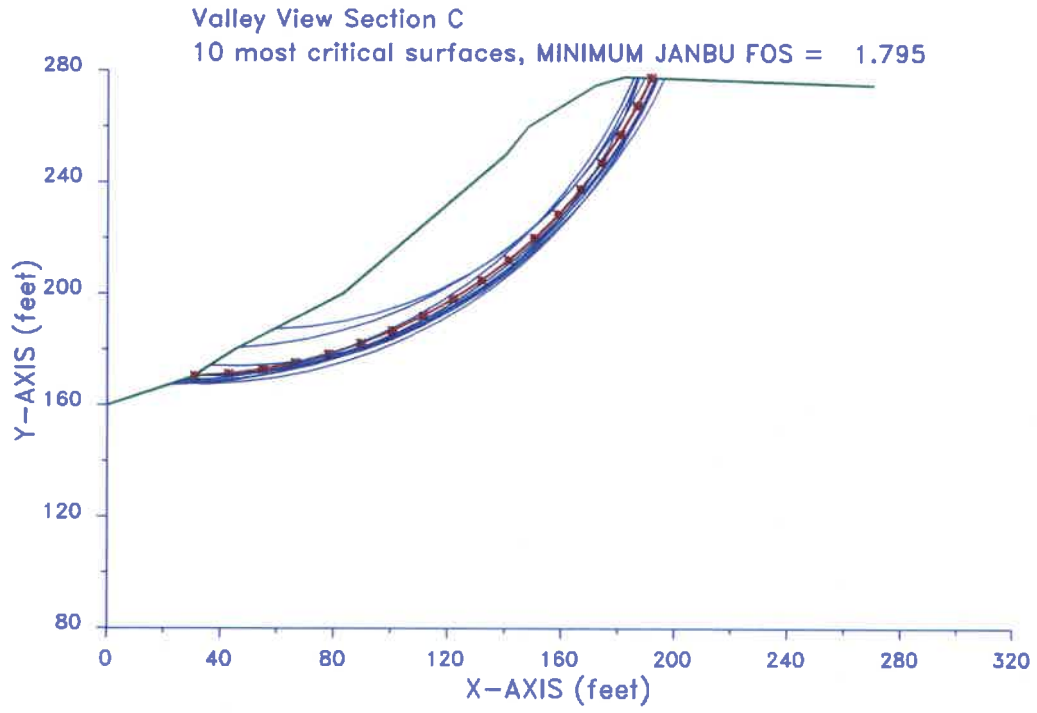
SECTION C – C'

Modified JANBU FOS	Correction Factor	Initial x-coord (ft)	Terminal x-coord (ft)	Available Strength (lb)
1.	1.795	1.057	30.90	191.38	4.631E+05
2.	1.798	1.059	30.90	192.69	4.966E+05
3.	1.802	1.061	30.90	193.45	5.157E+05
4.	1.804	1.060	59.37	186.46	3.379E+05
5.	1.805	1.057	22.36	193.56	5.002E+05
6.	1.806	1.058	25.20	196.01	5.246E+05
7.	1.807	1.056	46.56	189.02	3.680E+05
8.	1.807	1.058	26.63	185.22	4.295E+05
9.	1.807	1.062	23.78	192.70	5.424E+05
10.	1.808	1.065	36.59	186.88	4.685E+05
