**DRAFT**  
**GEOTECHNICAL BASIS OF DESIGN**  
**CARLSBAD BEACH ACCESS REPAIRS**  
**CARLSBAD, CALIFORNIA**

*REFERENCE: CIP PROJECT 3896*

Prepared by  
**TERRACOSTA CONSULTING GROUP, INC.**  
San Diego, California

Project No. 3009  
July 3, 2018

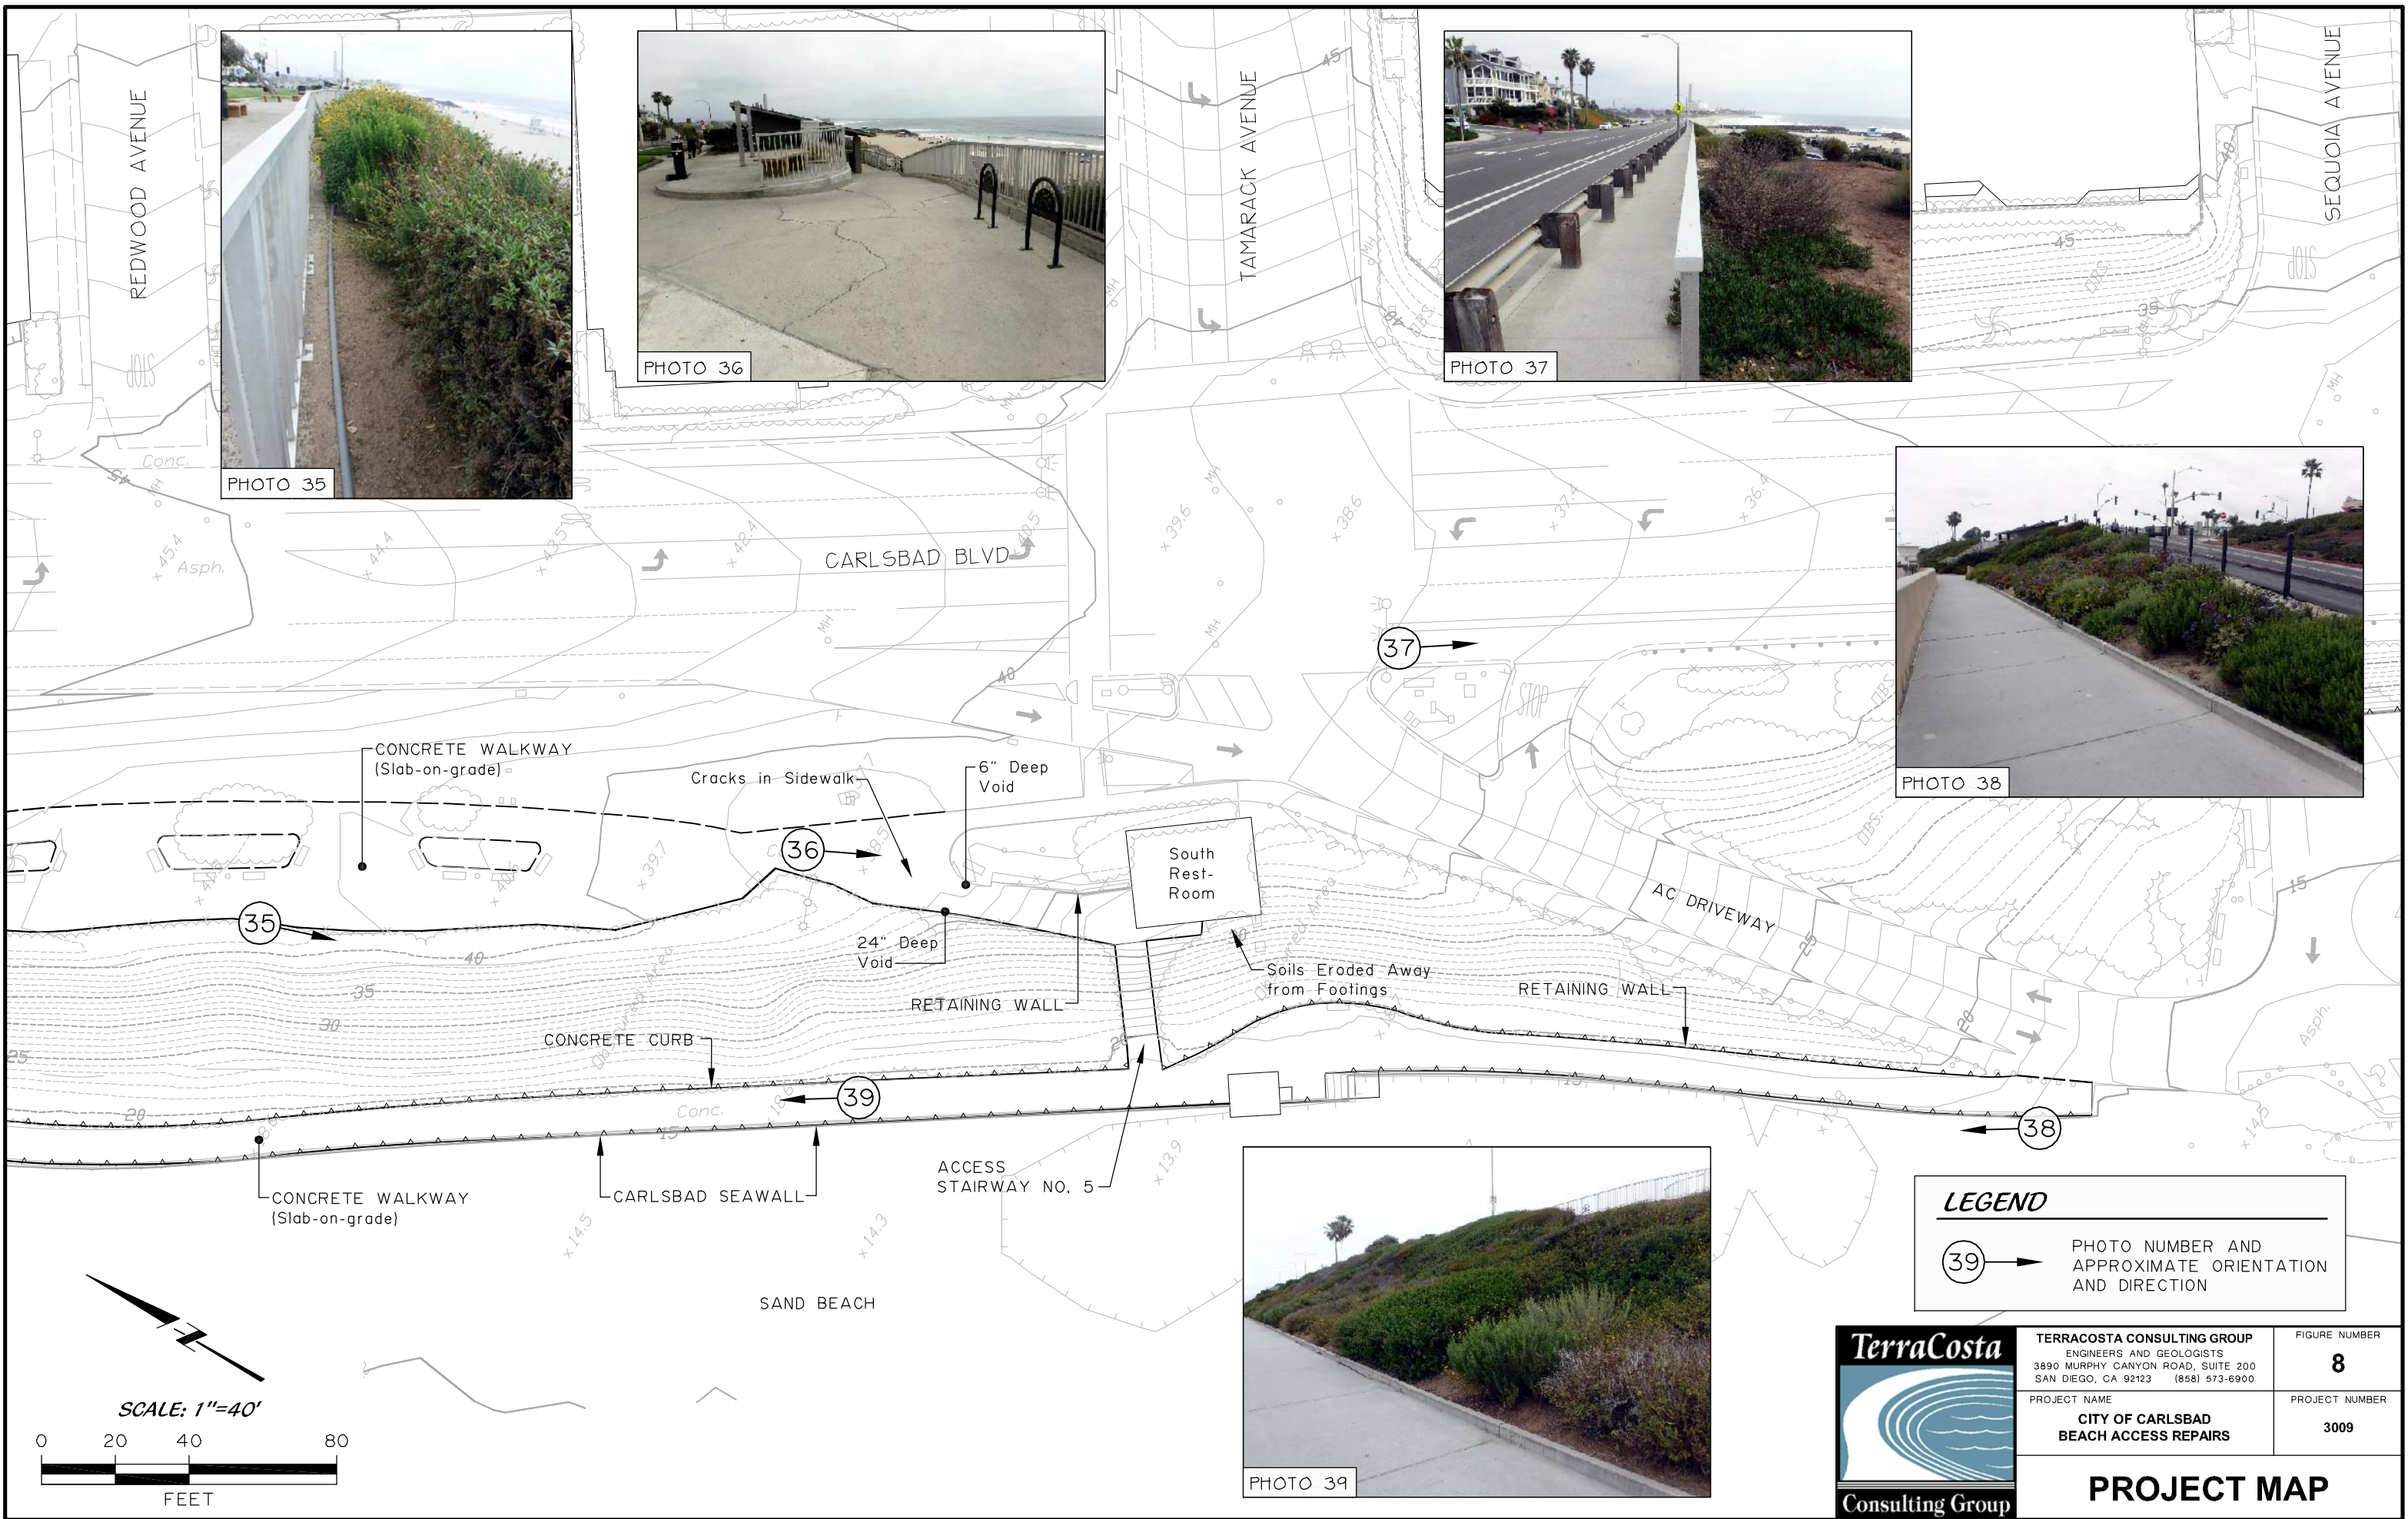
<b>TERRACOSTA CONSULTING GROUP</b> ENGINEERS AND GEOLOGISTS 3890 MURPHY CANYON ROAD, SUITE 200 SAN DIEGO, CA 92123 (858) 573-6900	FIGURE NUMBER <b>8</b>
	PROJECT NAME <b>CITY OF CARLSBAD          BEACH ACCESS REPAIRS</b>	PROJECT NUMBER <b>3009</b>
<b>PROJECT MAP</b>

A concrete stairway and the southerly restroom building are located at the western terminus of Tamarack Avenue in the project area. This stairway is labeled as Access Stairway No. 5 on Figure 8. Photos of this stairway and restroom building are included in Appendix A. This stairway consists of concrete steps on grade that descend from the restroom to the bluff-toe walkway.

Cracks in the sloping sidewalk were observed and voids under the sidewalk were detected (see Figure 8 and photos in Appendix A). Rodent burrows were observed adjacent to the restroom and hardscape improvements. Soils have been eroded away from the foundations for the restroom (likely by surface water, rodents, and gravity).

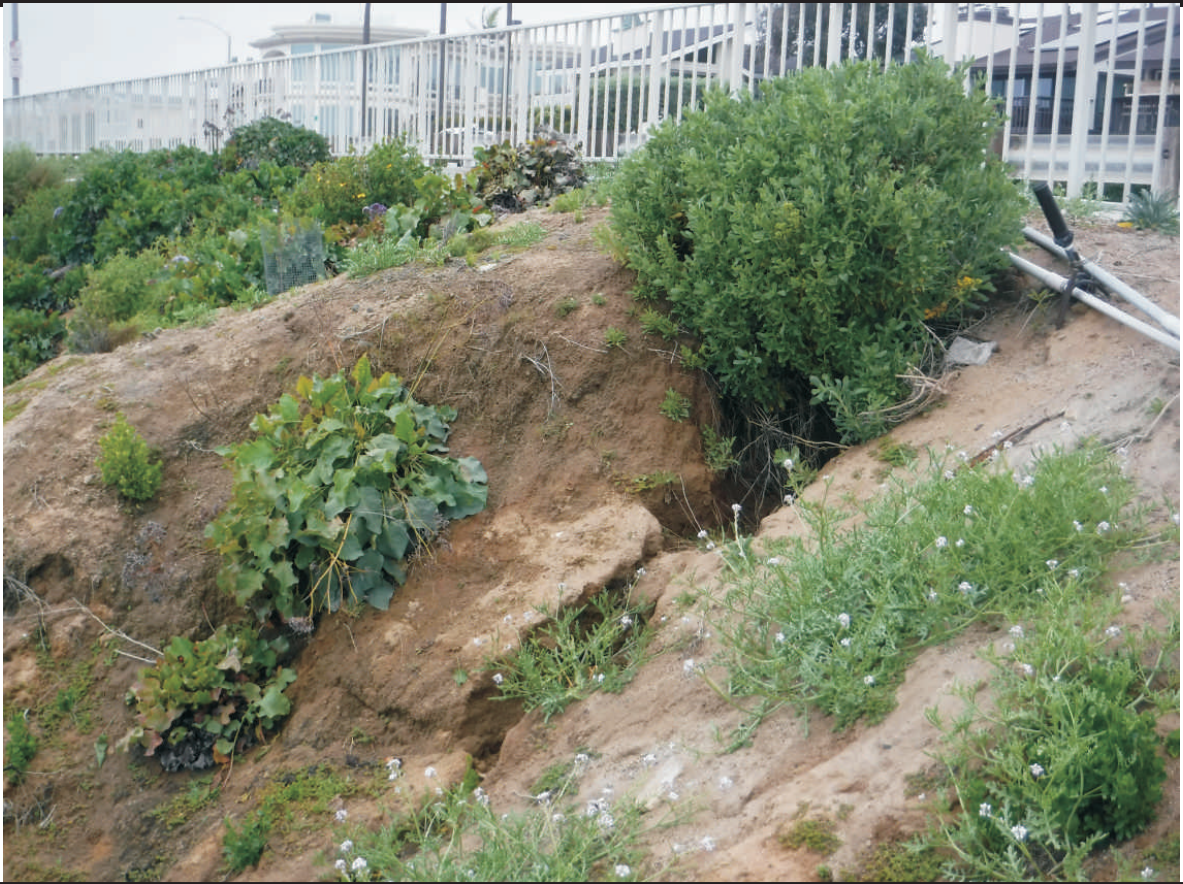
APPENDIX FIGURE NO.:  
**A-2b**

GULLY AND  
WET SOILS  
(Due to  
irrigation leak?)

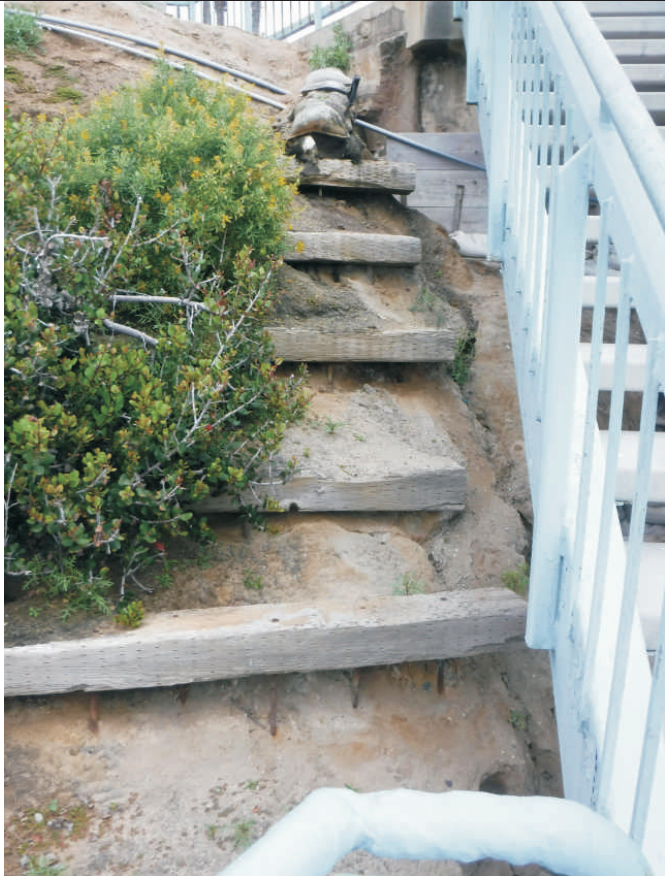
APPENDIX FIGURE NO.:  
**A-2c**

NORTH SIDE  
(Old Stairway)

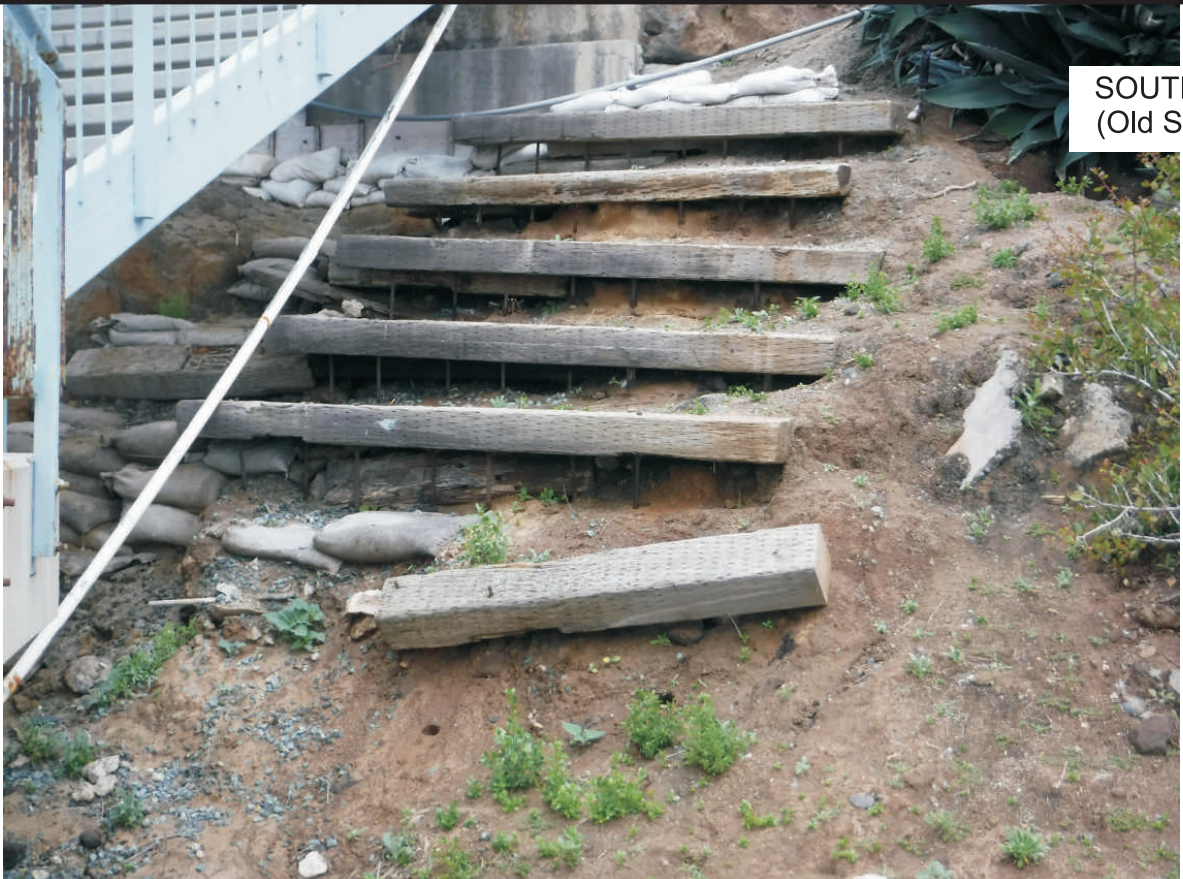
SOUTH SIDE  
(Old Stairway)

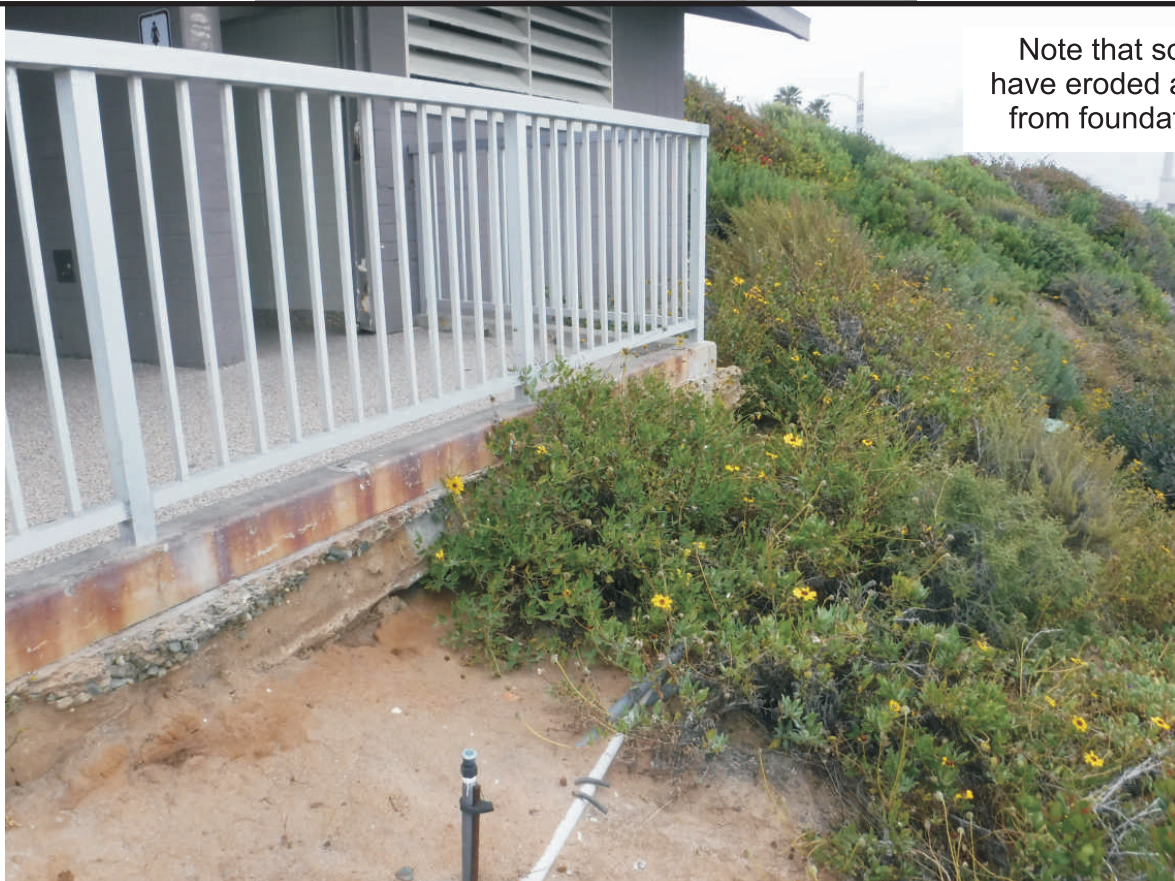
APPENDIX FIGURE NO.:  
**A-5a**

Note that soils have eroded away from foundation

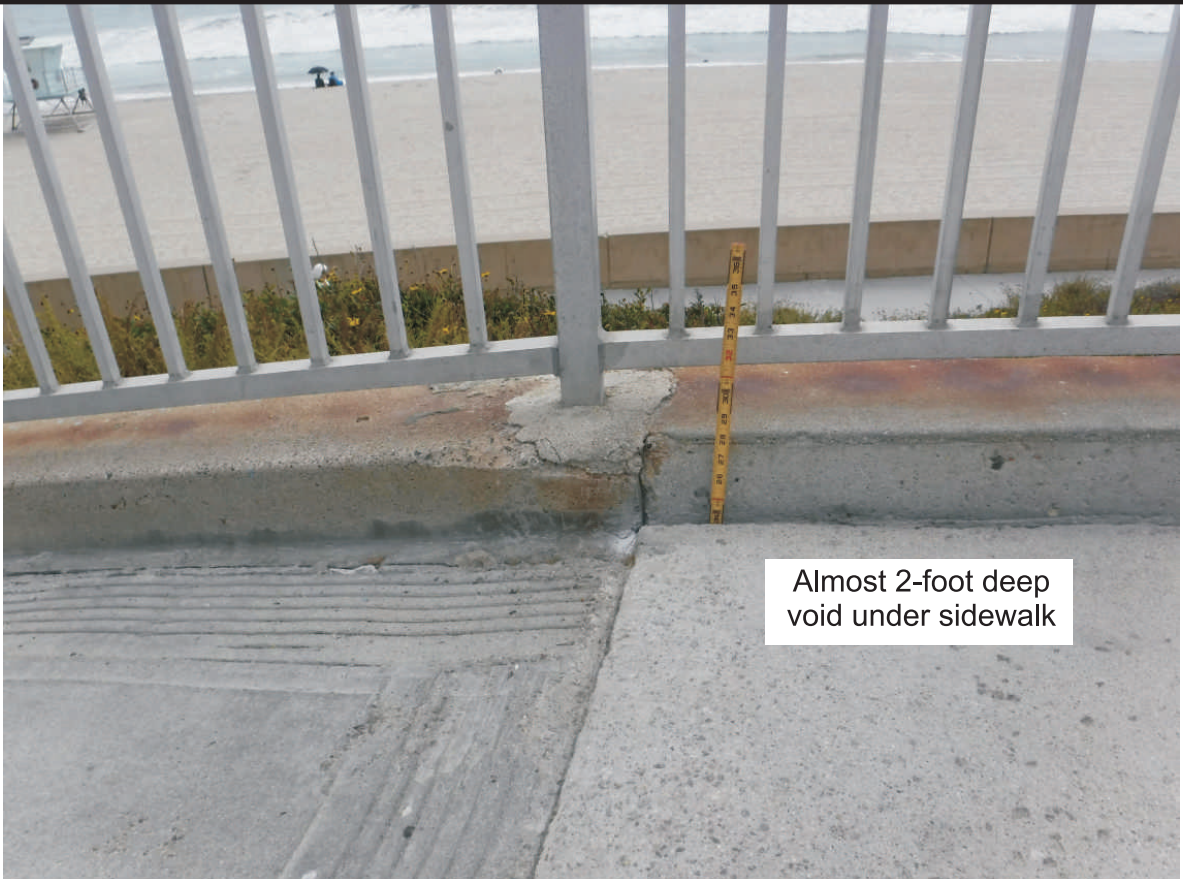
APPENDIX FIGURE NO.:  
**A-5b**

Almost 2-foot deep  
void under sidewalk

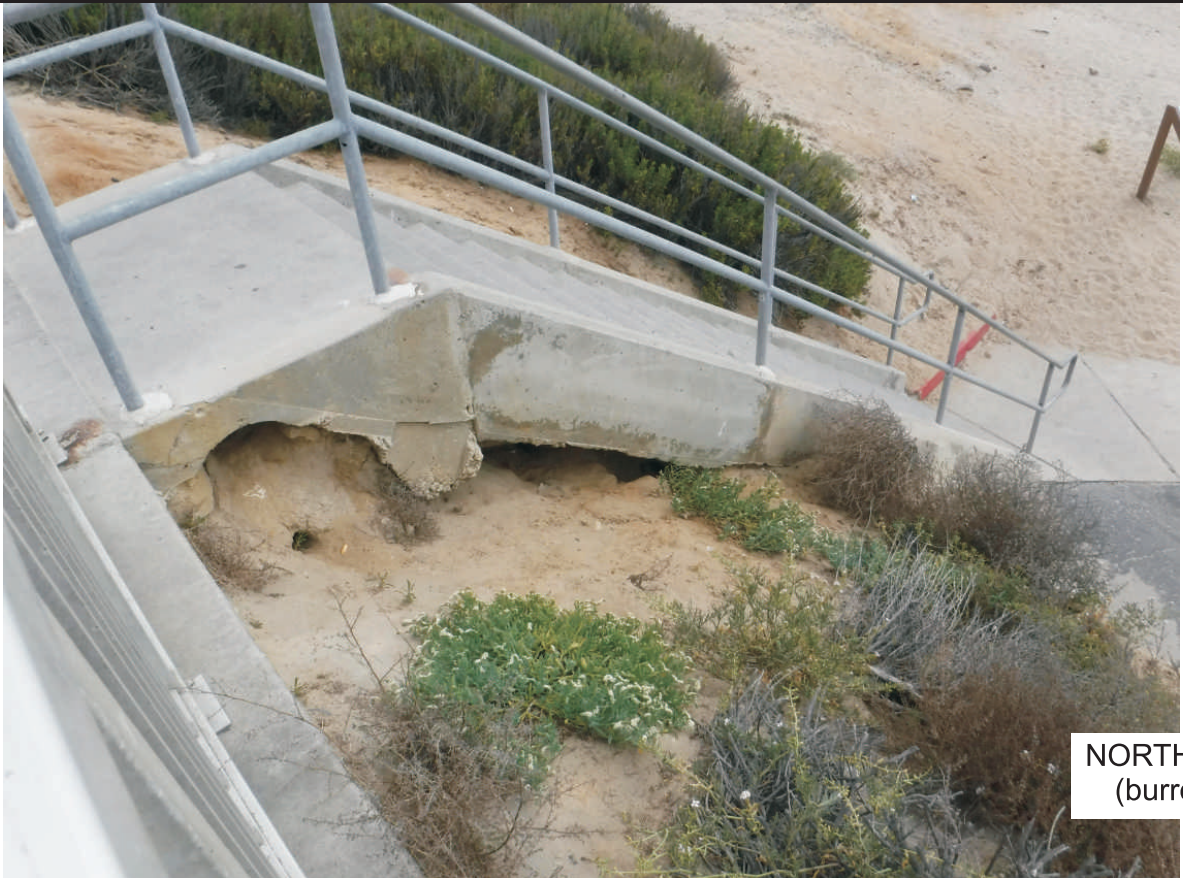
APPENDIX FIGURE NO.:  
**A-6**

NORTH SIDE  
(burrows)

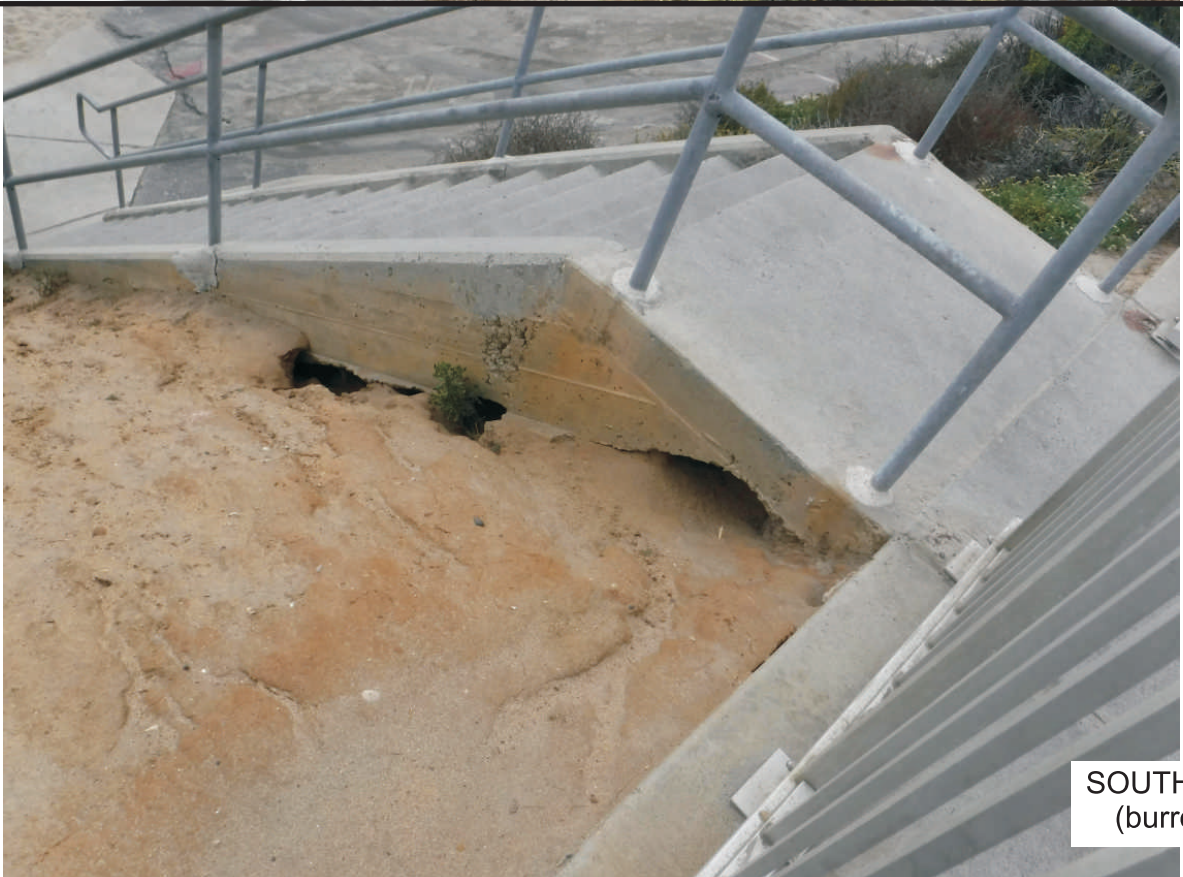
SOUTH SIDE  
(burrows)
